Wagga Wagga

Urban Salinity Status Report

July 2009 – June 2010

Prepared by the Directorate of Environment and Community Services
Wagga Wagga City Council

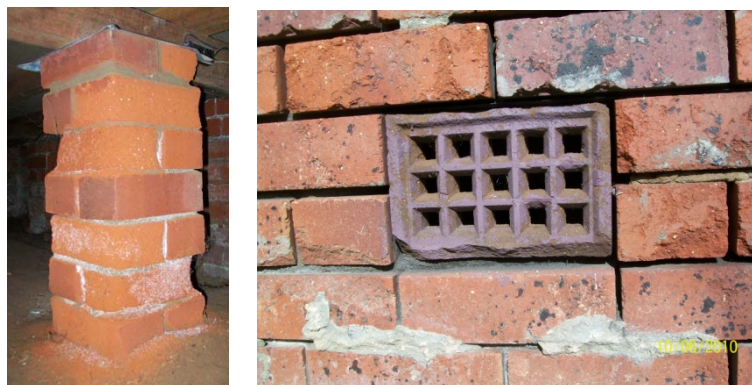
- Damage to houses, buildings and other structures caused by the weakening of brick (Figure 1), mortar and concrete due to saline water crystallising in the brickwork;

Figure 1: Salt damage to footings and mortar at a residential dwelling, Turvey Park, Wagga Wagga.

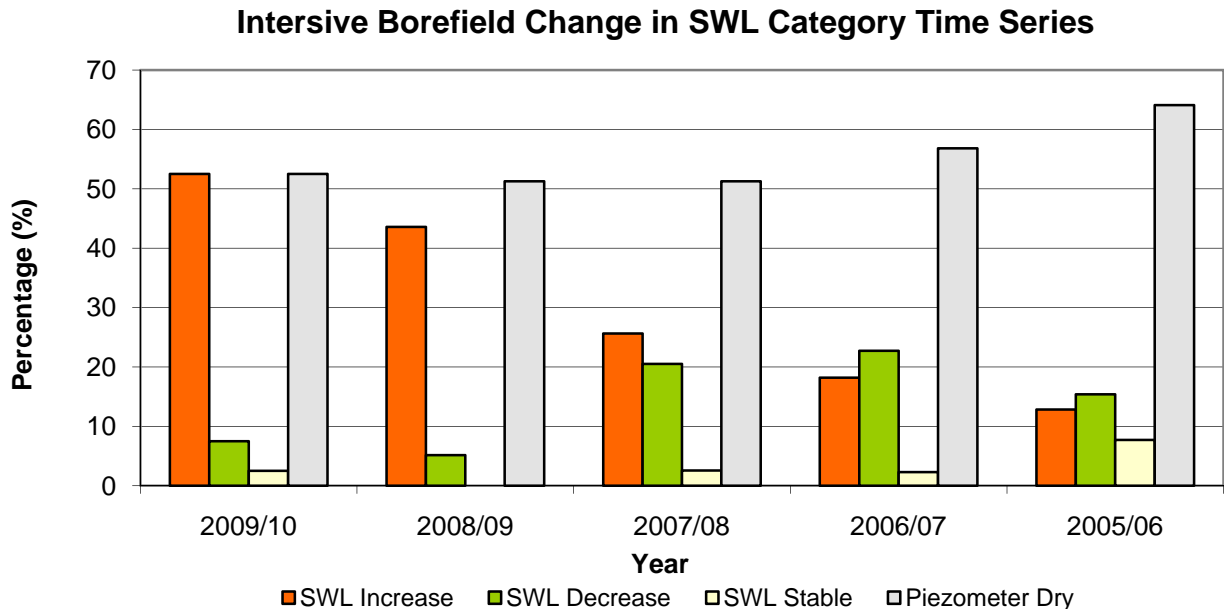
Figure 5. A comparison between change in SWL category in the Intensive Borefield from 2005/06 to 2009/10

The change in SWL over the last five reporting periods is presented in Figure 5. The figure shows an upward trend in the number of increasing piezometers since 2005/06. The number of increasing piezometers has risen significantly since the turning off of the dewatering bores in June 2008. It must be noted that the dewatering bores were previously switched off from February 23 to March 30, 2007.

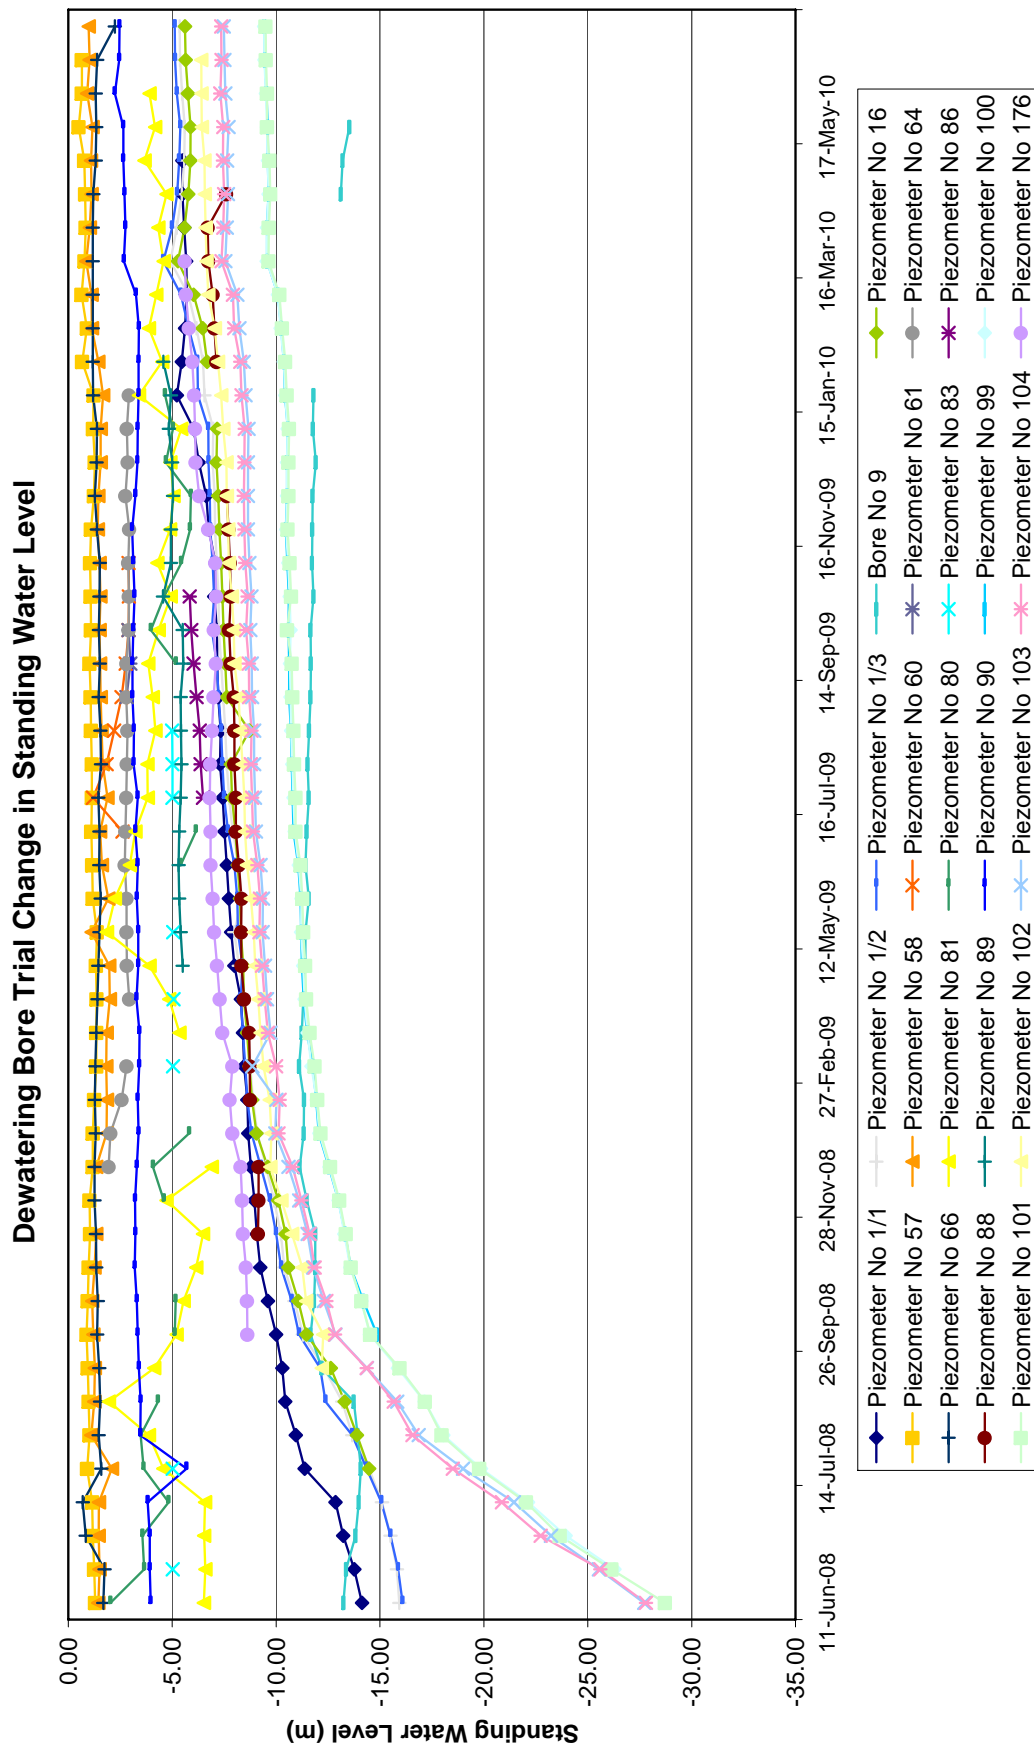
A graph depicting the response from water bearing piezometers in the intensive borefield to the dewatering trial are shown in Figure 6. Two groups can be distinguished from the figure. The first group incorporates shallow piezometers and the graph shows no distinct change in groundwater levels caused by the switching off of the dewatering bores. The three piezometers (no. 57, no.58 and no.66) unaffected by the switching off of the dewatering bores are all located in Chaston Street or Mortimer Place. This suggested that the radius of influence of the dewatering bores is limited.

Figure 6. The change in SWL for water bearing piezometers in the intensive borefield during the dewatering trial

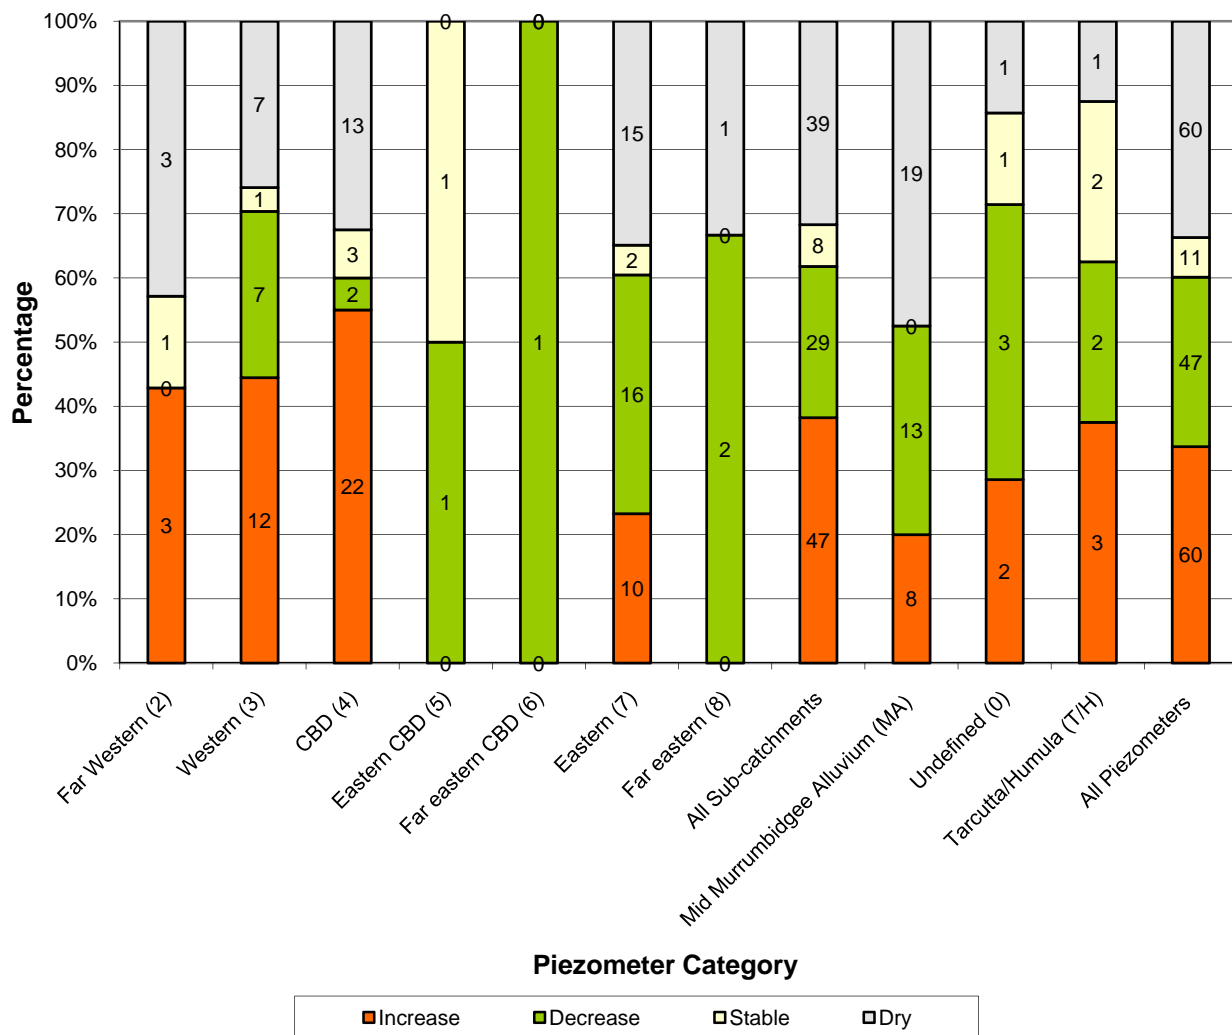
Piezometers that contained water in the previous year that are now dry have been included in the 'SWL decreased' category, whereas piezometers that started as dry but now contain groundwater have been included in the 'SWL increased' category. These results were omitted from average increase/decrease calculations. Graphs of individual piezometers containing groundwater have been placed in Appendix D.

Figure 8: Chart depicting change in Standing Water Levels for each piezometer category

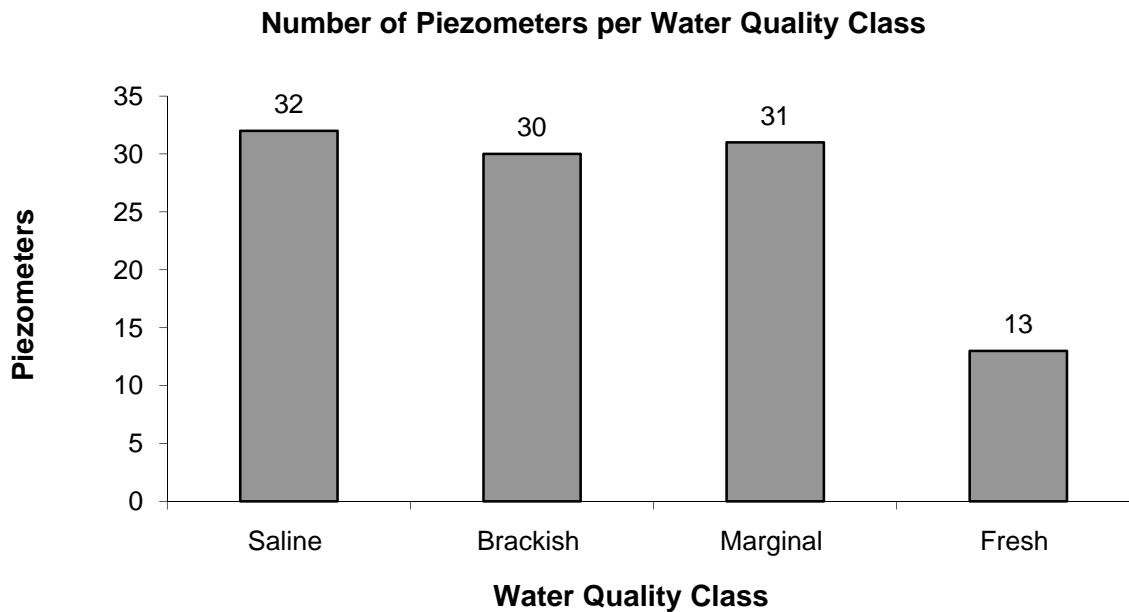
The number of piezometers in each water quality class is presented in Figure 9. Similar numbers of piezometers were defined within the saline, brackish and marginal water quality classes.

Figure 9: Average EC 2009/10 water quality classes
