Wagga Wagga Urban Salinity Status Report

2011-2012

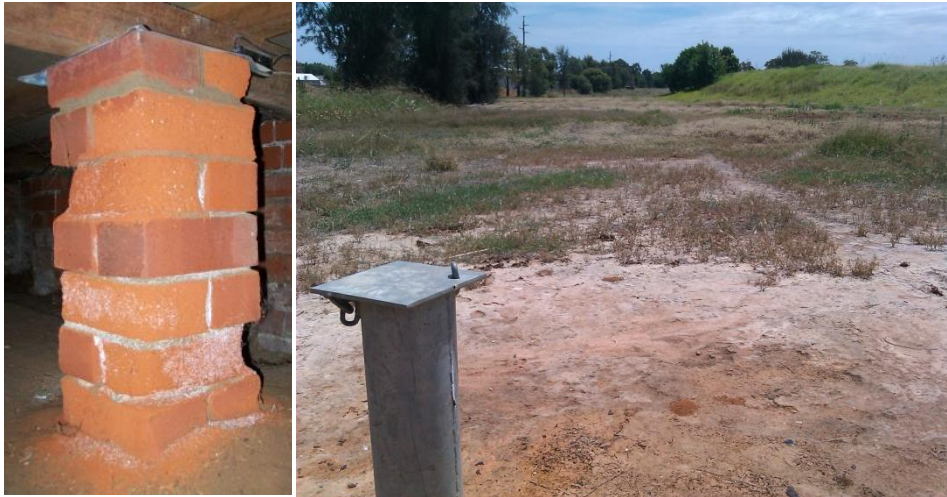
Figure 1: Salt damage to footings (left) and salt scalding (right), Turvey Park, Wagga Wagga.

- Damage to houses, buildings and other structures caused by the weakening of brick (Figure 1), mortar and concrete due to saline water crystallising in the brickwork;

- Septic tank failures due to high water tables can lead to other environmental and health concerns;
- Loss of amenity in recreational areas such as parks, gardens and sporting fields due to salt and waterlogging causing salt scalds and bare patches where vegetation fails to grow (Figure 1); and

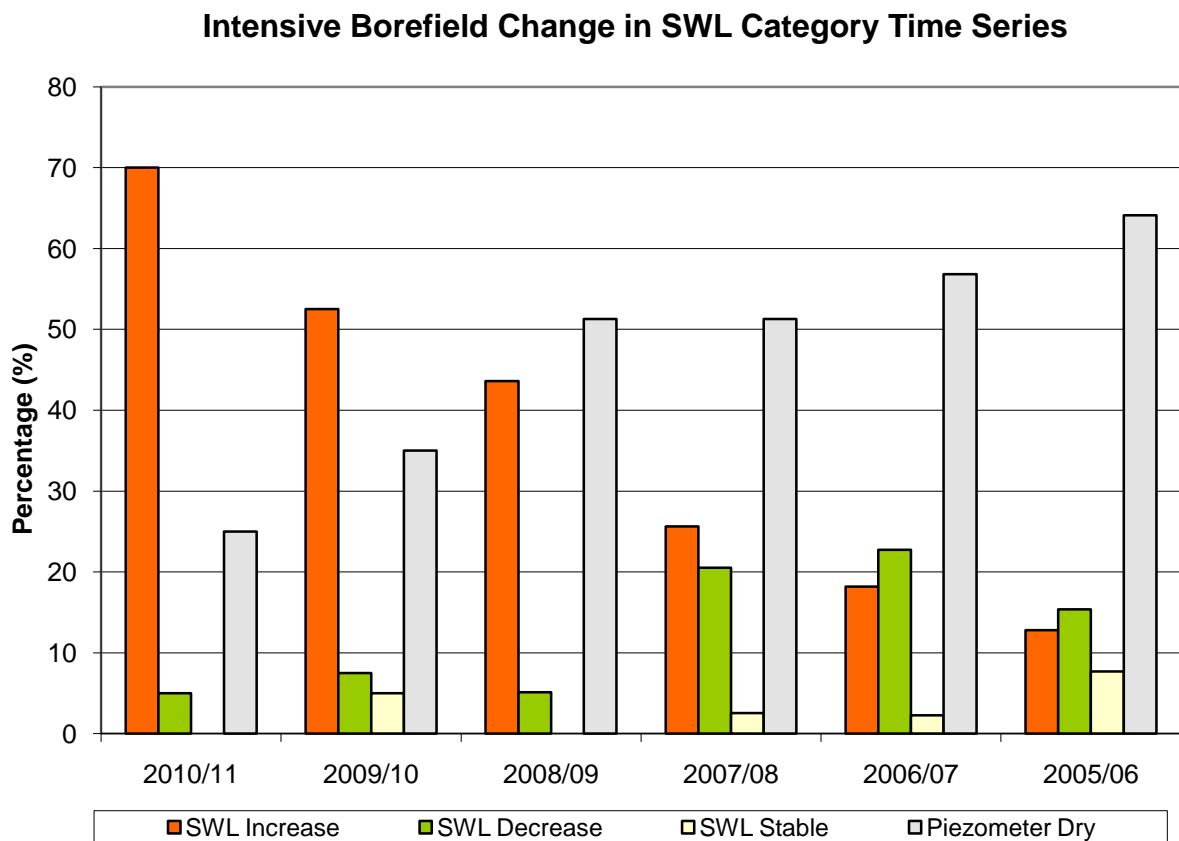
Figure 5. A comparison between changes in SWL category in the Intensive Borefield from 2005/06 to 2010/11.

The change in SWL over the last six reporting periods is presented in Figure 5. The figure shows an almost lineal upward trend in the number of increasing SWL piezometers since 2005/06. The number of increasing piezometers has risen significantly since the turning off

of the dewatering bores in June 2008. It must be noted that the dewatering bores were previously switched off between February 23 and March 30, 2007.

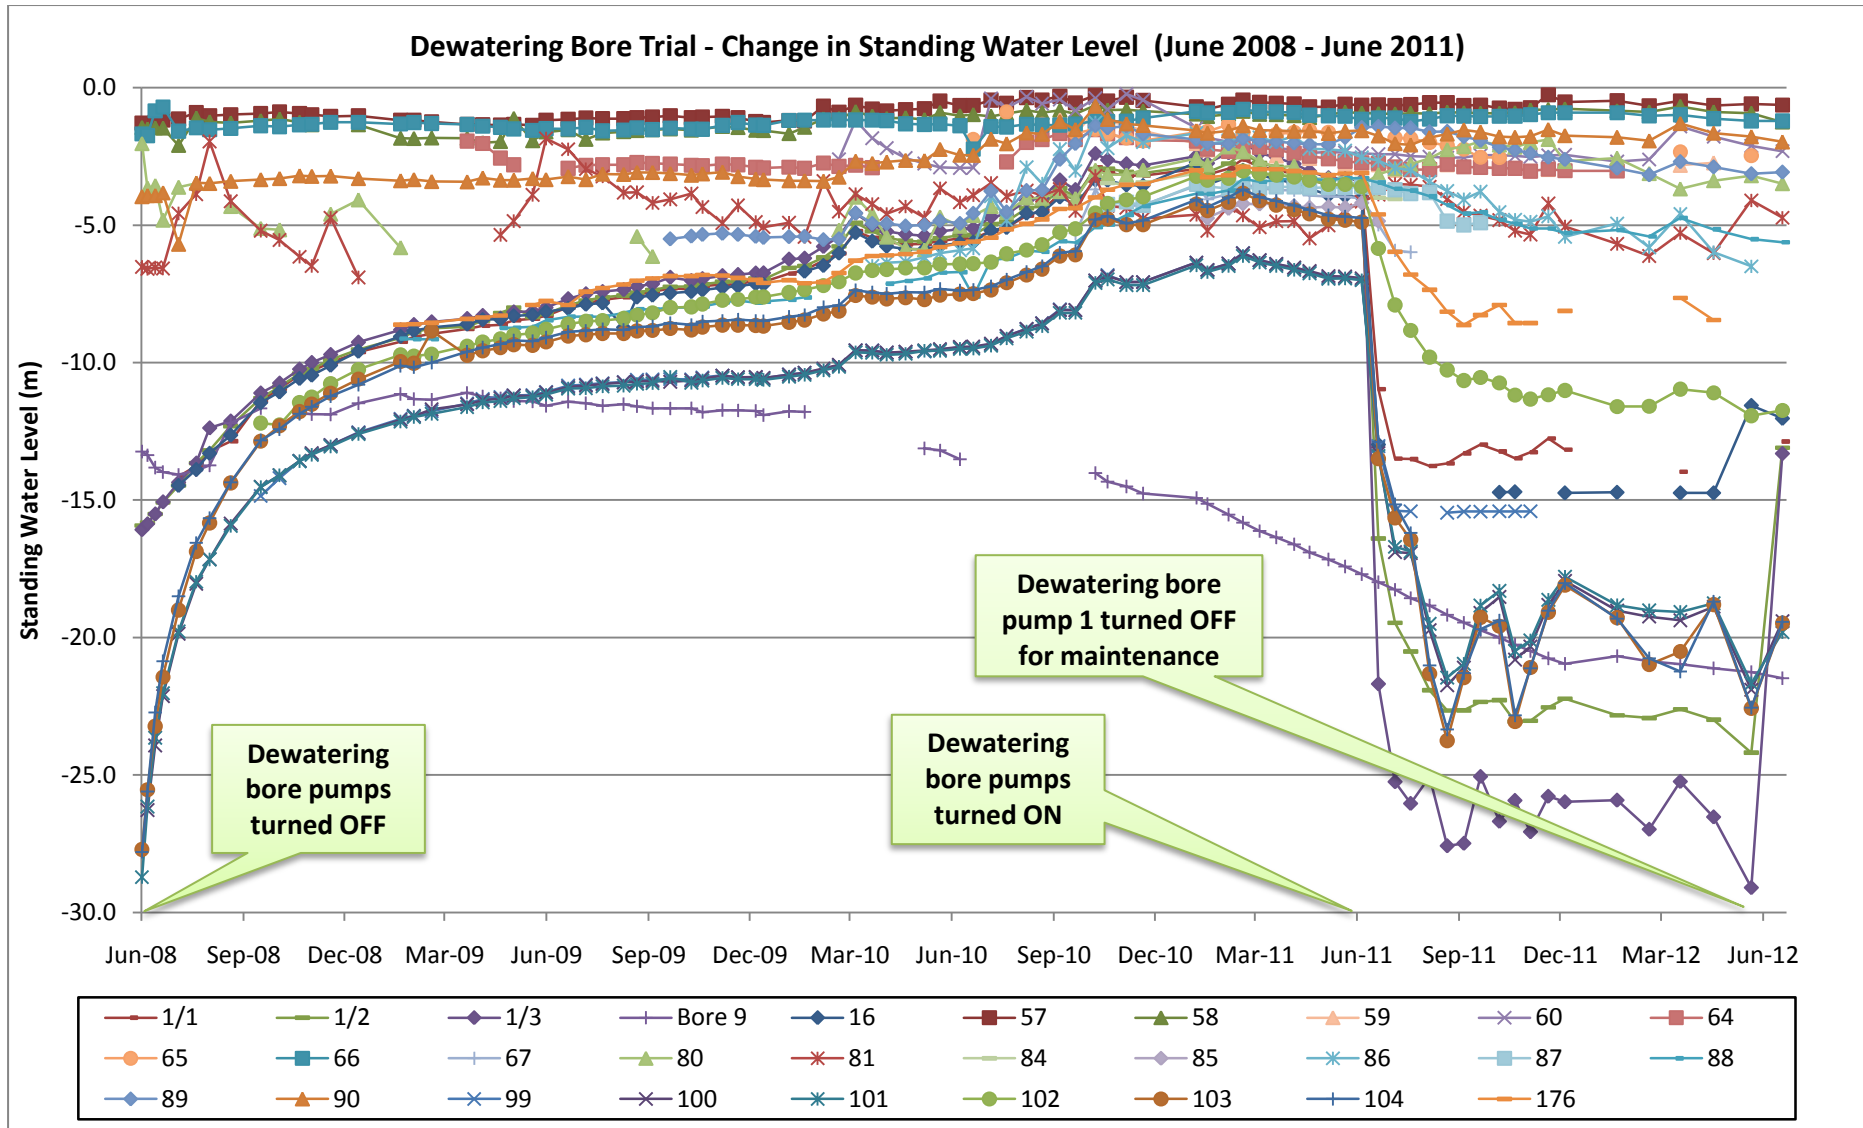
Figure 6. The change in SWL for water bearing piezometers in the intensive borefield during and after the dewatering trial.

A graph depicting the response from water bearing piezometers in the intensive borefield to the dewatering trial are shown in Figure 6. Two groups can be distinguished from the figure. The first group incorporates shallow piezometers and the graph shows no distinct change in groundwater levels caused by the switching off of the dewatering bores. The three piezometers (no. 57, no.58 and no.66) unaffected by the switching off of the dewatering bores are all located in Chaston Street or Mortimer Place. This suggested that the radius of influence of the dewatering bores is limited. Piezometer no. 90 located on the corner of Chaston Street and Cullen Road has experienced a slight but gradual increase in SWL over the trial period.

Nine dewatering bores were switched on in June 2011. Figure 6 shows the hydrographs of the affected piezometers declining sharply as SWL responds to the pumping. Not surprisingly, these piezometers are the same deeper drilled group that exhibited an instantaneous increase in SWL when the dewatering pumps were turned off.

Table 1 reveals the overall rate of change as shown by the dewatering bore trial hydrograph (Figure 6). A general trend followed that the 3 metre shallow drilled piezometers (no 57-66) exhibited negligible movement in DWT after the pumps were turned back ON. Piezometers drilled to a depth of between 3.40m - 10m returned to a DRY state or decreased in DWT after pumps turned ON. Deeper drilled piezometers of between 15.0m - 61.0m in depth showed an immediate decrease in DWT after pumps turned ON.

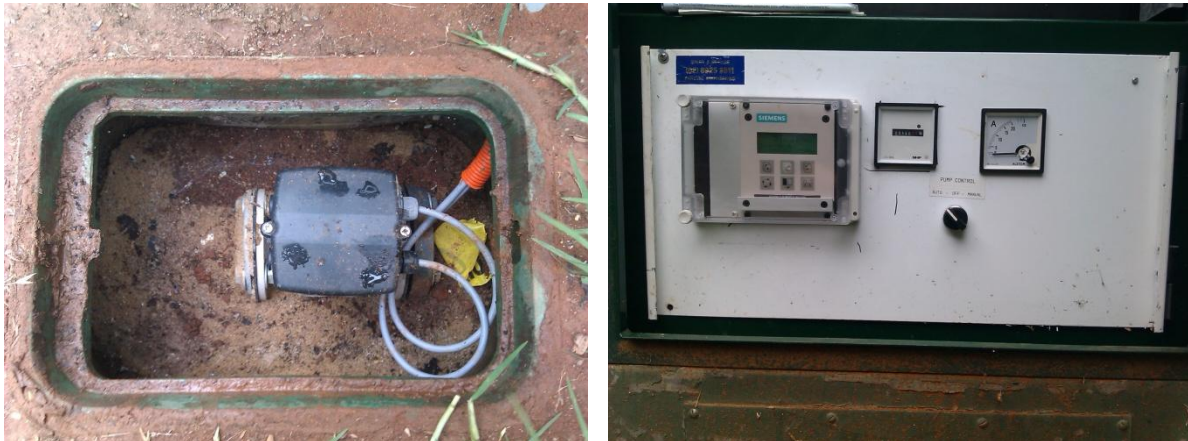
Figure 7: Electromagnetic flow meter and transmitter fitted to six Calvary Borefield pumps.

In September 2011, six electromagnetic flow meters and transmitters (Figure 7) were fitted to nine of the Calvary precinct pumping bores. Mechanical flow meters in Bores 2, 3, 4, 5, 6 and 8 were upgraded in order to minimise inaccuracies in flow readings given by the older style analog meters that were prone to mechanical and human error. Meters were replaced based on their levels of historical inaccuracies during borefield pumping readings.

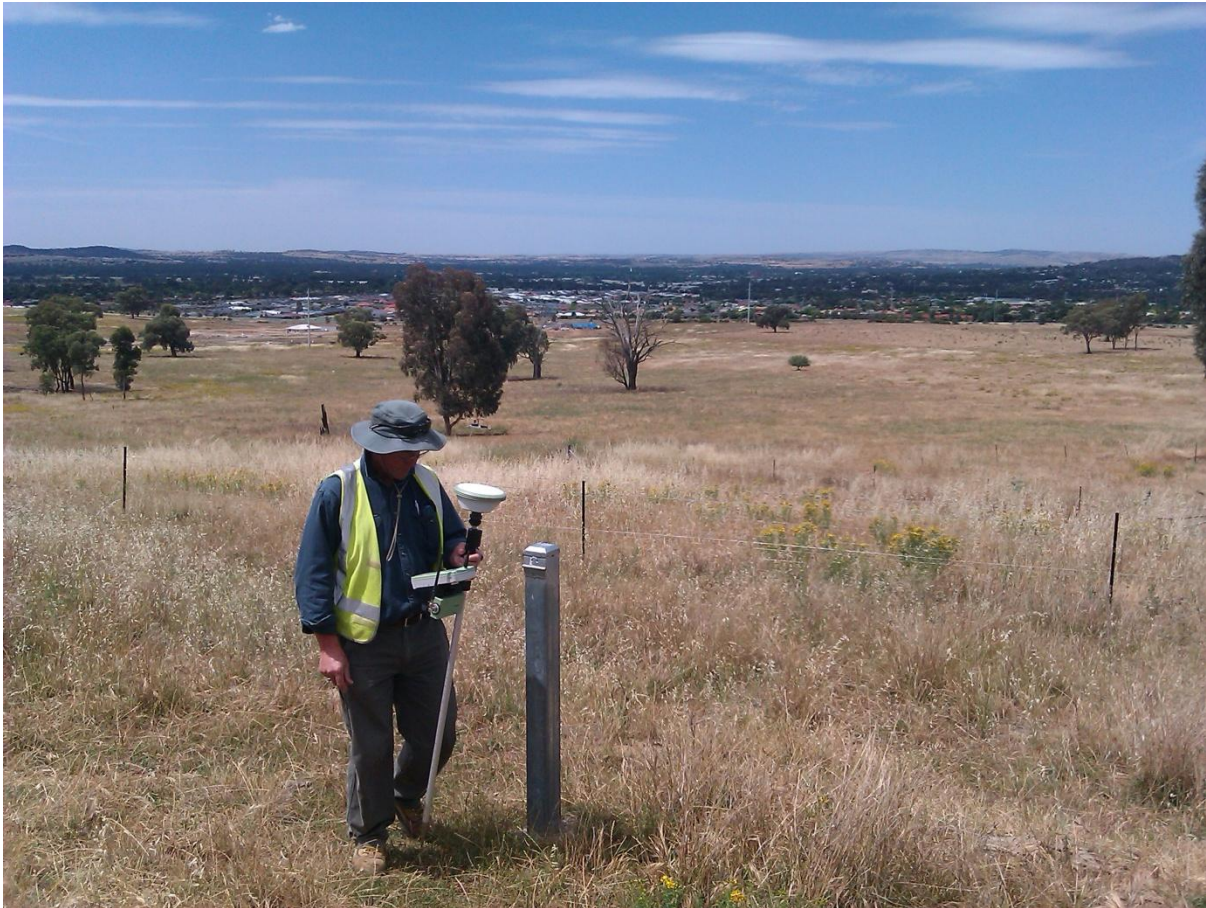
Figure 8: Differential GPS readings are taken following construction of a Lloyd West piezometer.

Eleven groundwater monitoring piezometers were constructed within selected areas and boundaries of the new subdivision of Lloyd West in June 2011. All piezometers were constructed to a depth of 24.0 - 25.0m. At the time of drilling, four piezometers were found to contain water, with the remainder in a dry state. These piezometers have now become part of Council's groundwater monitoring network and will be monitored on a quarterly basis (Figure 8).

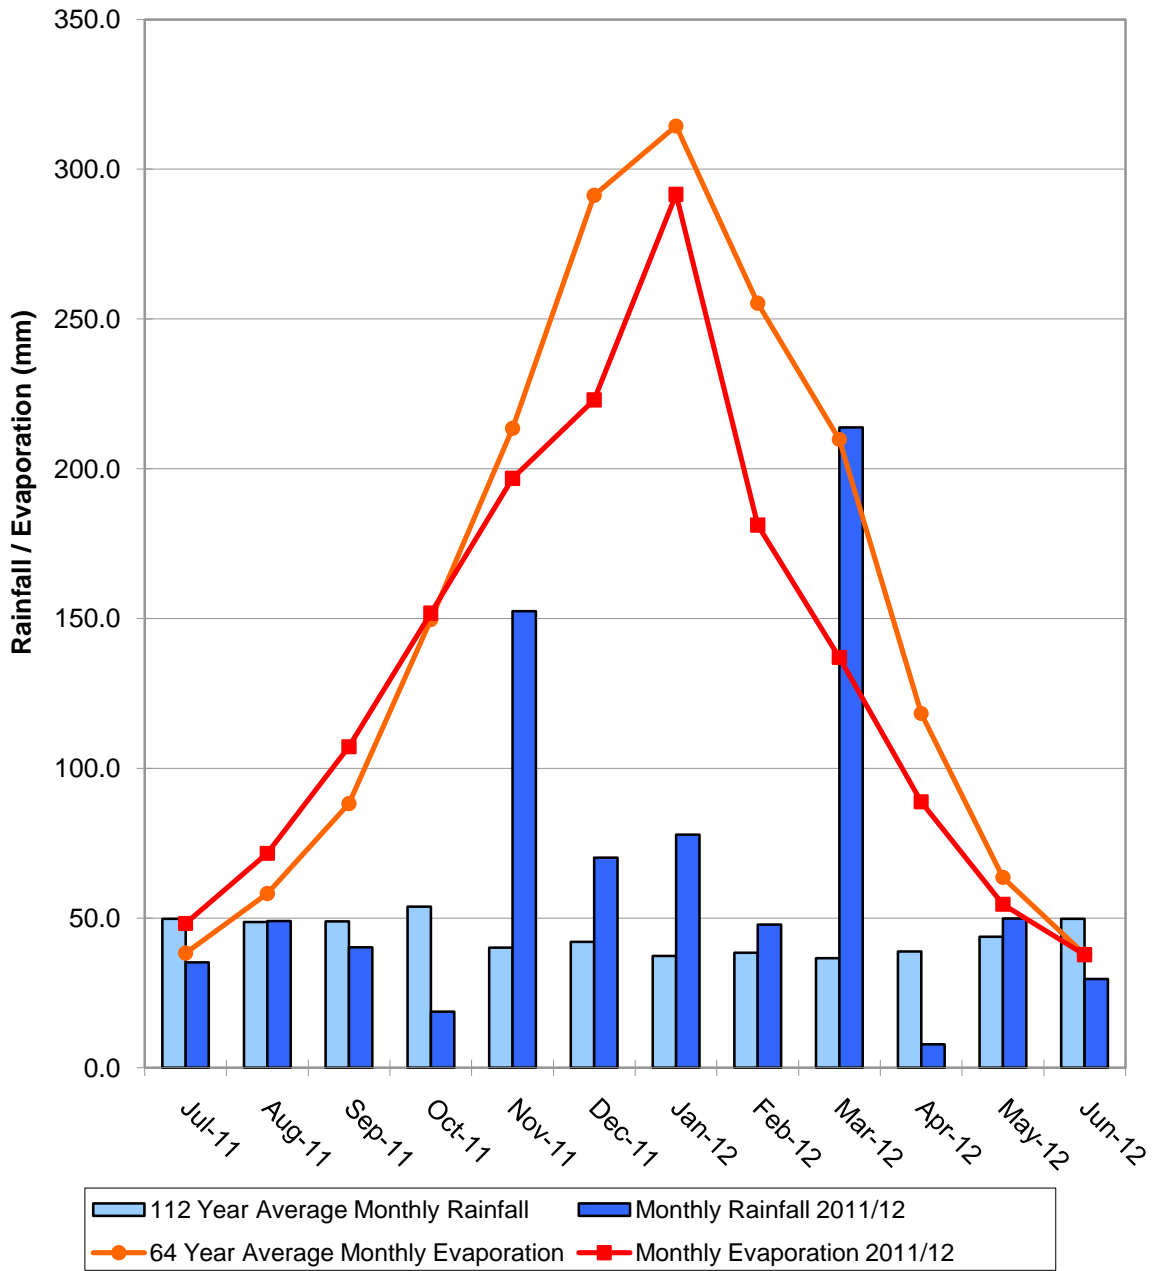
Long Term versus Short Term Rainfall and Evaporation Data for Wagga Wagga

Figure 9: Monthly rainfall and evaporation graph for Wagga Wagga 2011/12.

Long term monthly rainfall averages were exceeded on four occasions during 2011/12, with November 2011, December 2011, January 2012 and March 2012 recording 152mm, 70mm, 78mm and 214mm respectively. These widespread high summer rainfall events resulted in major flooding throughout the district caused by runoff inundation and high river levels.

Monthly rainfall exceeded evaporation on one occasion, during March 2012.

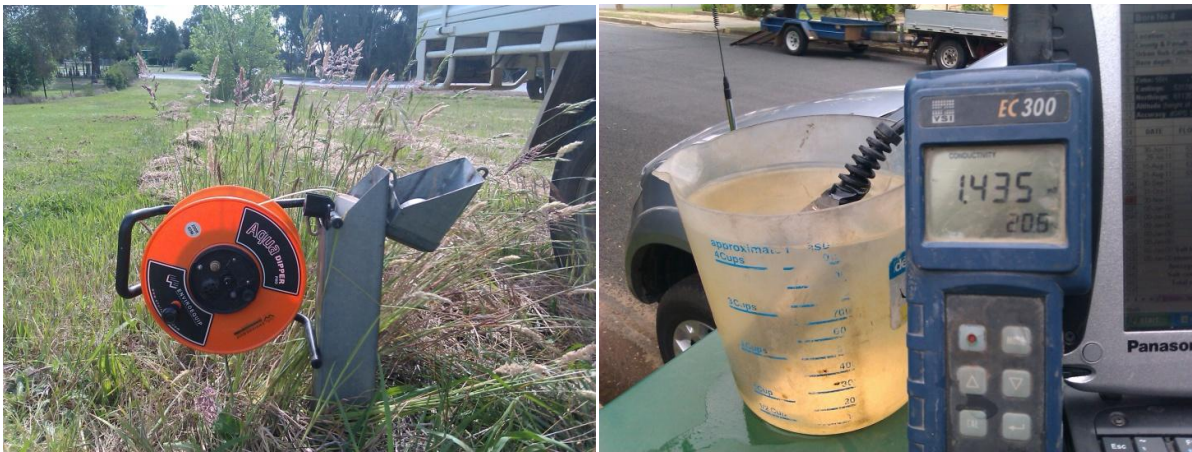
Figure 10: Measuring standing water level (left) and electrical conductivity (right) of groundwater.

Standing water level (SWL) and electrical conductivity (EC) readings are collected and used to monitor urban salinity. The SWL is measured in metres below the ground surface to the nearest centimetre using a water level meter. Measurements are taken from the height of the piezometer casing and the height of the extension subtracted from the reading. Piezometers at ground level do not require a subtraction. Water is extracted from the piezometer using a bailer to measure for EC. The EC is measured in decisiemens per metre (dS/m) to two decimal places using a handheld conductivity meter (Figure 10).

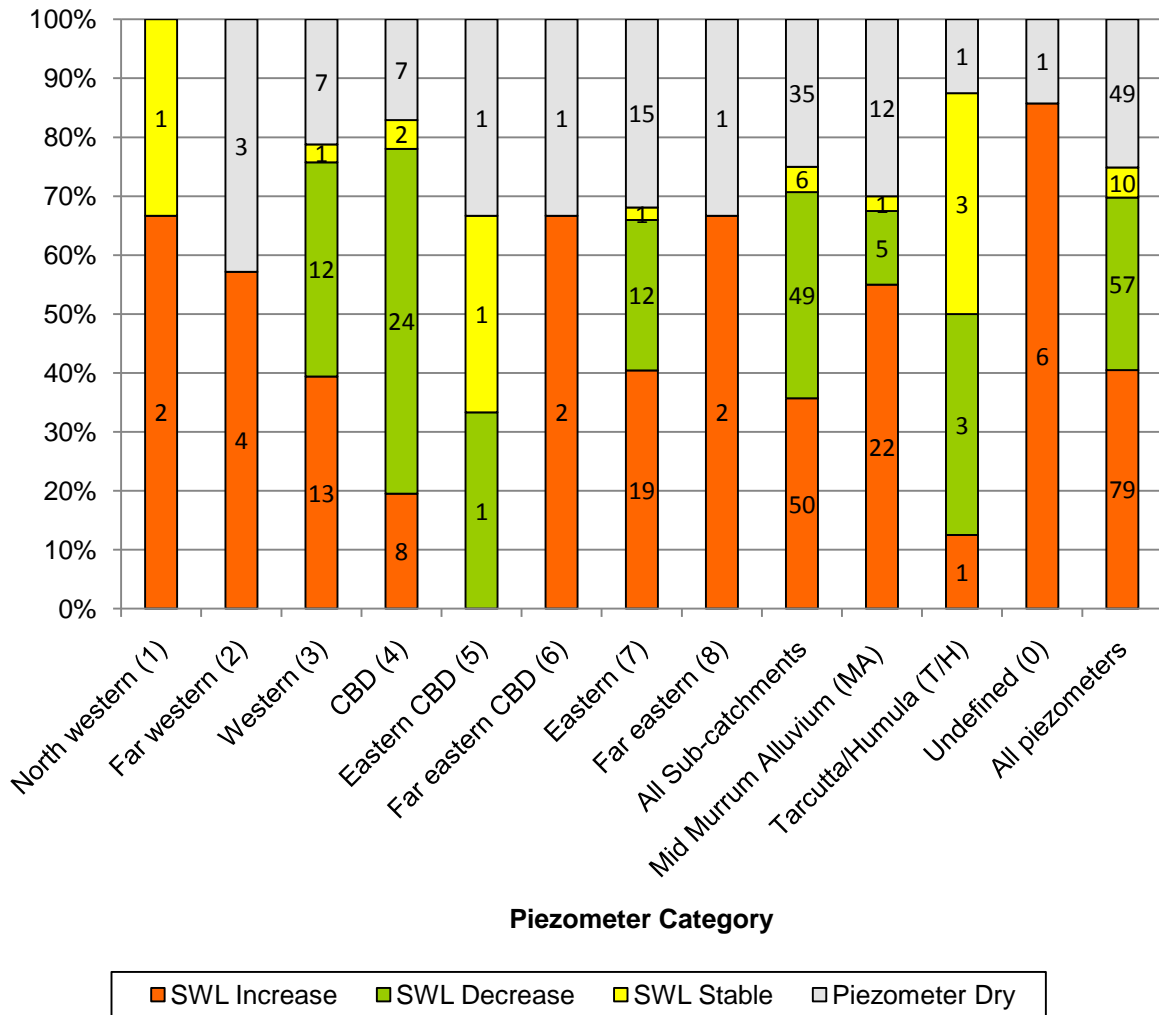
Standing Water Level for each Piezometer Category 2011/12

Figure 11: Chart depicting change in Standing Water Levels for each piezometer category

Piezometers that contained water in the previous year that are now dry have been included in the 'SWL decreased' category, whereas piezometers that started as dry but now contain groundwater have been included in the 'SWL increased' category. These results were omitted from average increase/decrease calculations. Graphs of individual piezometers containing groundwater have been placed in Appendix D.

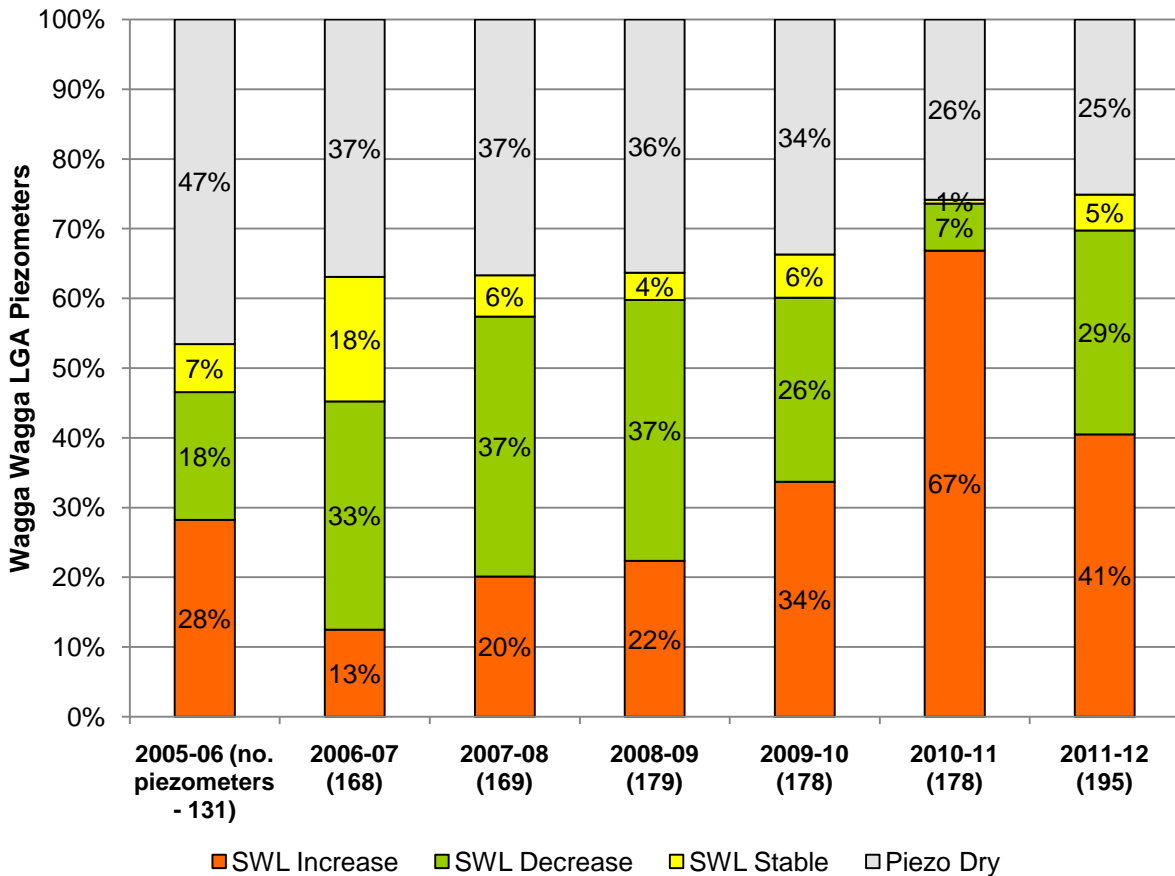
Annual Changes in Standing Water Level (SWL) - Wagga Wagga LGA Piezometers 2005/06 - 2011/12 (%)

Figure 12: Graph depicting annual change in overall piezometer readings as a percentage of all piezometers in the Wagga Wagga LGA.

Figure 12 shows annual changes (as a percentage) in SWL for all piezometers in the Wagga Wagga LGA for annual reporting periods between 2005/06 - 2011/12. For example, of the one hundred and ninety five piezometers measured during the 2011/12 reporting period, 41% showed an increase in SWL when compared to the previous years' readings, 29% decreased in SWL, 25% were dry and 5% remained stable. This allows for overall trending of groundwater conditions for the region based on all piezometers recorded.

For the current reporting period (2011/12), overall piezometers showing a SWL increase dropped from 67 - 41% when comparing results between 2010/11. The majority of these piezometers migrated to a SWL decrease change, increasing from 7 to 29% of all piezometers, when comparing the two reporting periods.

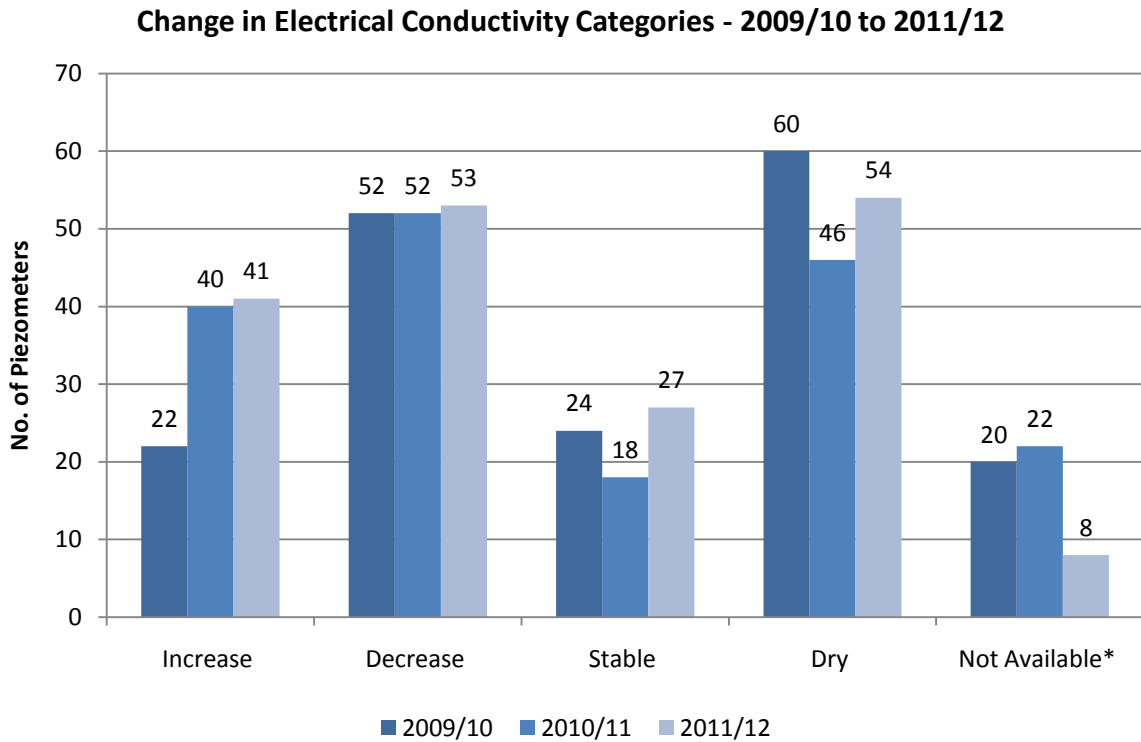
Figure 13: EC Categories 2009/10 to 2011/12. *Not available refers to a piezometer that did not contain enough water to sample (NETS) or a piezometer that is not able to be bailed.

When comparing 2011/12 EC change with previous reporting period (Figure 13), results show an overall migration towards dry and stable EC change categories from marginal increase and in EC. Results show an overall net decrease (53 decrease, 41 increase) in EC between water bearing piezometers (not including stable category samples) for the 2011/12 reporting period.

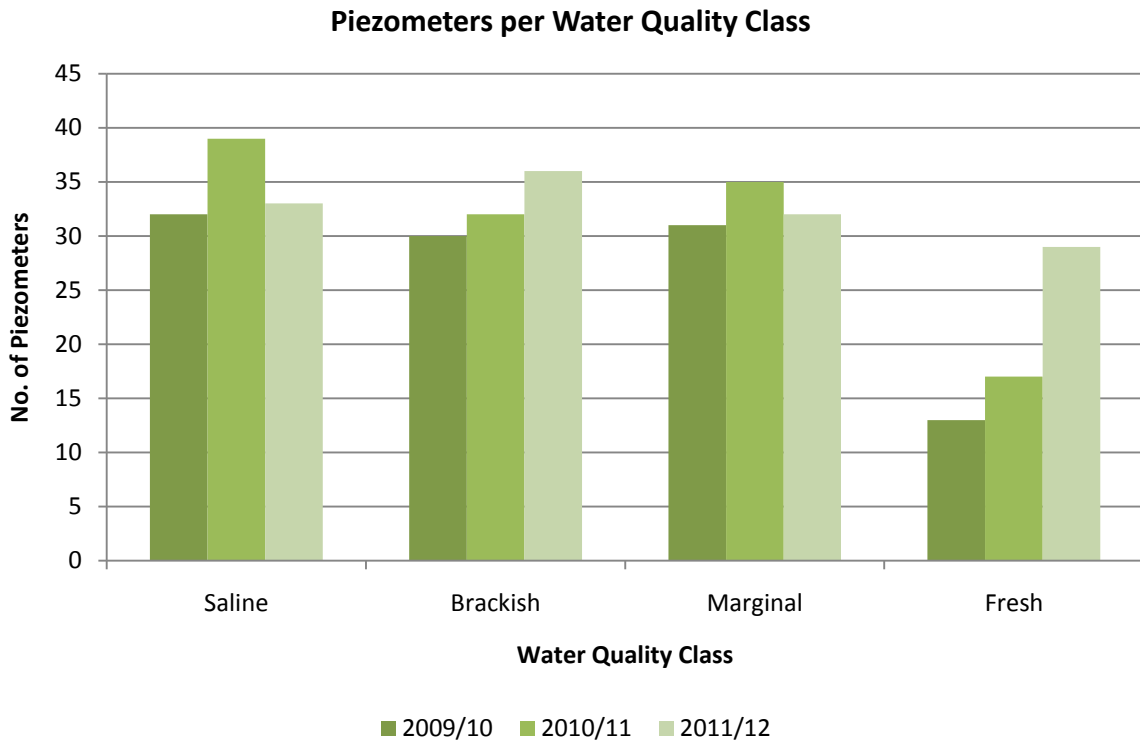
Figure 14: Average EC 2009/10 and 2010/11 water quality classes as defined by *Australian Water Resources Council (1976)*. Saline = >4.8 dS/m; Brackish = 1.6-4.8; Marginal = 0.8-1.6; Fresh = <0.8.

To measure the severity of electrical conductivity results within the Wagga Wagga Local Government Area EC results were sorted into water quality classes. The number of piezometers in each water quality class is presented in Figure 14. A migration from high

saline piezometers to an increase in piezometers containing fresher and brackish groundwater can be seen when comparing 2011/12 with the previous reporting period.
