Statement of Heritage Impact

HAMPDEN BRIDGE

MURRIMBIDGEE RIVER, WAGGA WAGGA

Hampden Bridge Demolition

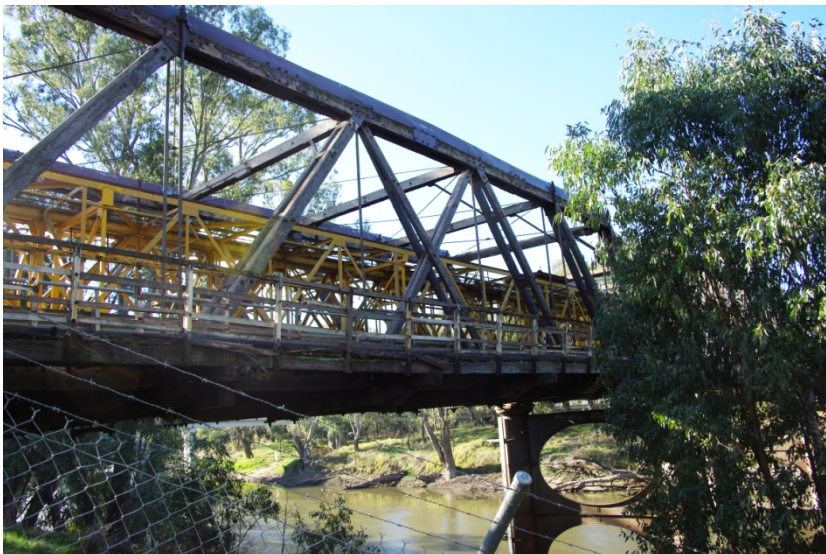
Span 1 is the most severely degraded of all the spans, to the point where it may not be able to support its own dead weight in parts.

Figure 4-1: Span 1, with the yellow steel stabilisation truss

- Span 1 is in a seriously degraded condition, and is falling down under its own dead weight in places
- The western abutment is in danger of lateral collapsing as a result of the extra strain placed on the abutment with the steel truss
- Span 2 could not be fully surveyed for safety reasons
- Span 1 is a serious health hazard and public access should be immediately limited
- A loss of lateral brace support is demonstrated by the three trusses leaning downstream

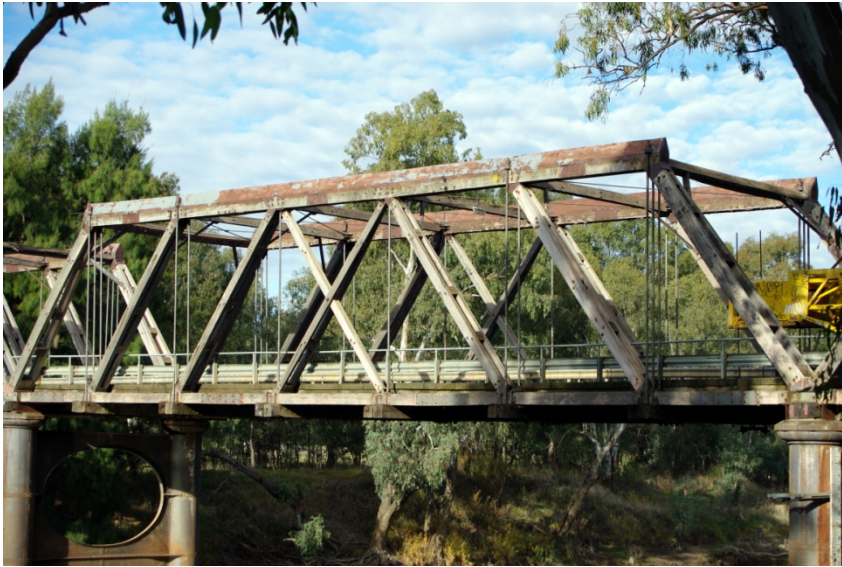
Span 2 (Figure 4.2) has not been accessible for safety reasons in order for comprehensive testing to be undertaken. Its exact condition is not known.

Figure 4-2: Span 2

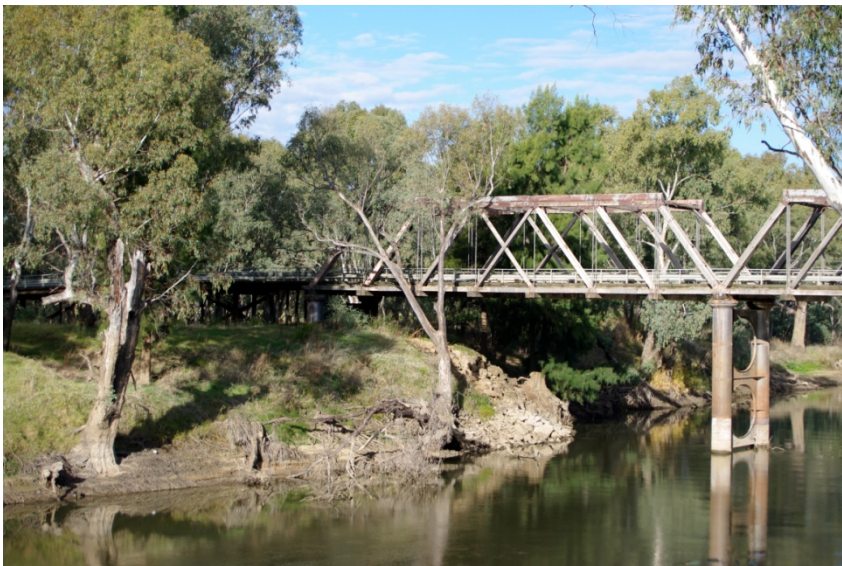
Span 3 is less degraded than Span 1, although it still contains areas that are significantly degraded. Its slightly better condition is perhaps caused by better air flow around the span.

Figure 4-3: Span 3

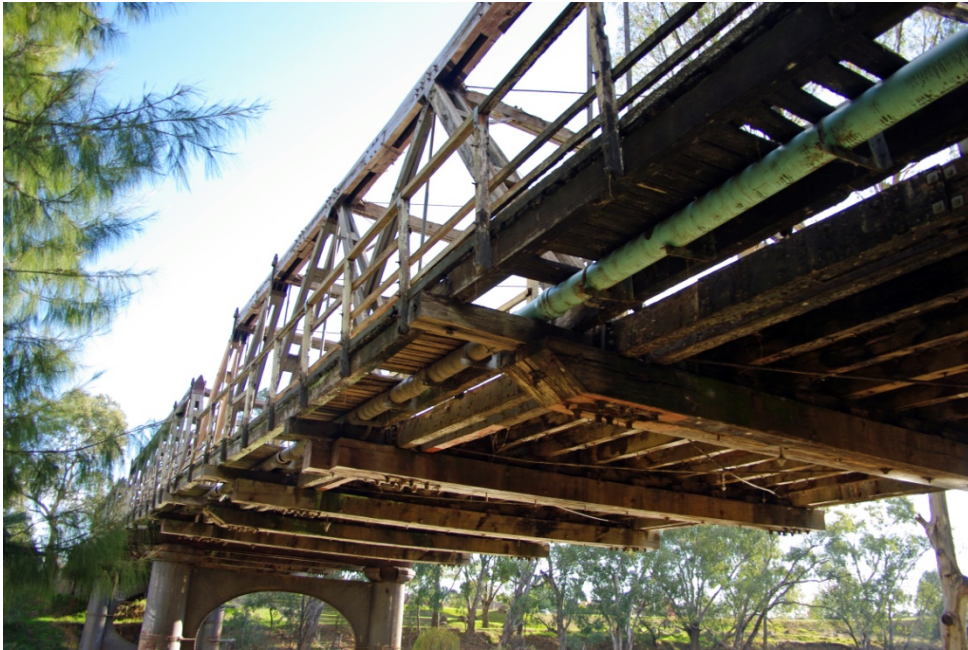
The walkway contains many missing wooden planks along the length of the bridge, including the eastern approach (Figure 4.4). The handrail has fallen away in some places (Figure 4.5).

Figure 4-4: Missing parts of the walkway can be clearly seen

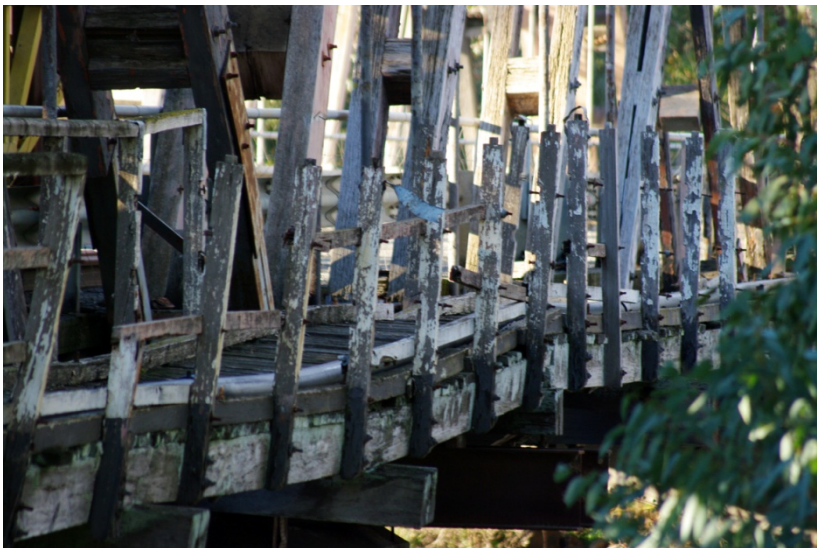
Figure 4-5: Handrail along span 1

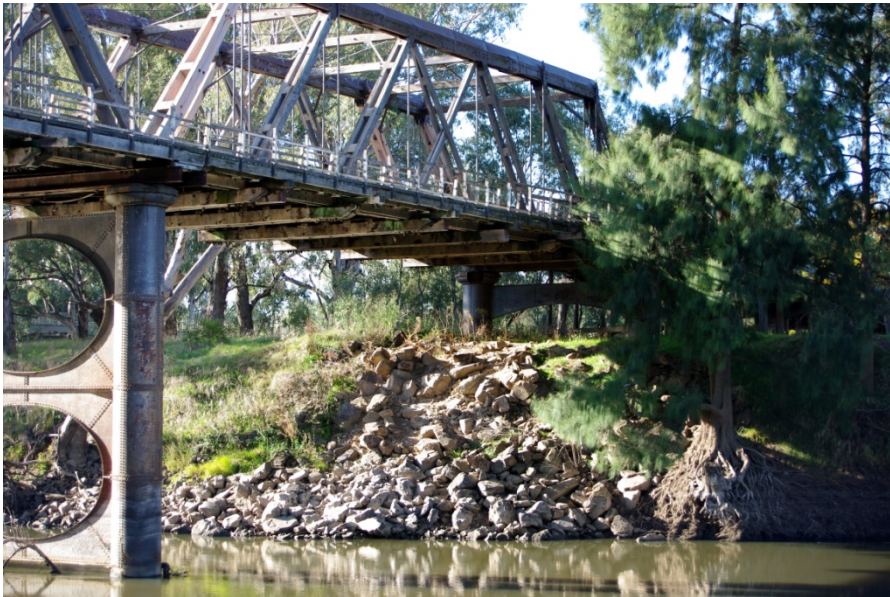
The eastern abutment is reinforced with rocks (Figure 4.6), while the western abutment is reinforced with a concrete wall. The western abutment is collapsing laterally under the combined weight of the truss and the steel truss. The abutments were not designed to carry such heavy loadings for an extended period of time, and will eventually collapse under pressure if not stabilised (Figure 4.7).

Figure 4-6: The Eastern abutment is reinforced with rough laid rocks

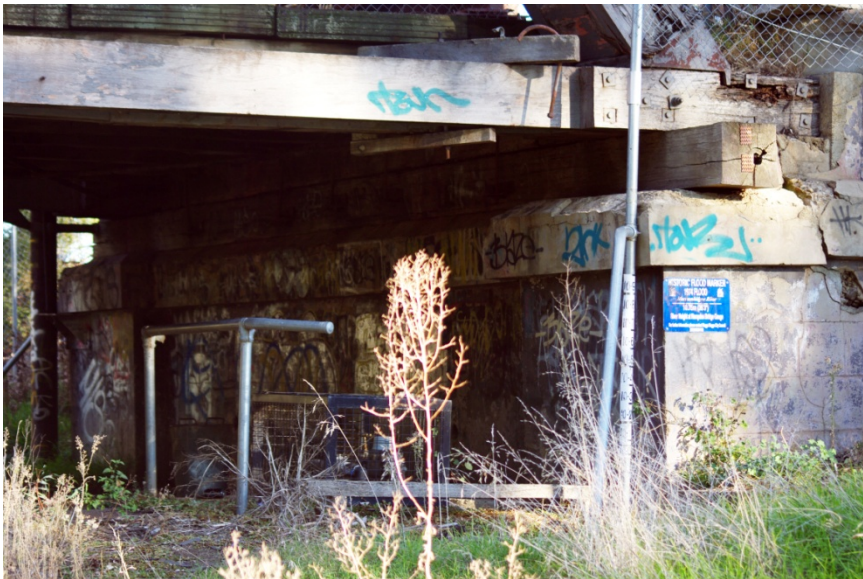
Figure 4-7: Western abutment

It is proposed to retain the western (city side) abutment in its entirety. The western abutment contains several plaques including the Engineers Australia plaque. Restoration, retention and interpretation options are being considered by Wagga Wagga City Council. Recommendations have been made in this report.

- The western abutment should be recommended for listing as a Heritage item on Wagga Wagga City Council's LEP 2010.
- The Heritage Council should be notified of the decision to remove the in-stream piers.

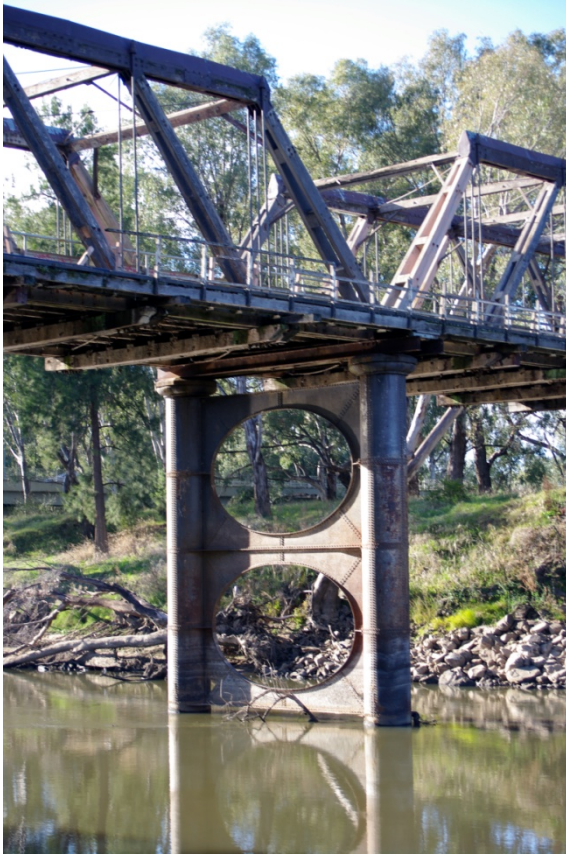
The super structure is supported by three steel piers. Two of these are in the river; the third stub pier is on the eastern side (Figures 4.8, 4.9, 4.10).

Figure 4-8: Eastern steel pier

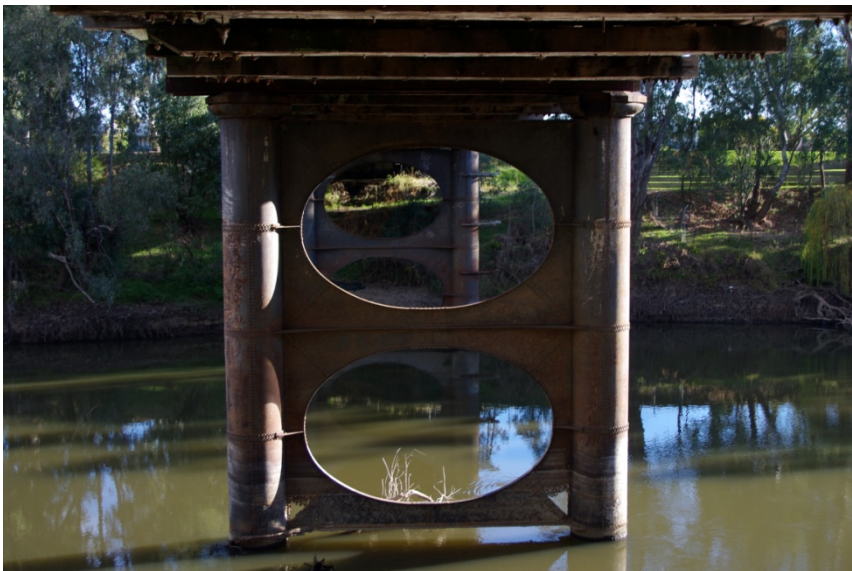
Figure 4-9: River piers, viewed from the eastern abutment

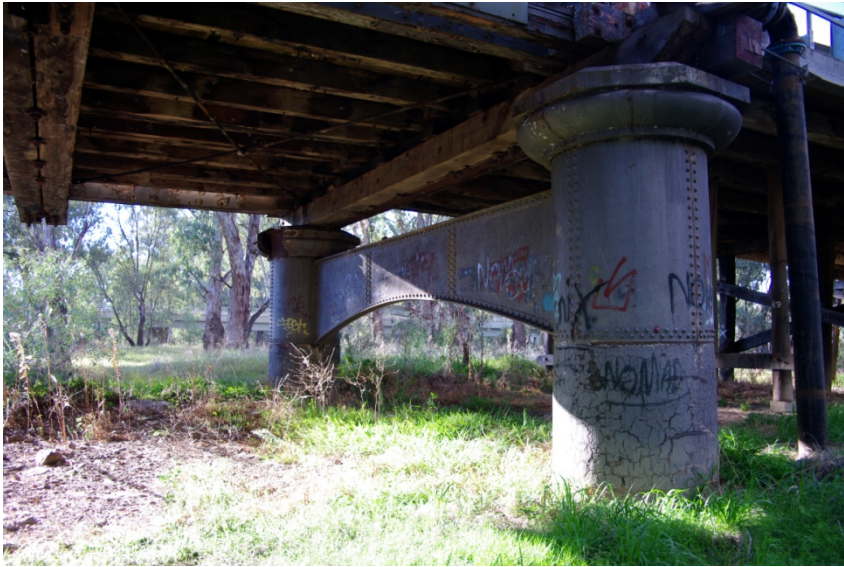
Figure 4-10: In ground pier on the western side

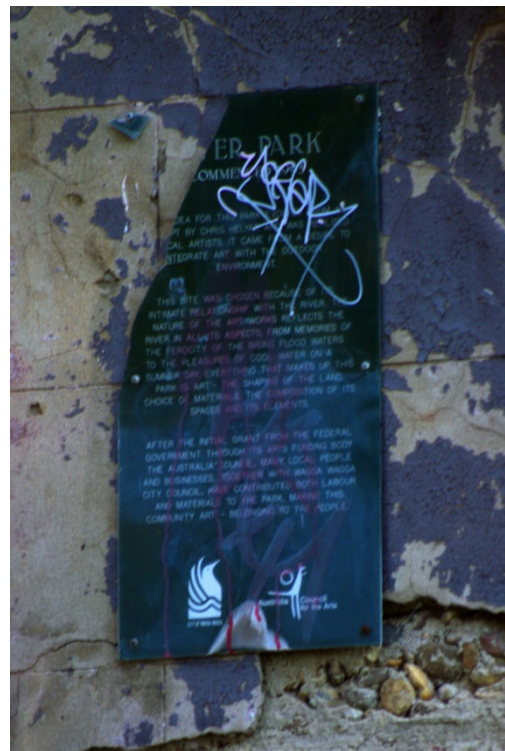
The bridge has received various historic markers and interpretive displays in the past. Some of these have been vandalised and damaged (Figure 4.11-4.15).

Figure 4-12: Damaged historical commemoration plaque
