FIGURE 8
Calibration event - 1974 - Stage / Discharge Rating Comparison at Hampden Bridge
Gauged vs Modelled

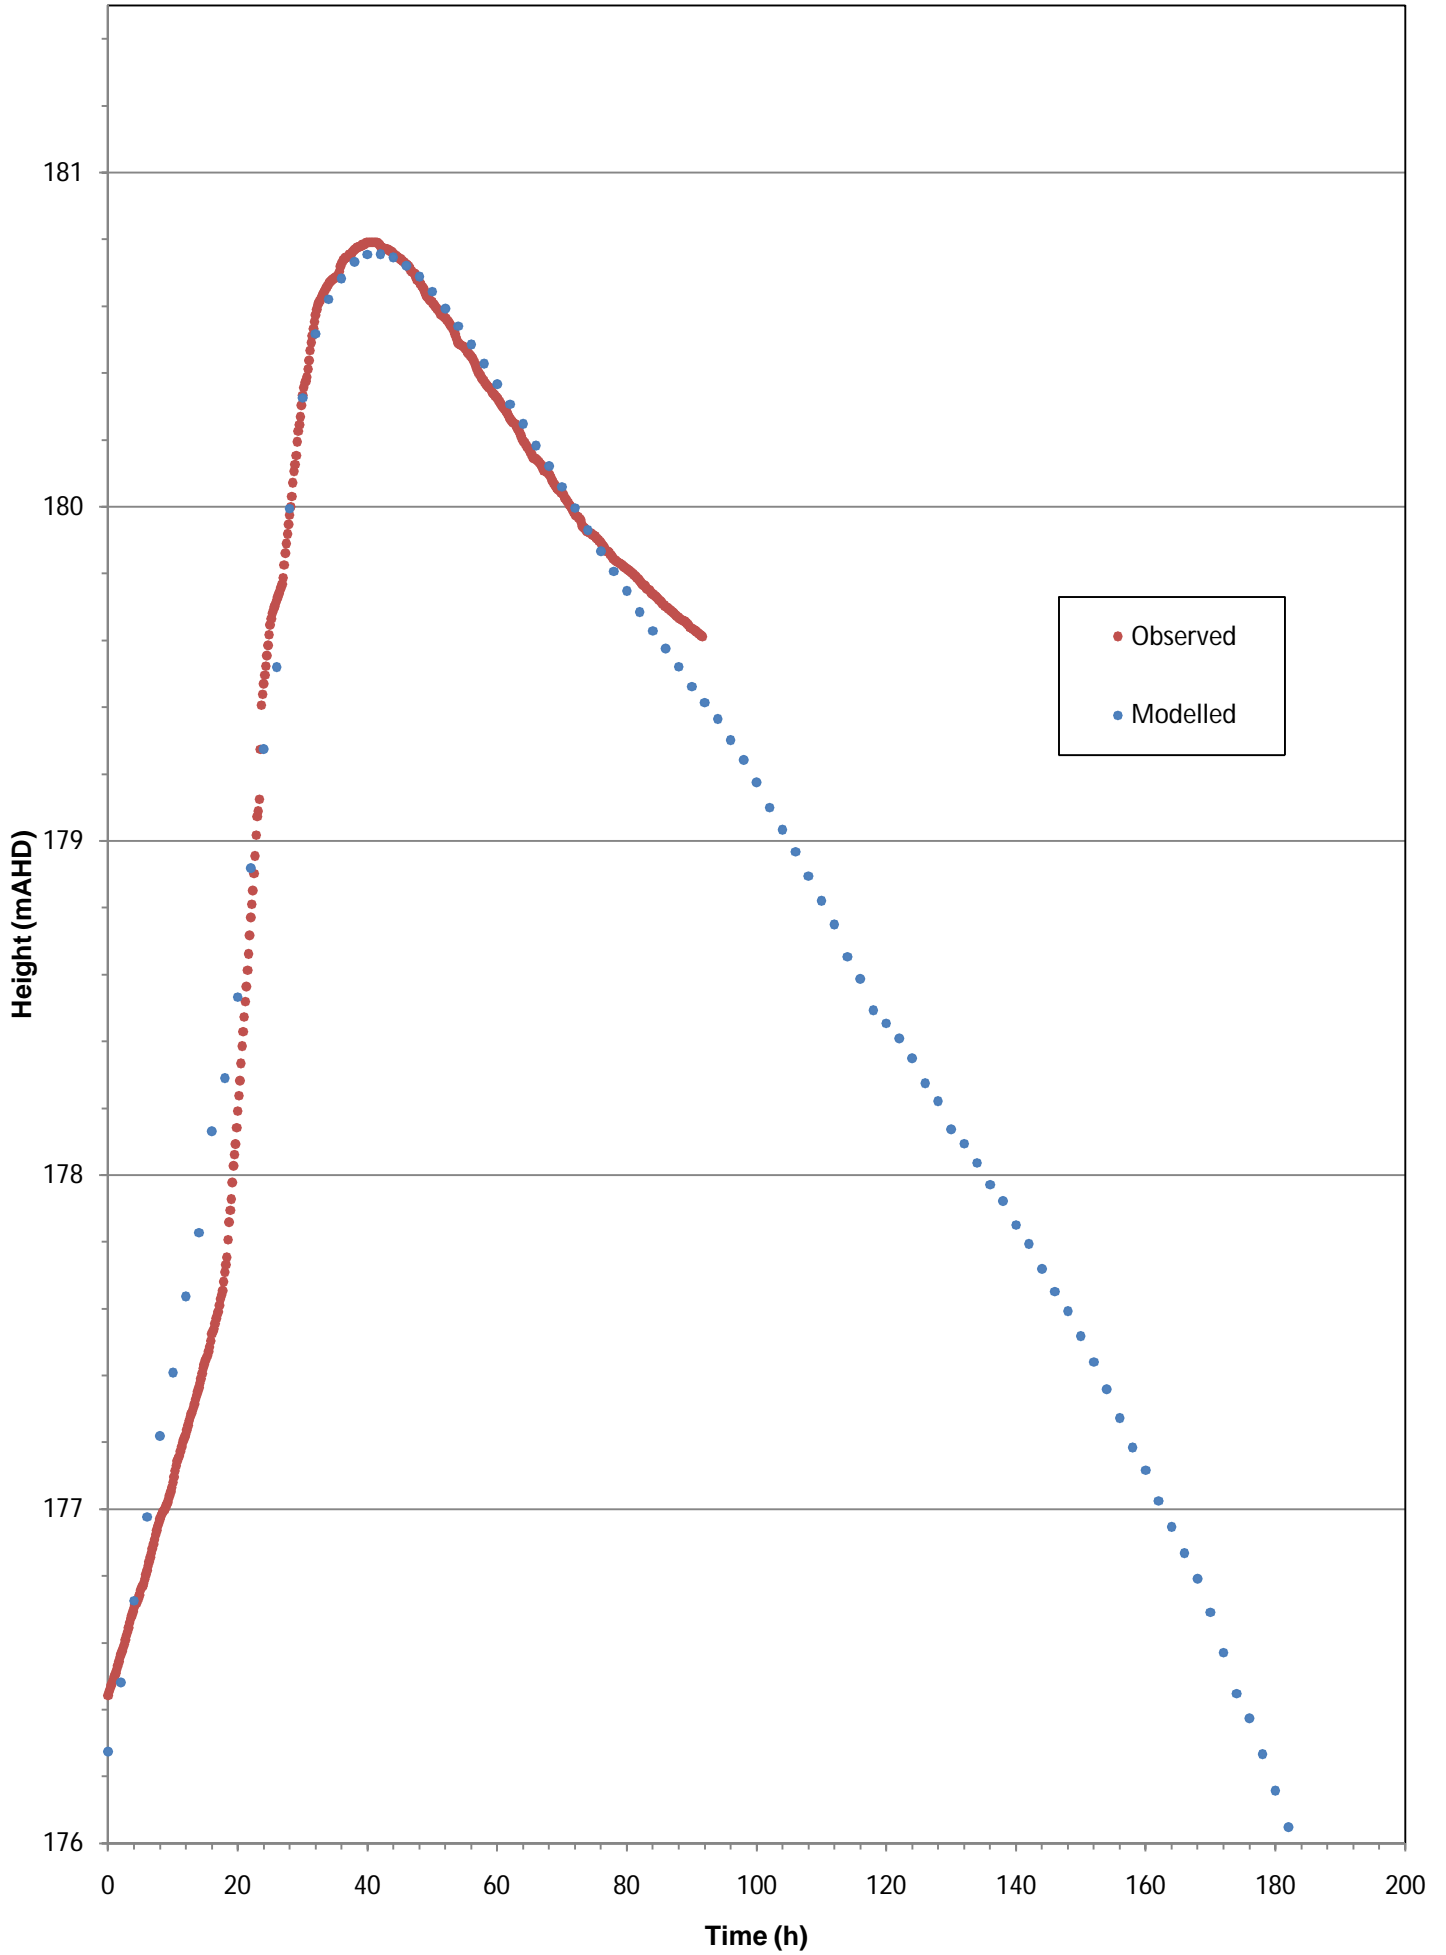
FIGURE 9
Calibration results - 1974 - Hydrograph Comparison

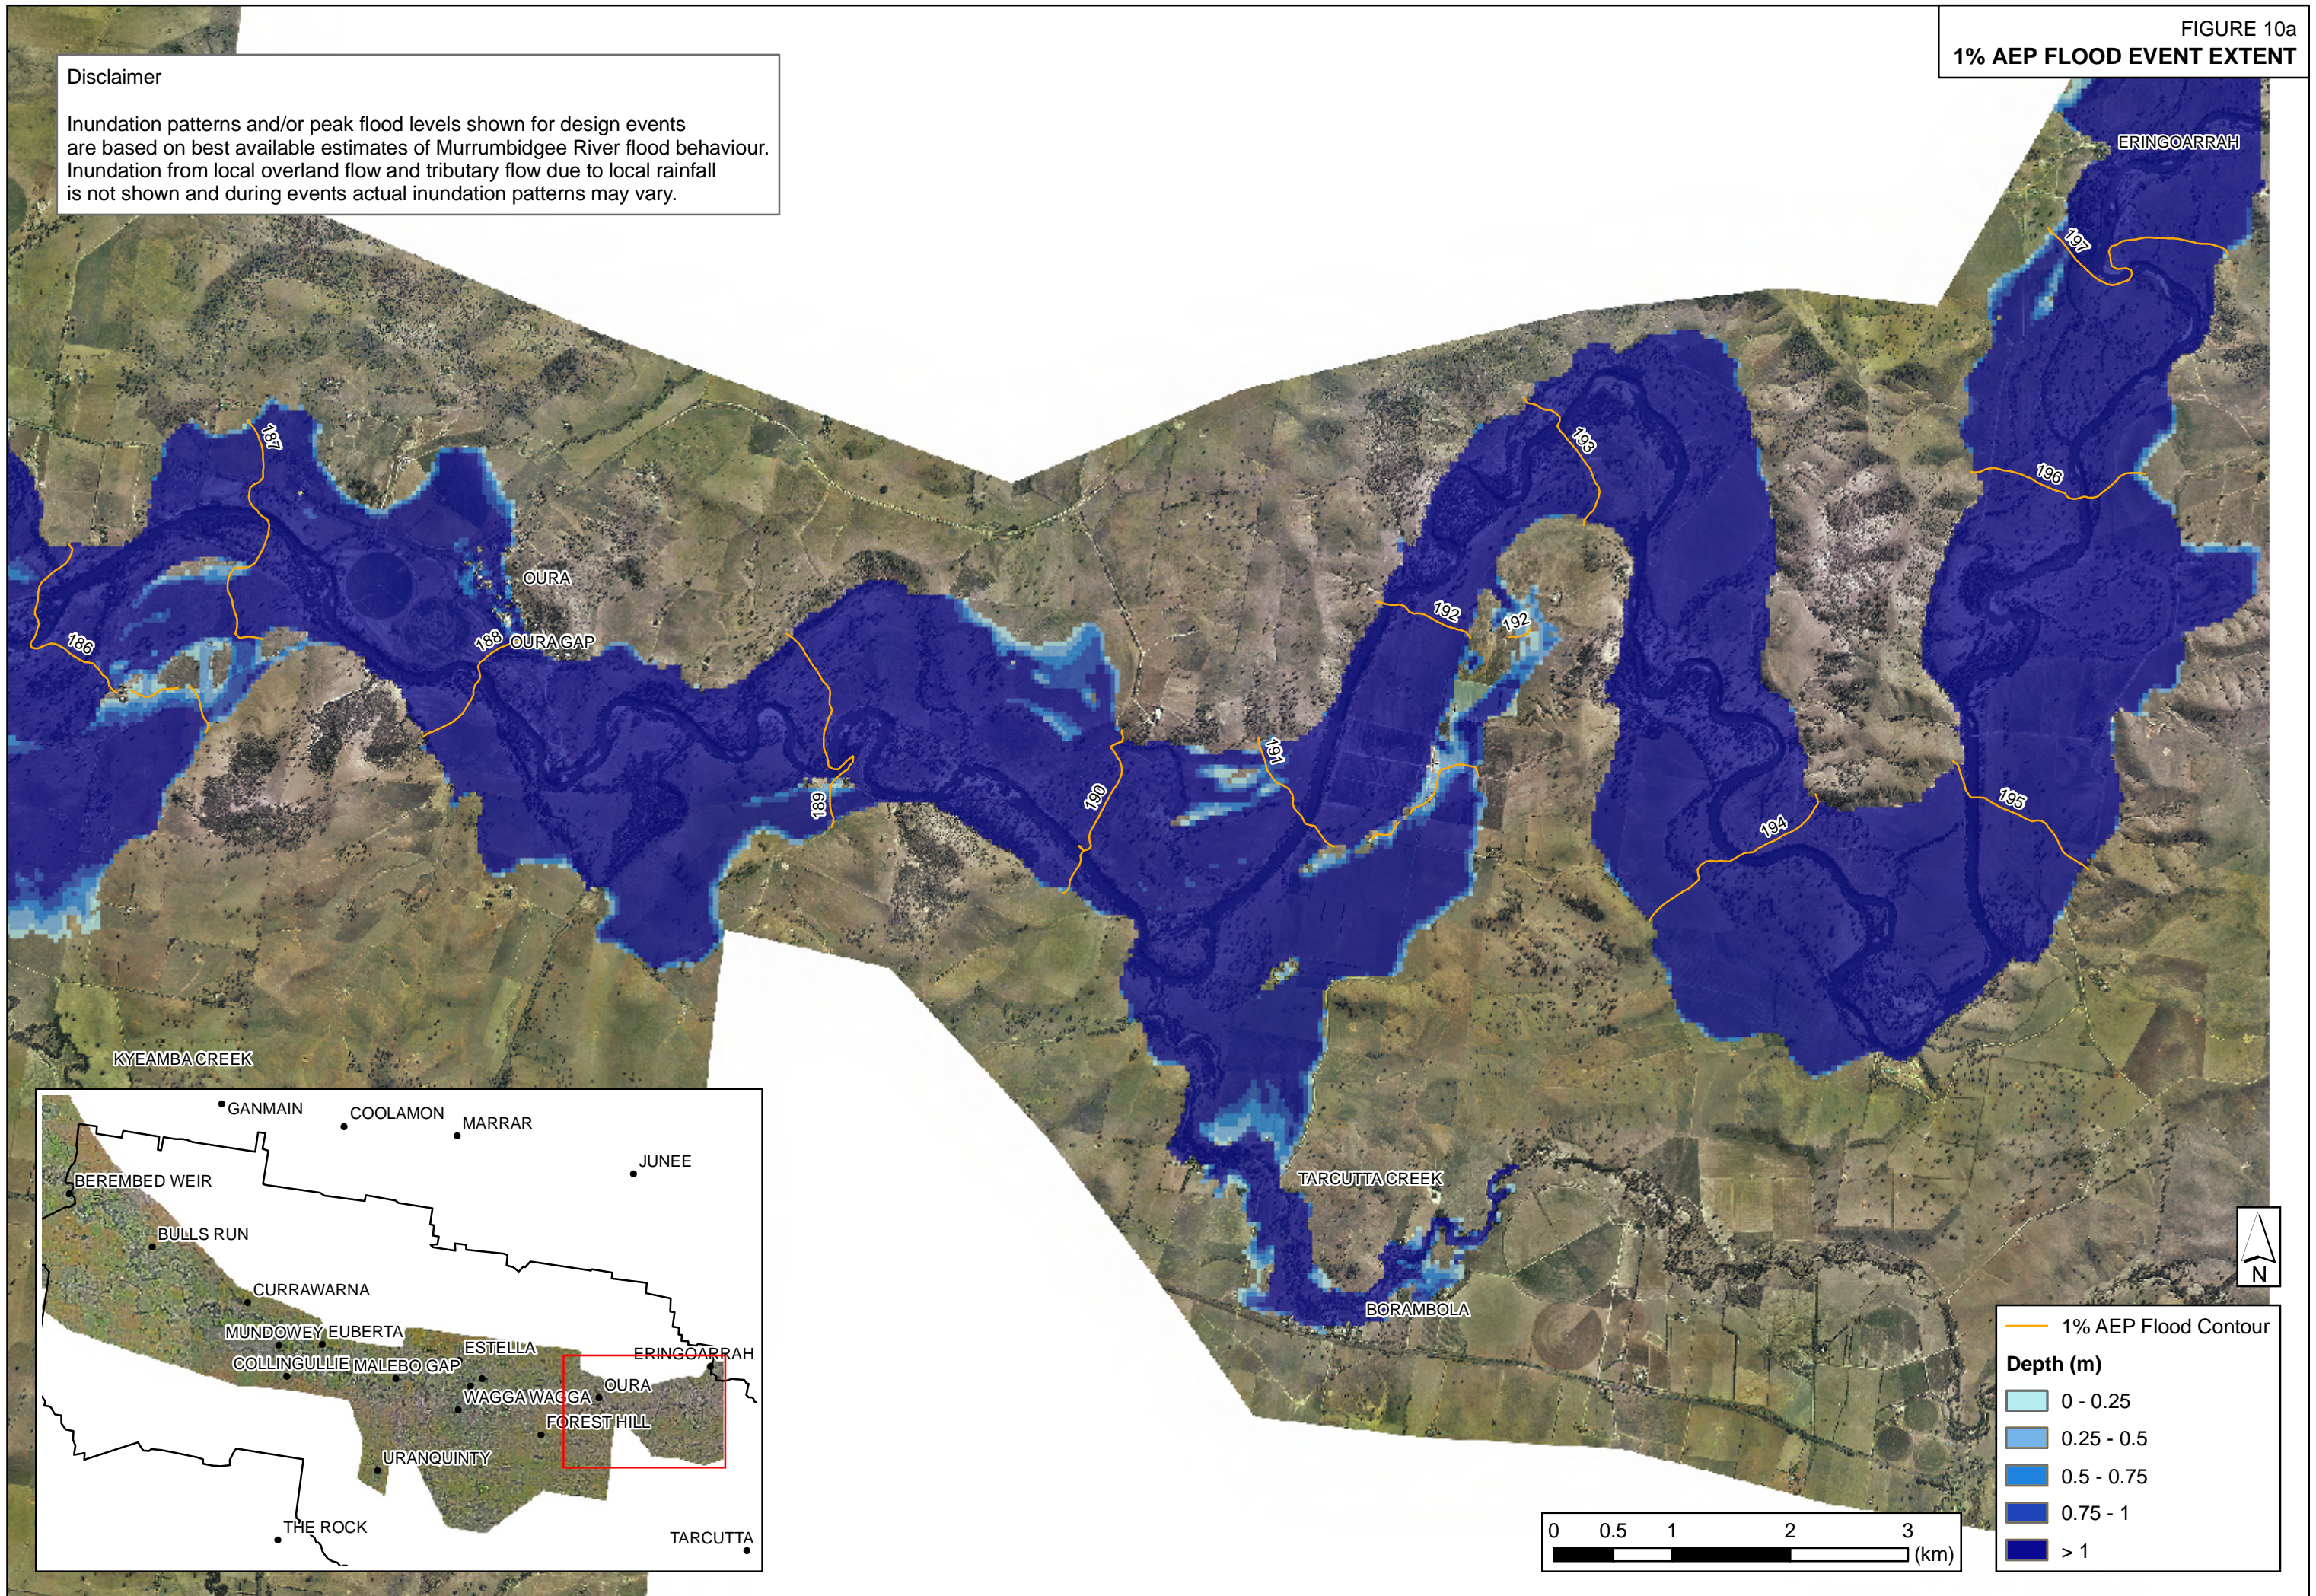
Inundation patterns and/or peak flood levels shown for design events are based on best available estimates of Murrumbidgee River flood behaviour. Inundation from local overland flow and tributary flow due to local rainfall is not shown and during events actual inundation patterns may vary.

— 1% AEP Flood Contour

Depth (m)

0 - 0.25
0.25 - 0.5
0.5 - 0.75
0.75 - 1
> 1
