WAGGA WAGGA  
DETAILED FLOOD MODEL REVISION  
FINAL REPORT

## WAGGA WAGGA DETAILED FLOOD MODEL REVISION

### FINAL REPORT

AUGUST 2014

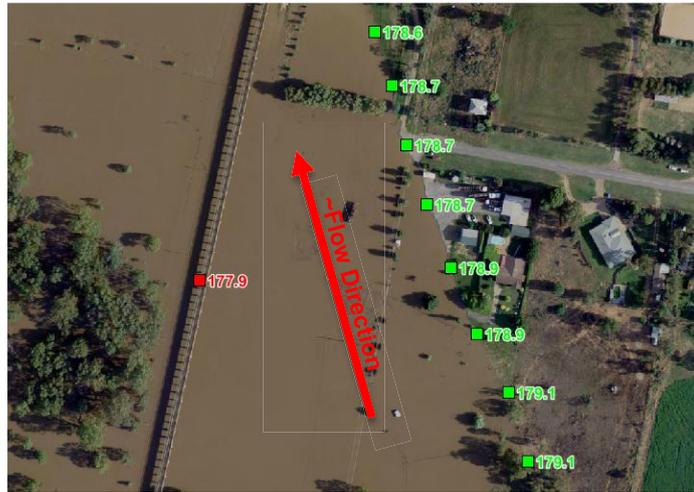
Image 3: Floormark 57

Flood mark 57 was eliminated by examining the approximate level of the adjacent peak flood extent (achieved by examining an aerial image of the peak flood extent and the DEM, displayed as green points on Image 3) and then comparing this to the surveyed flood level (displayed as a red point on Image 3). It was found that the surveyed peak flood level was approximately 1 m lower than the expected flood level.

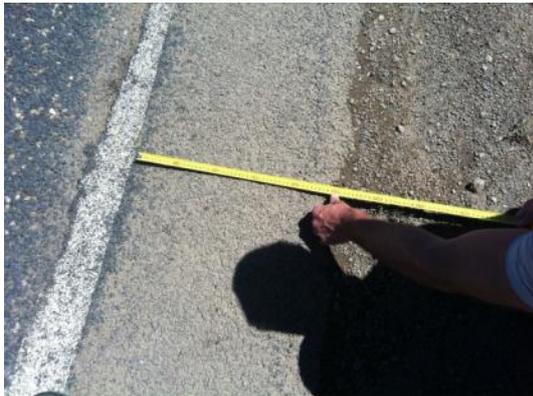
Image 4: Flood mark 66, brief photograph

Flood mark 66 was recorded as not overtopping Hampden Avenue at this location (see Reference 4). However Image 5 displays that water clearly did overtop the road at this location and flowed with significant depth in the area. As flood mark 67 has been recorded at the same level as 66 and is in close proximity it can be assumed that this flood mark is incorrect also. Interestingly, these flood marks have the same recorded level as flood mark 57 which shows that there was a large body of still or very slow flowing water sometime after the flood peak which is probably why the recorded marks were particularly obvious and recorded incorrectly.

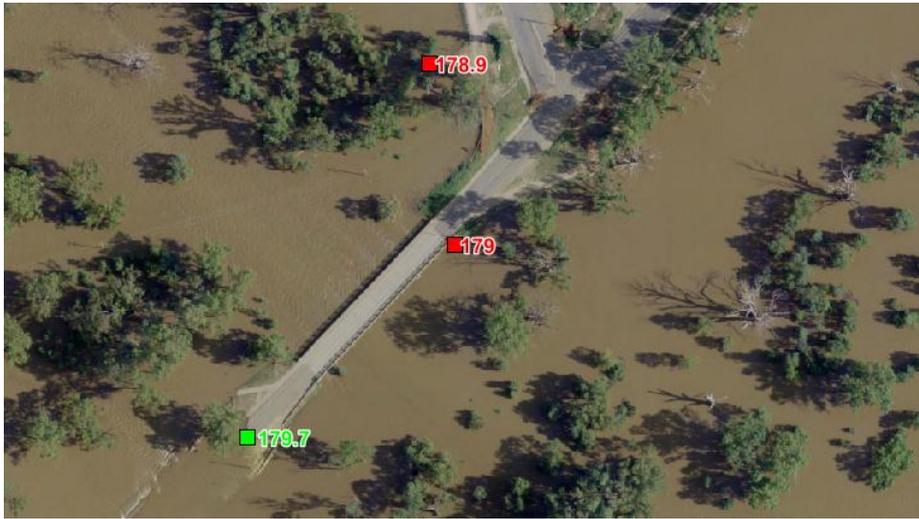
Image 6: Flood marks 64 and 65 (displayed in red)

Similarly flood marks 64 and 65 (point displayed in red, Image 6) are all likely caused by post peak still/slow flowing water as mentioned for flood marks 66 and 67. Again examination of peak flood level imagery in combination with the DEM (point displayed in green, Image 6) revealed that the recorded flood marks were lower than the peak flood level. Both flood marks 66 and 67 are estimated to be recorded as 0.7 m lower than the actual peak flood level.

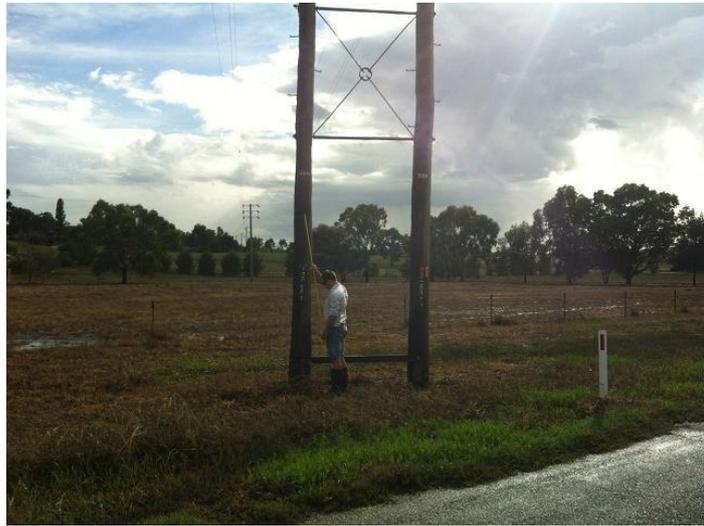
Image 7: Flood mark 85, 2012 flood

Flood mark 85 is likely incorrect with an approximate 0.5 m underestimate of peak flood level. Investigation of the flood mark photographs in in the Reference 4 Survey Brief display the recorded flood mark as being well above the height of the person who recorded it and was possibly missed due to difficulties in seeing the true flood mark. Image 7 shows the observer displaying the false flood mark well above head height and the true peak flood level is estimated to be higher still.

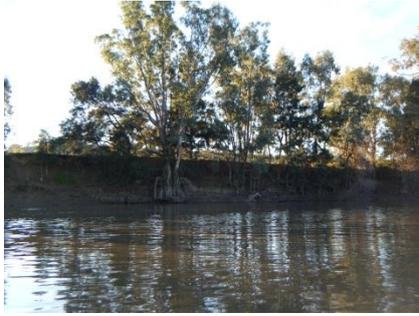
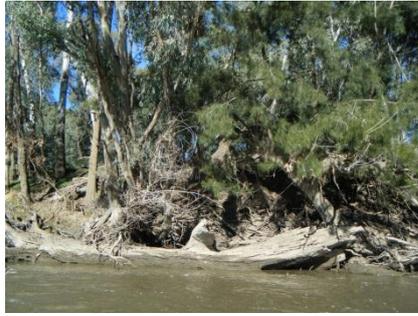
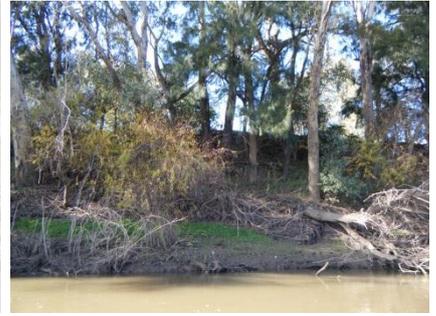
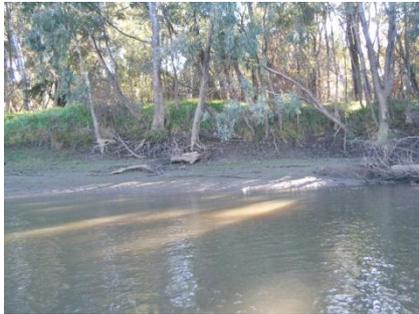
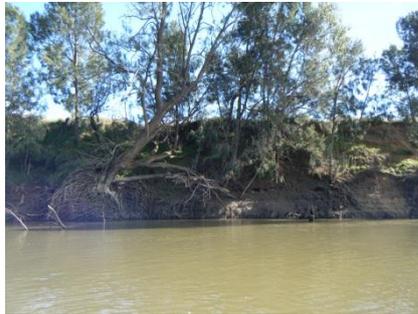
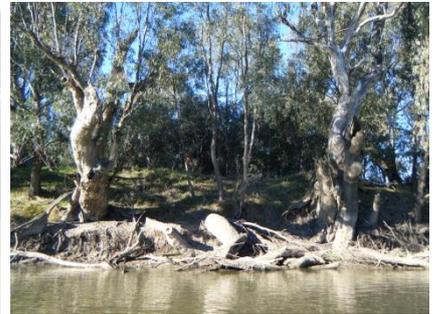
Image 8: Section 069\*

Image 9: Section 169

Image 10: Section 269

Image 11: Section 369

Image 12: Section 469

Image 13: Section 569

\*Please refer to Figure 3 for section locations.
