**TARCUTTA, LADYSMITH AND URANQUINTY  
FLOOD STUDIES**

**DATA COLLECTION REPORT**

**VOLUME 1 - REPORT**

**JULY 2012**

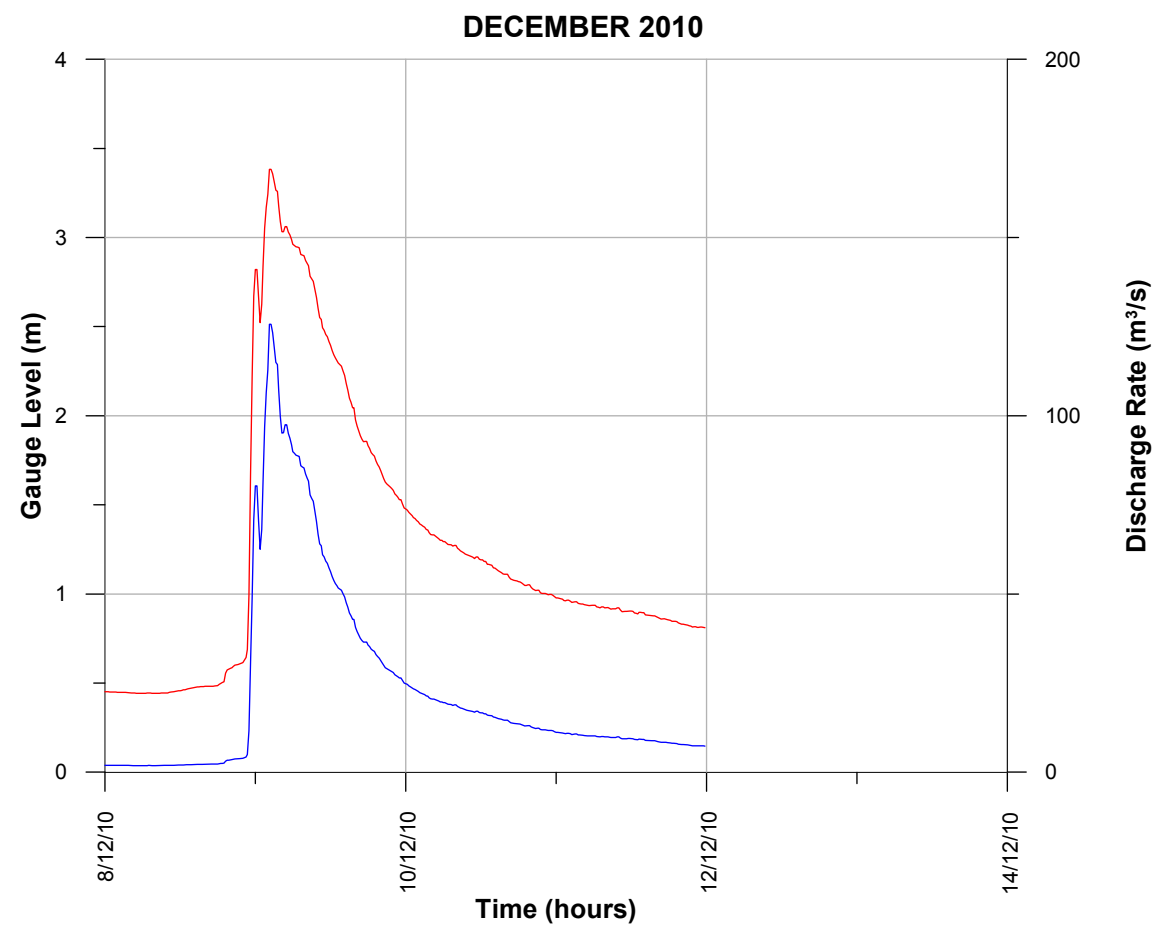
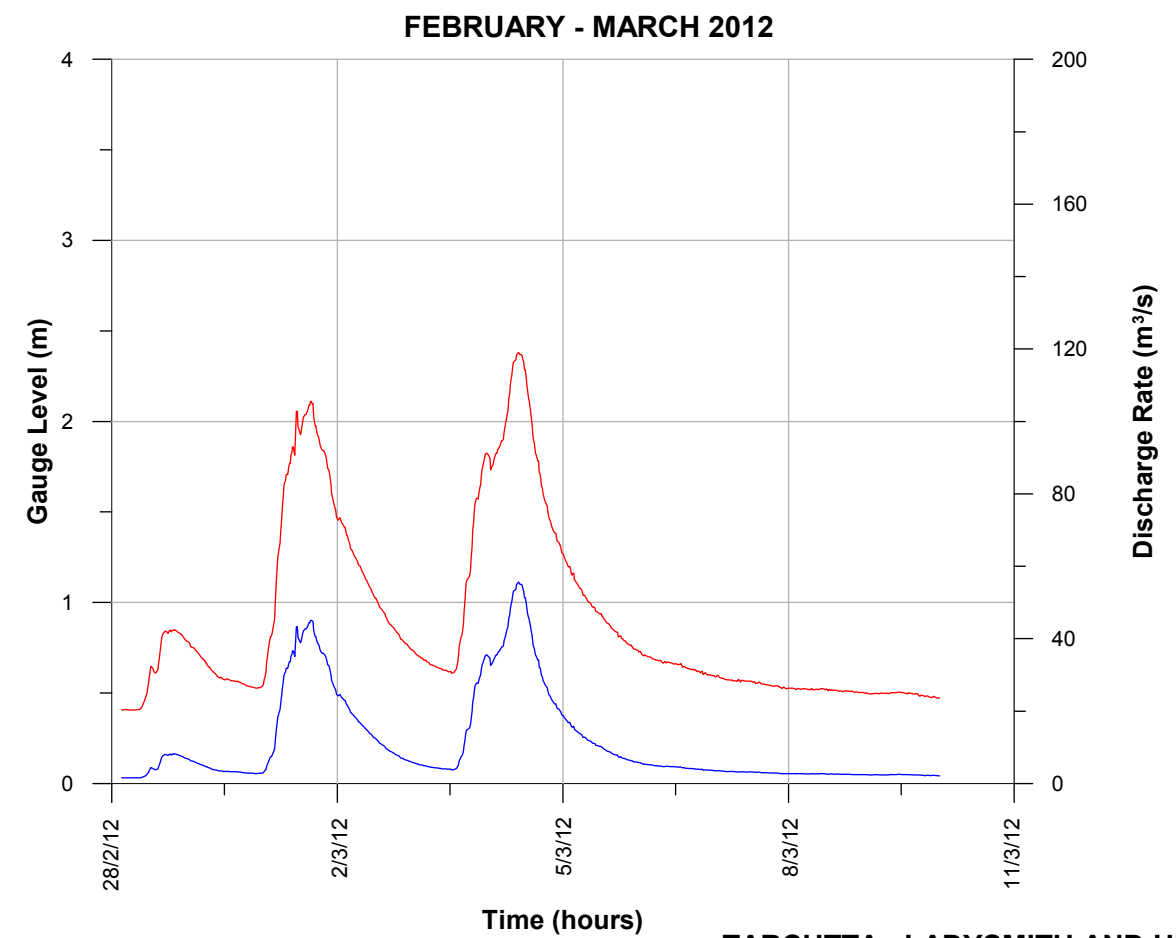
Figure 1.4  
 STAGE AND DISCHARGE HYDROGRAPHS  
 AT WESTBROOK GAUGE (GS 410058)

NOTE:  
 Station Not Rated  
 Gauge Zero: 284.367 m AHD

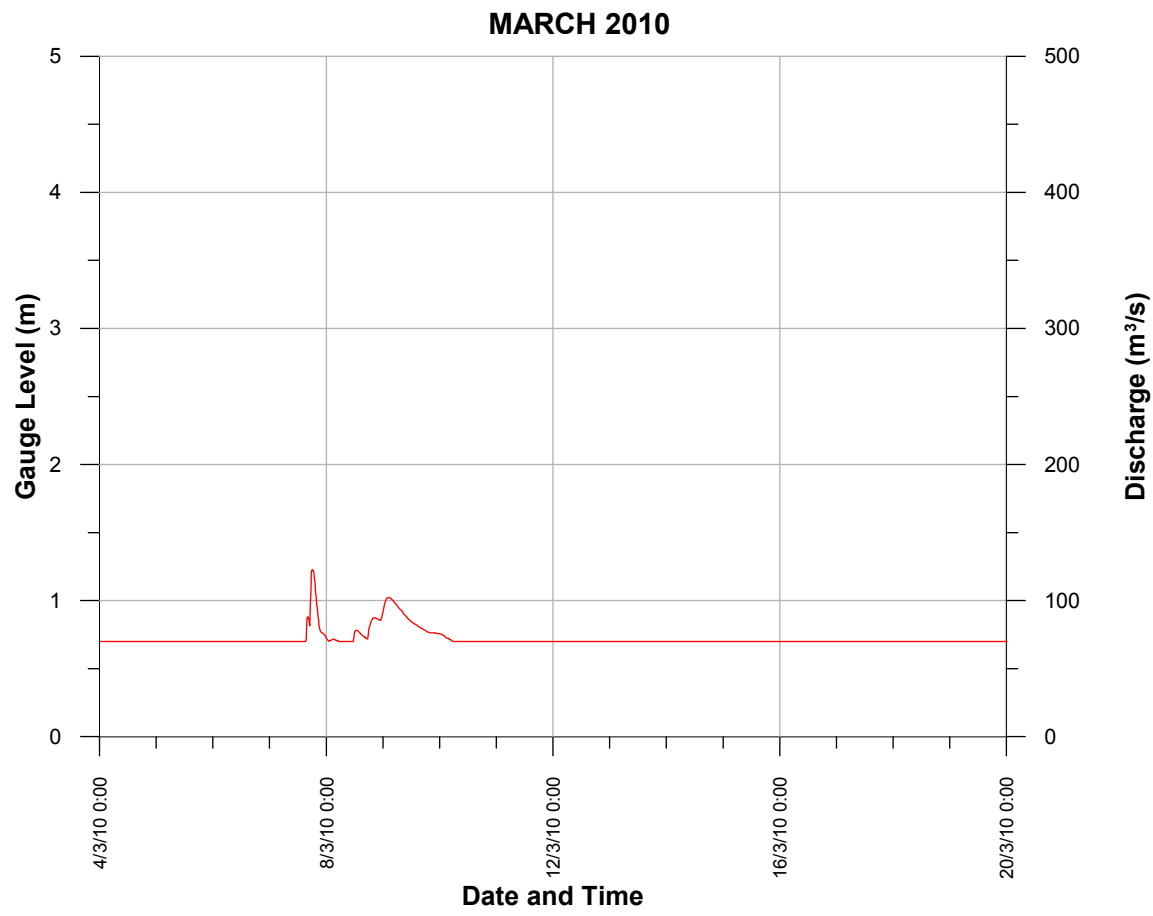
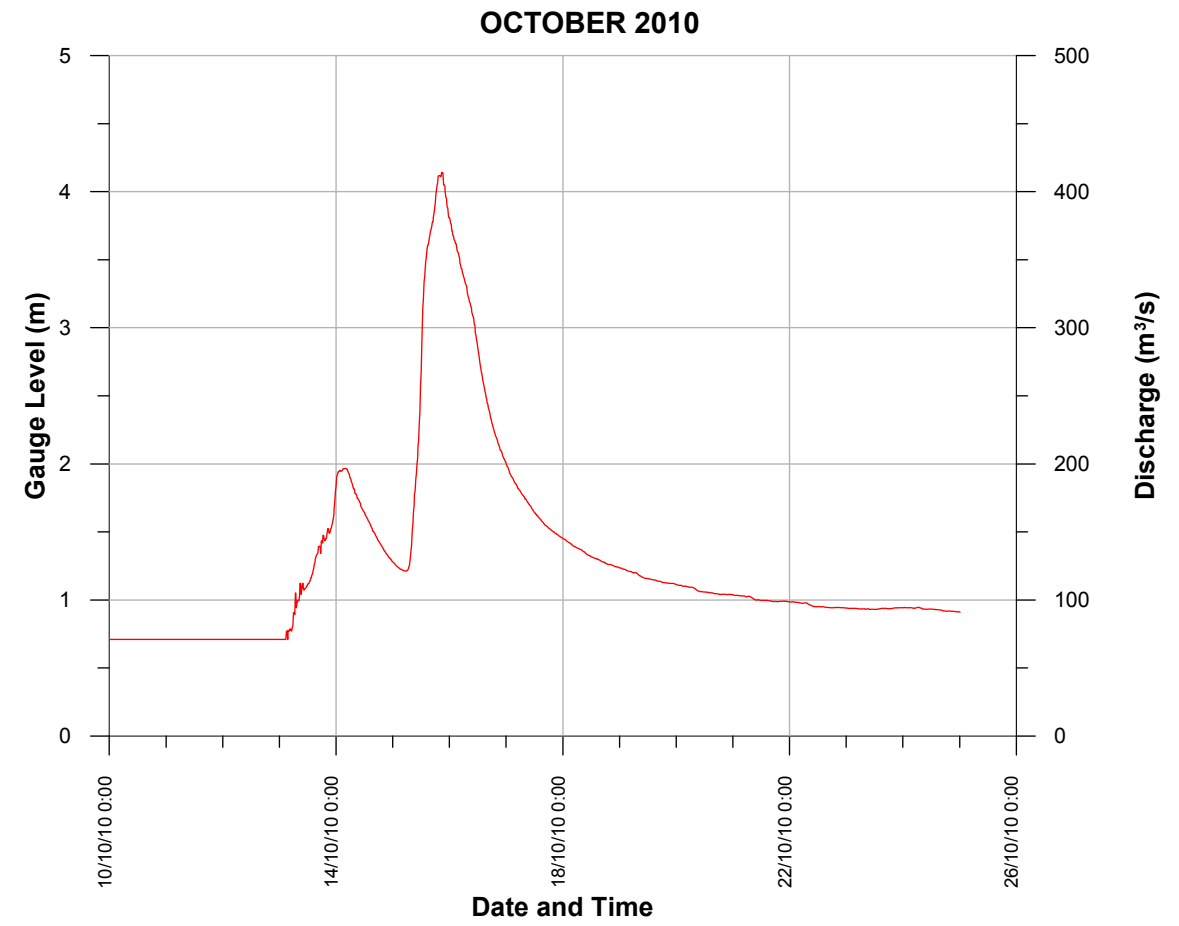
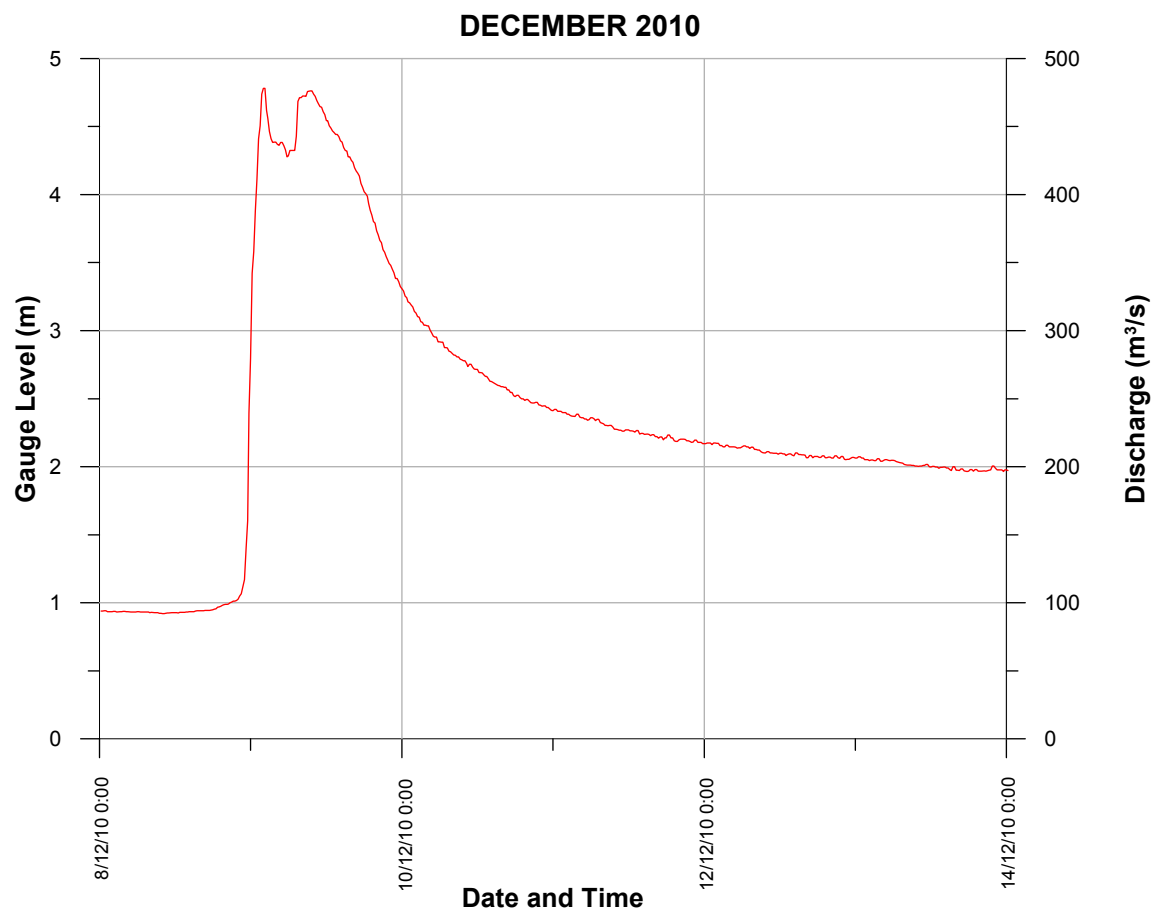
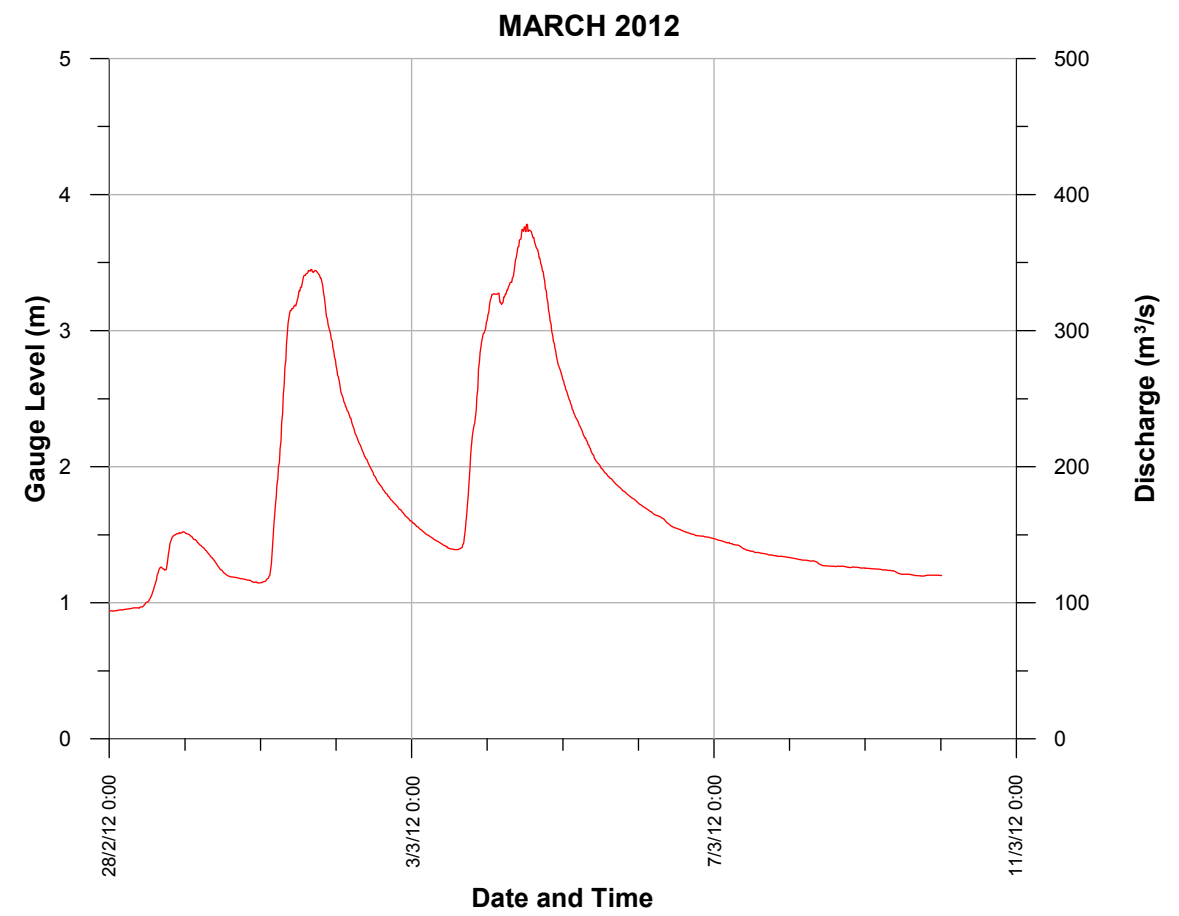
Figure 1.5

STAGE AND DISCHARGE HYDROGRAPHS  
 AT BELMORE BRIDGE GAUGE (GS 410155)

**NOTE:**  
 Catchment Area = 1,660 km<sup>2</sup>  
 Gauge Zero = 190.699 m AHD

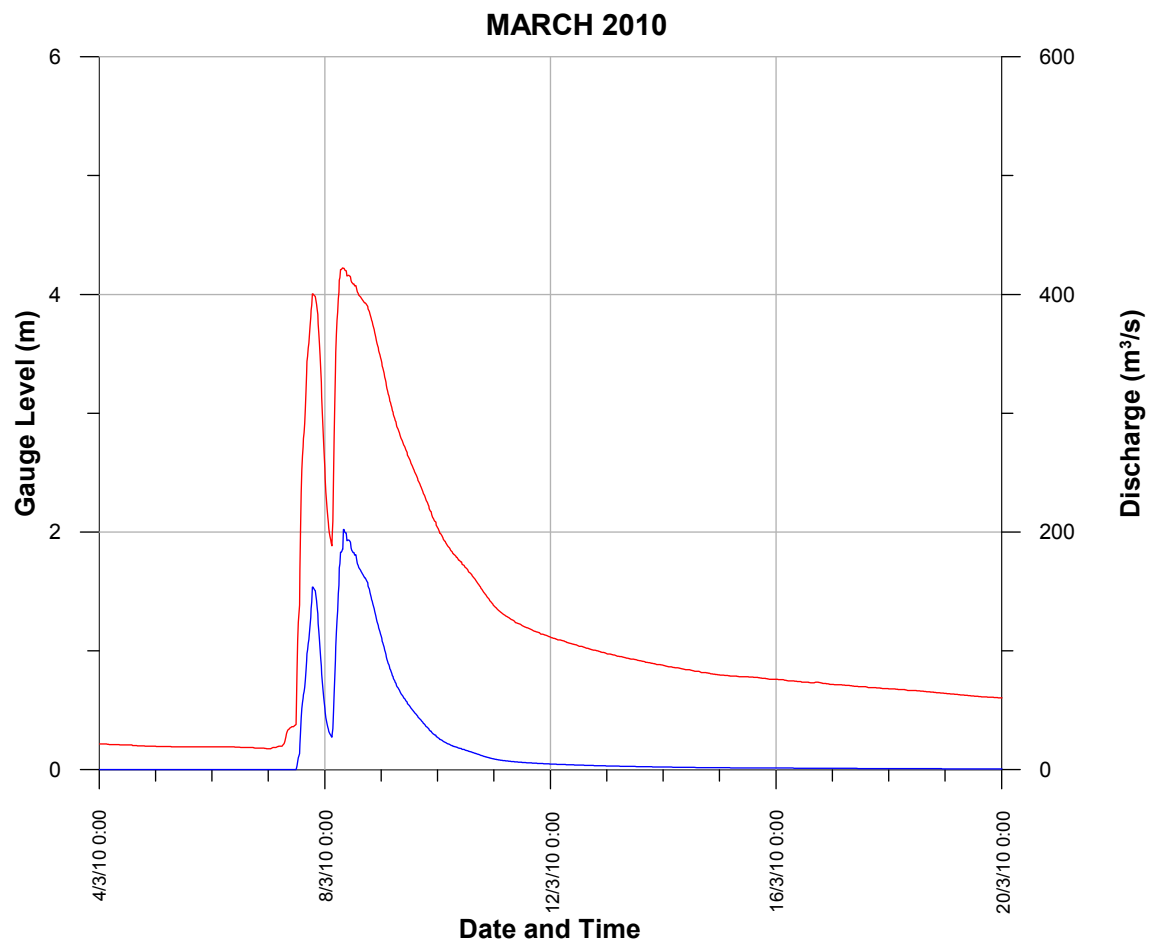
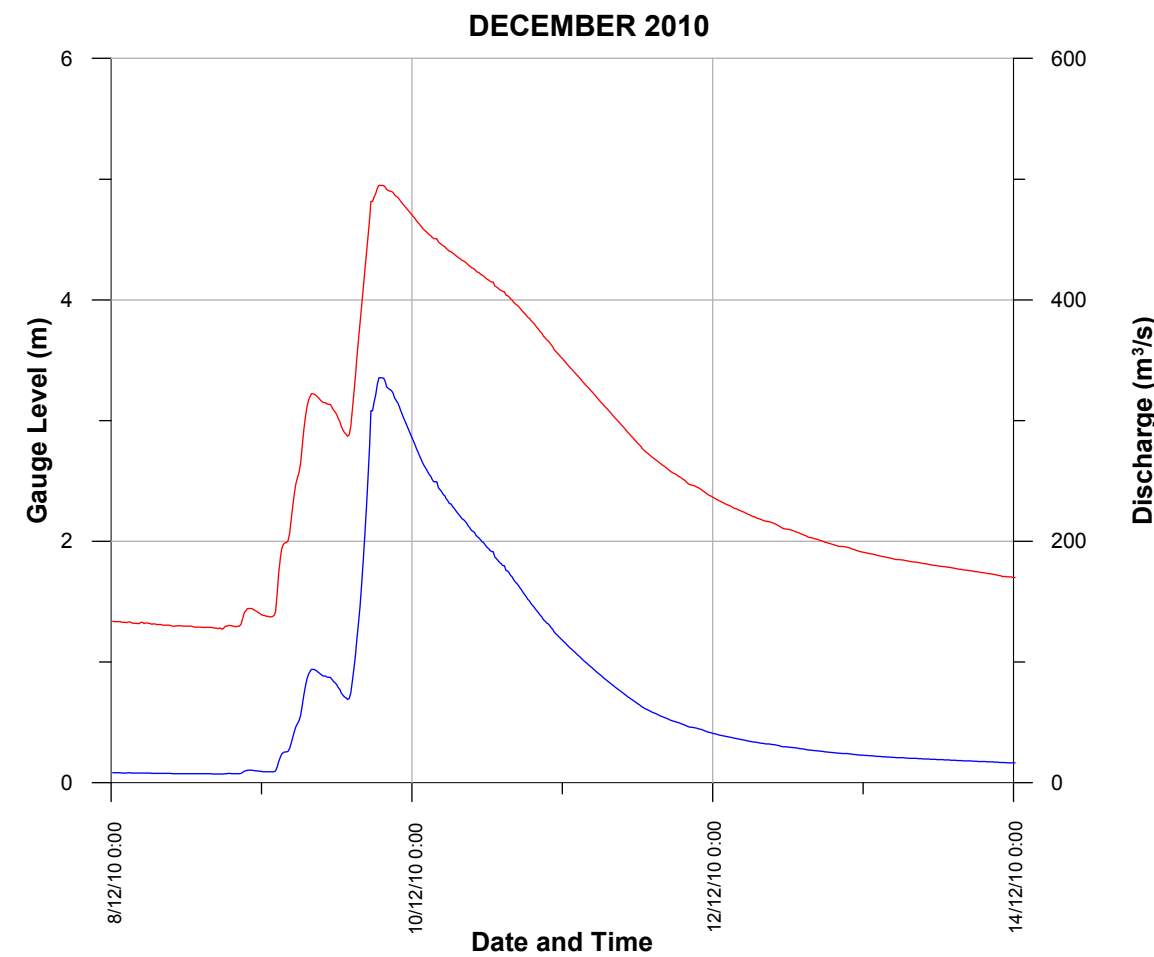
Figure 1.6  
 STAGE AND DISCHARGE HYDROGRAPHS  
 AT OLD BORAMBOLA GAUGE (GS 410047)

Gauge Zero = 190.699 m AHD  
 Refer Figure 1.15 for Location of Stream Gauge  
 and LiDAR Based Cross Section.

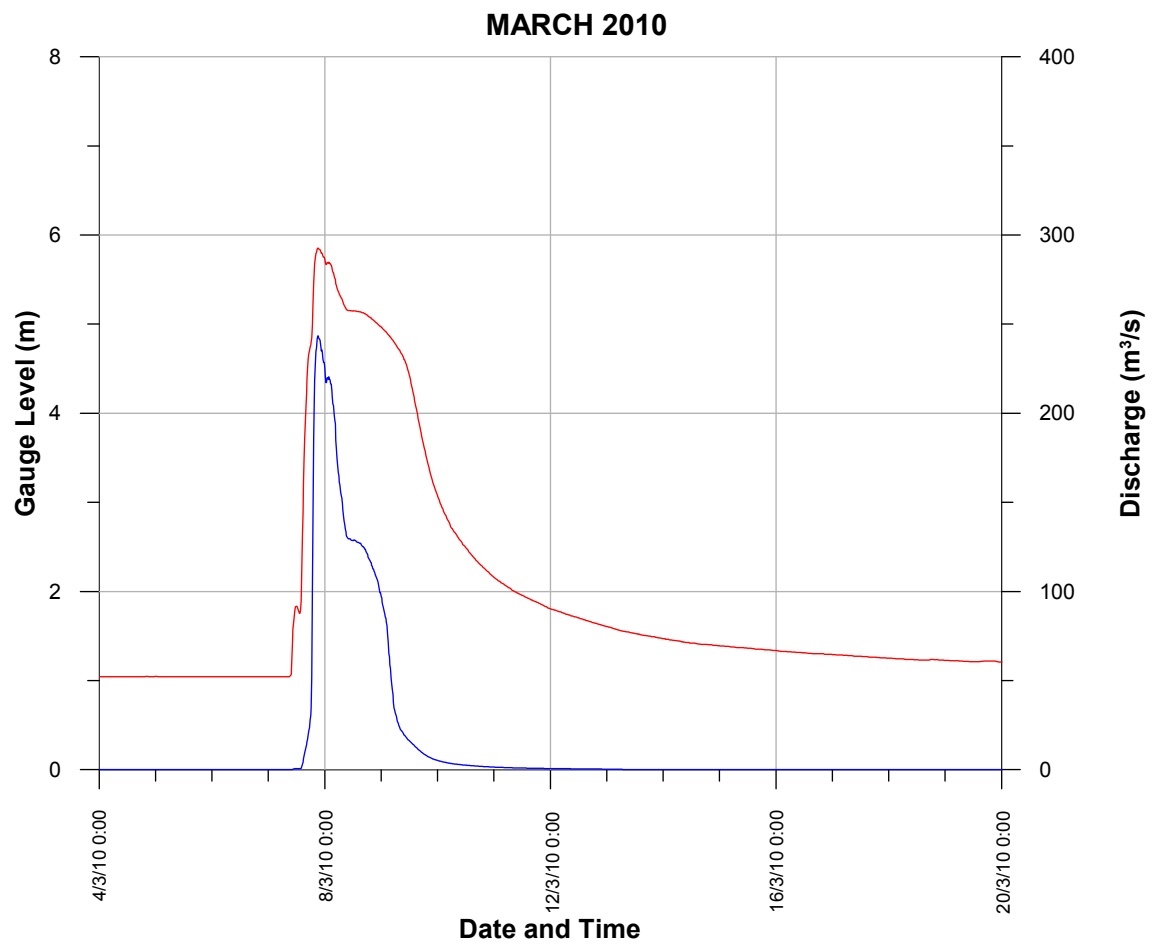
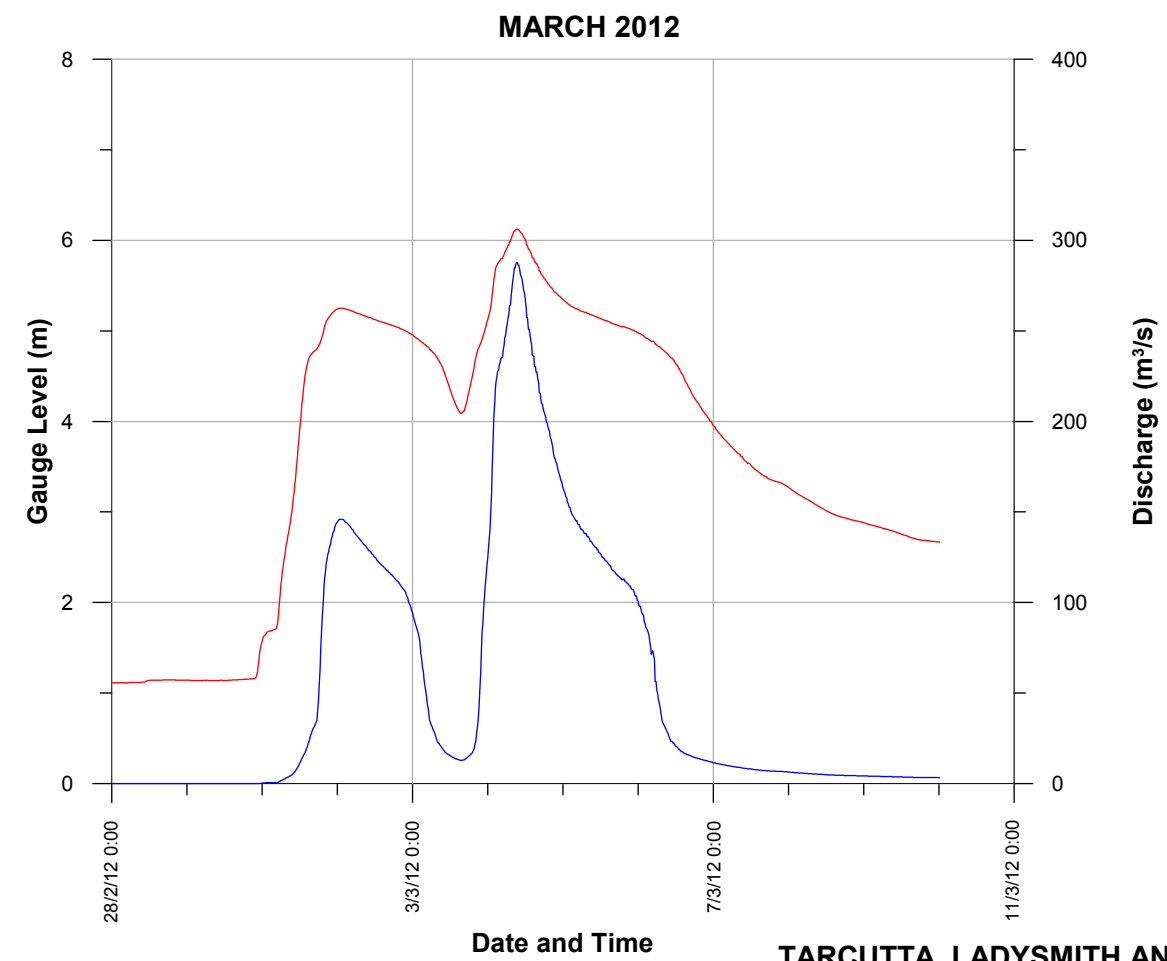
Figure 2.5  
 STAGE AND DISCHARGE HYDROGRAPHS  
 AT LADYSMITH GAUGE (GS 410048)

**NOTE:**  
 Catchment Area = 530 km<sup>2</sup>  
 Gauge Zero = 195.224 m AHD

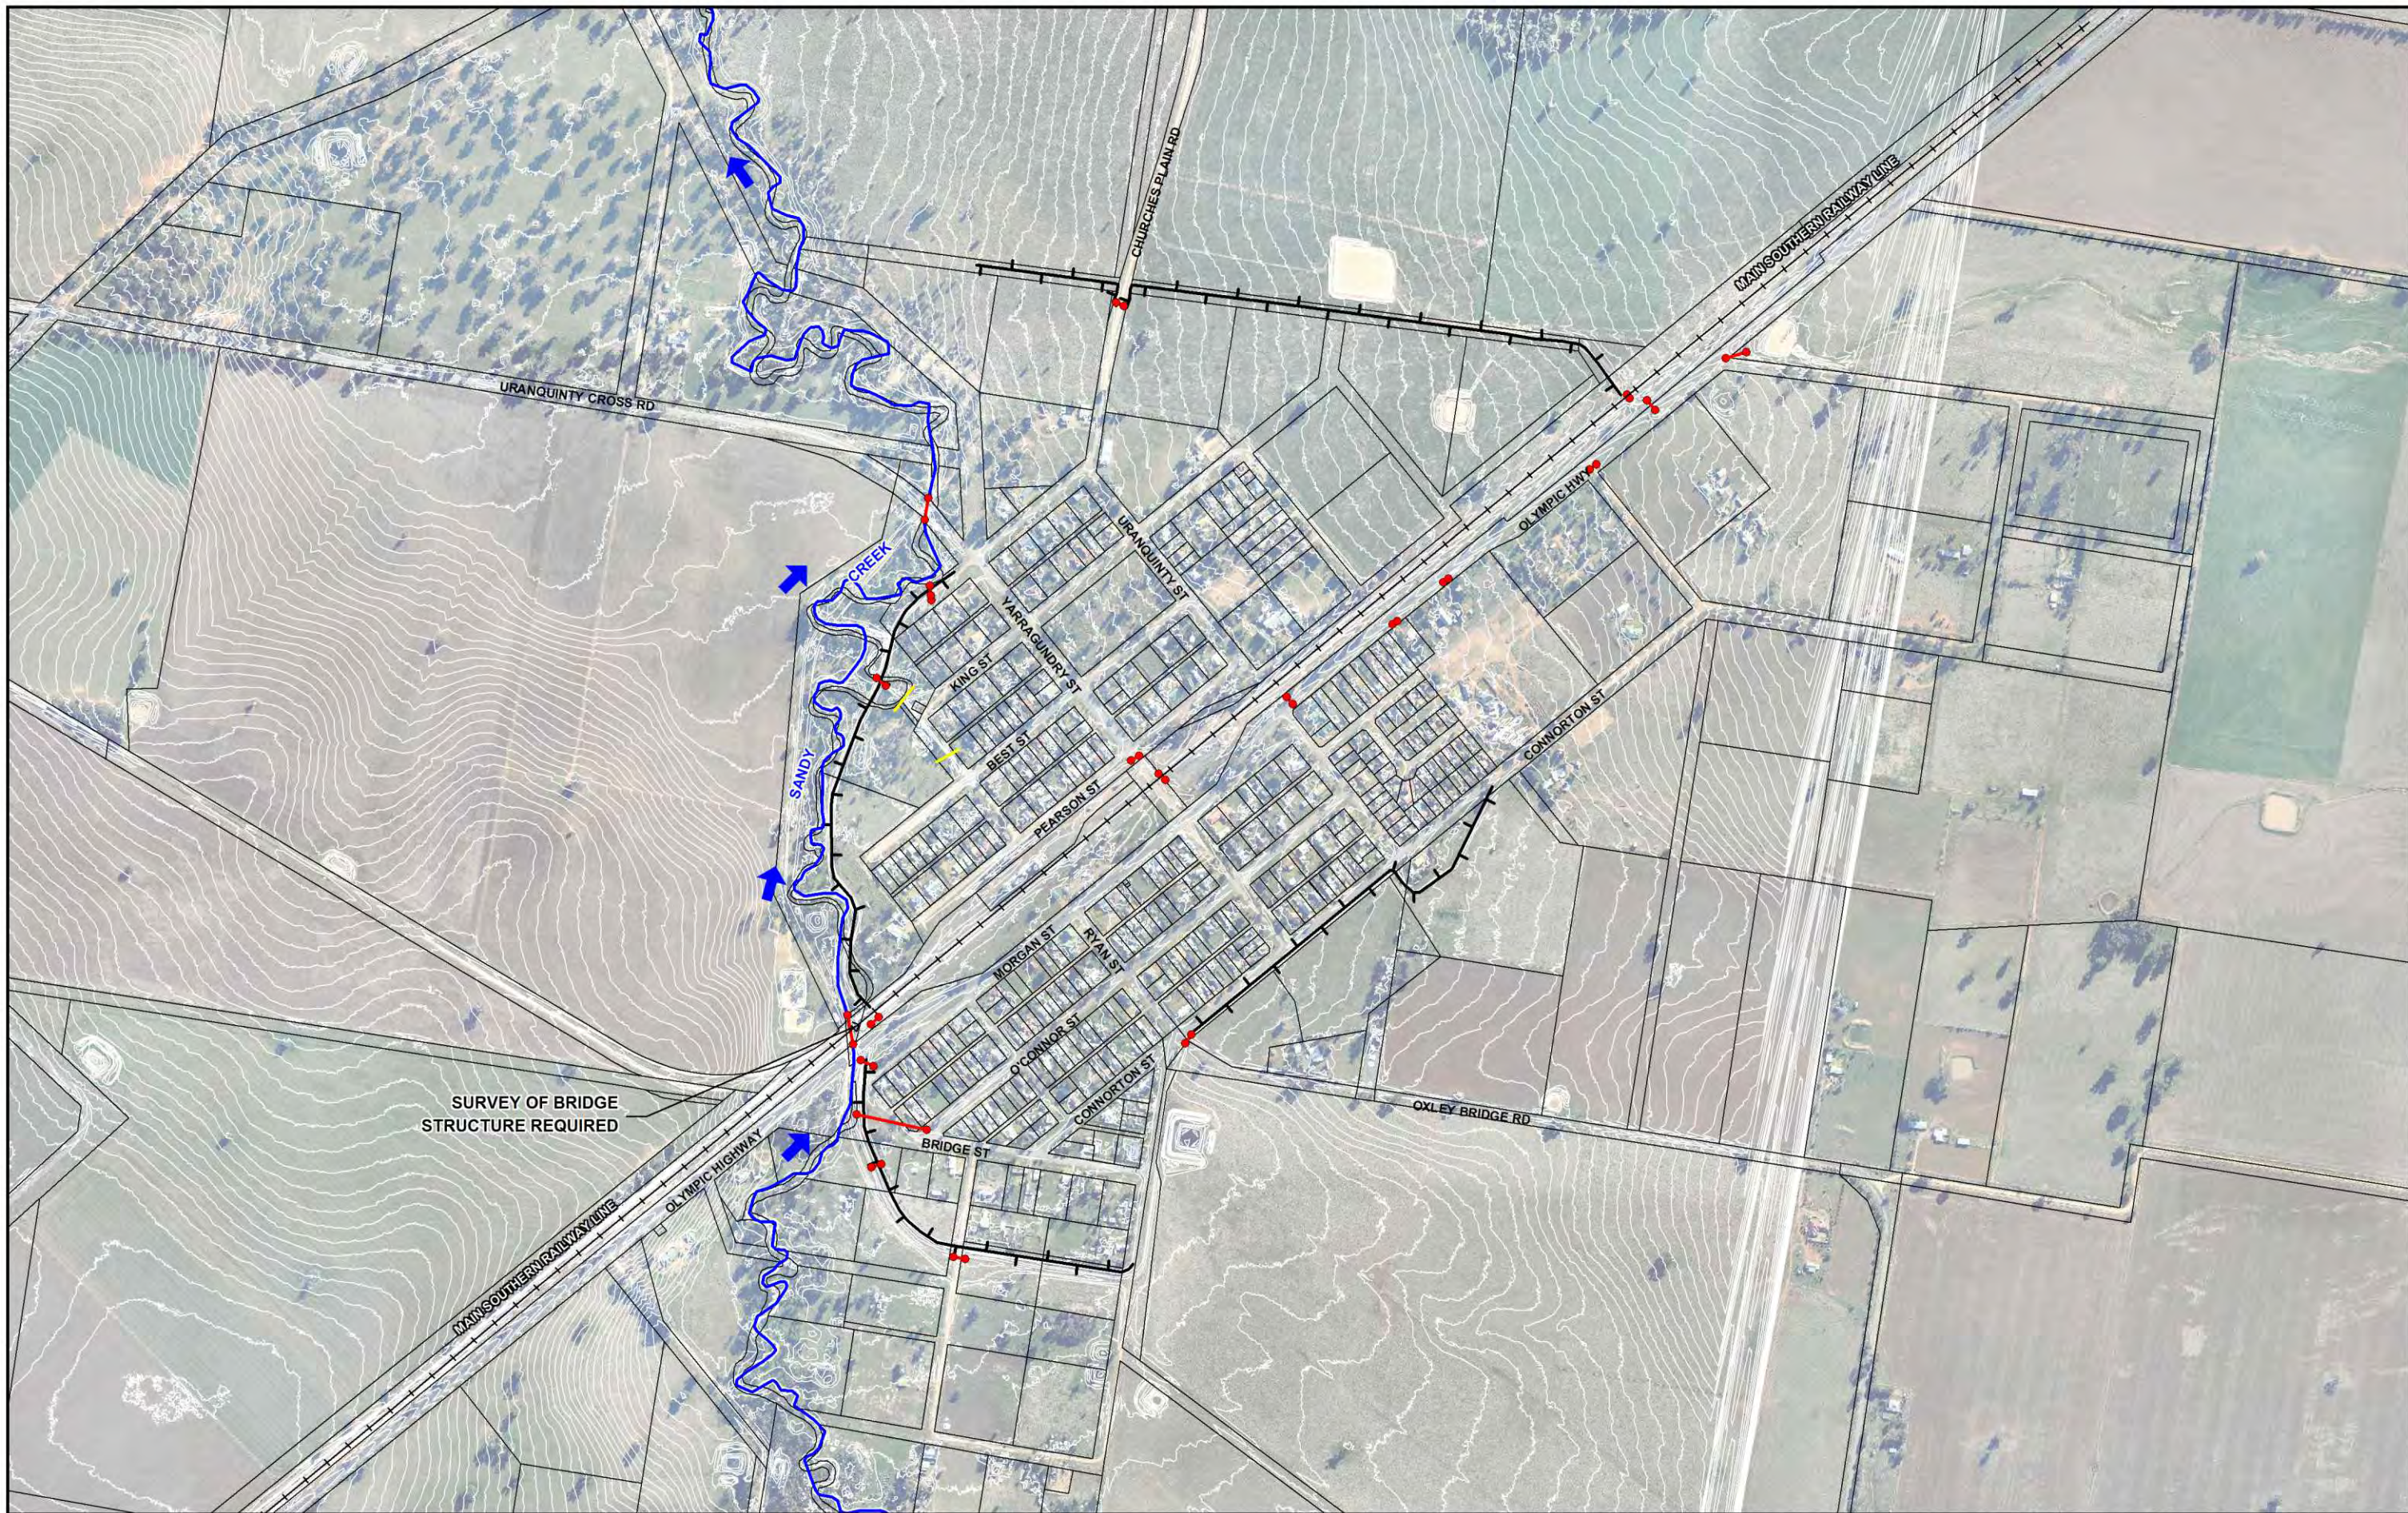
Figure 2

- LEGEND**
- Stormwater Structure to be Surveyed
  - Cross Section to be Surveyed
  - Levee
  - ← Direction of Flow
