**TARCUTTA, LADYSMITH AND URANQUINTY  
FLOOD STUDIES**

**DEVELOPMENT AND TESTING  
OF FLOOD MODELS**

**VOLUME 2 – FIGURES AND APPENDICES**

**FINAL REPORT**

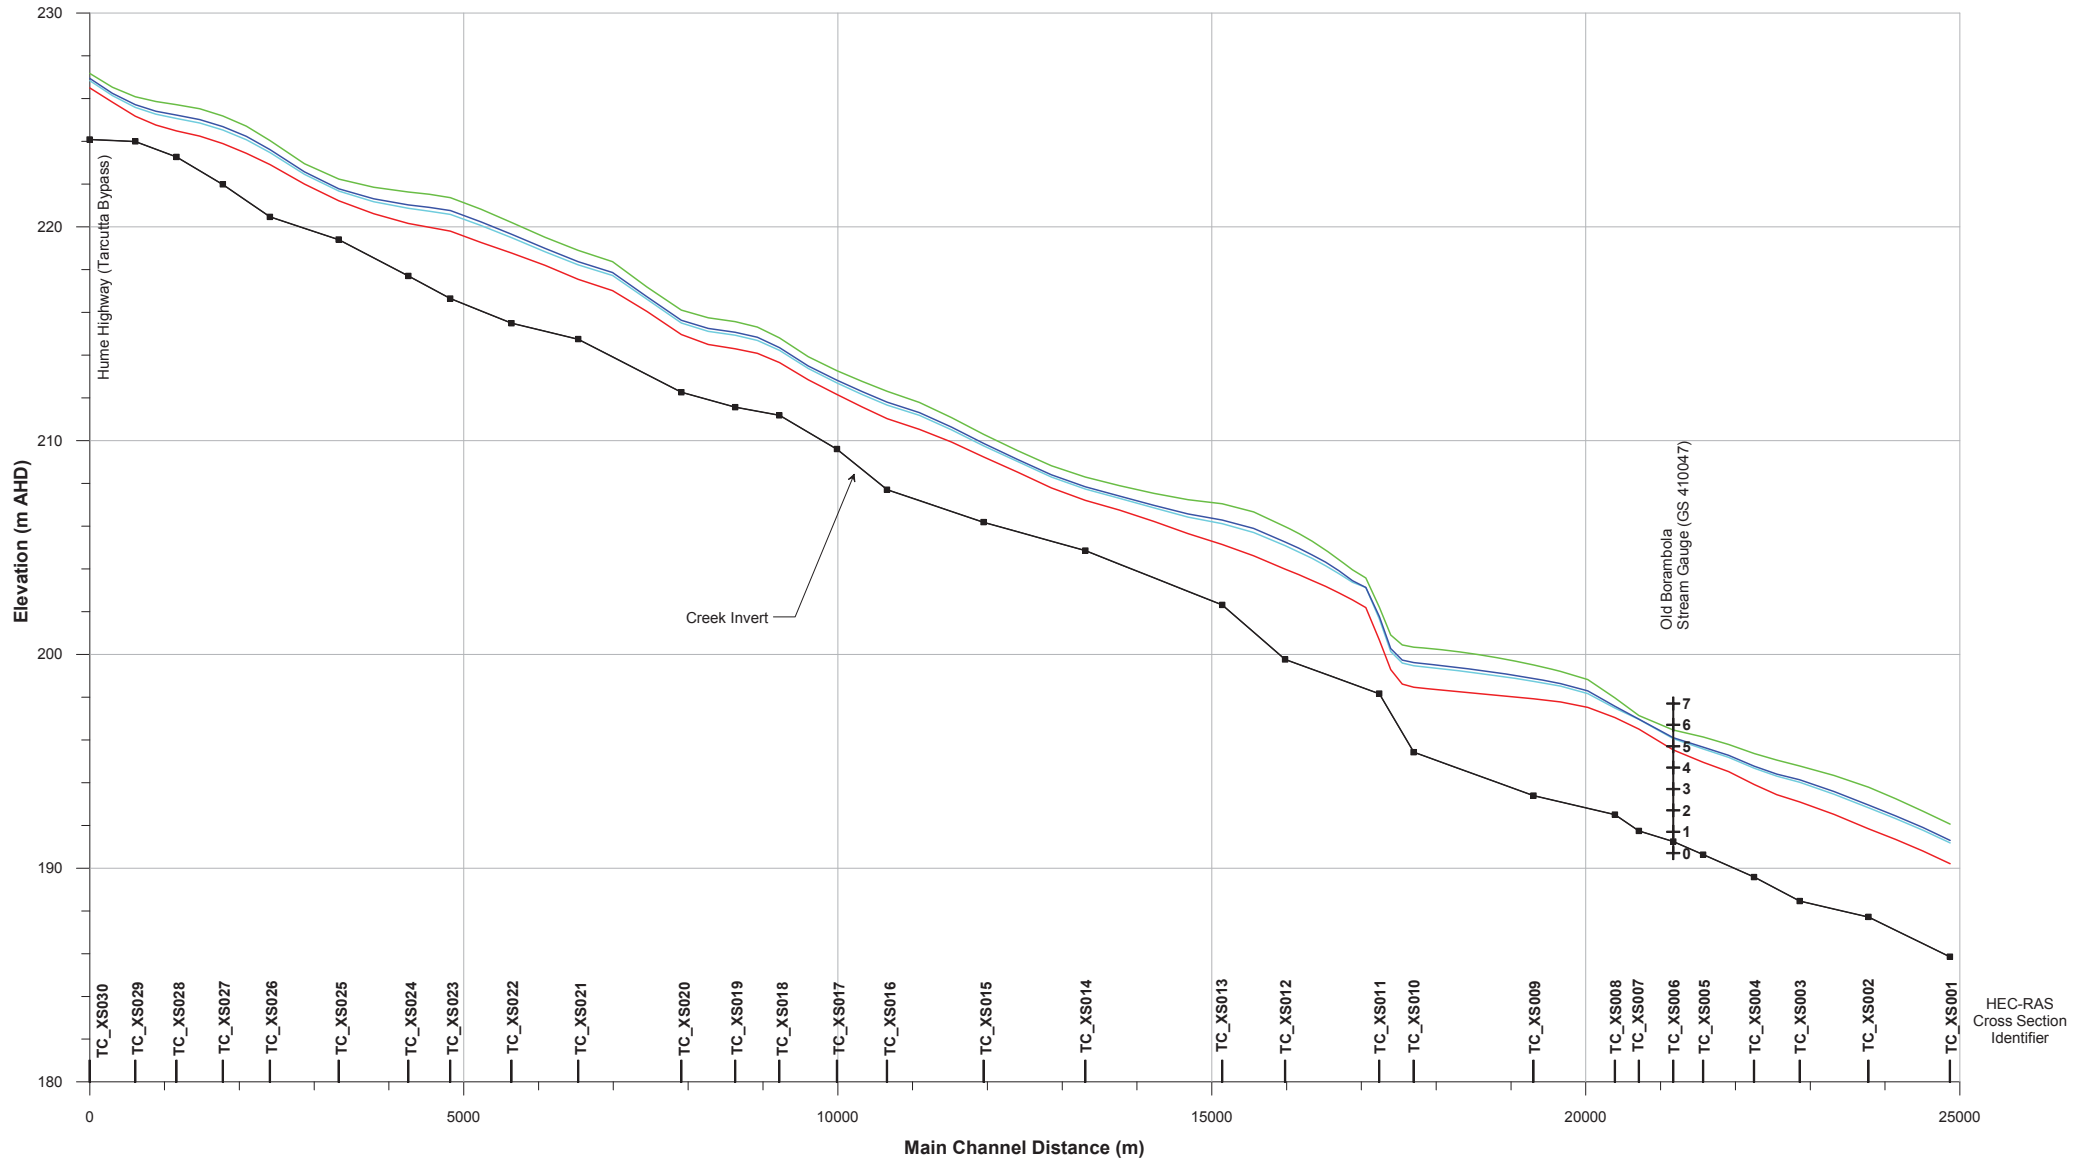
Figure 2.10

HISTORIC WATER SURFACE PROFILES  
TARCUTTA CREEK DOWNSTREAM OF TARCUTTA

**NOTE:**  
Refer Table 3.1 for comparison of recorded and modelled flood levels at Old Borambola Stream Gauge.

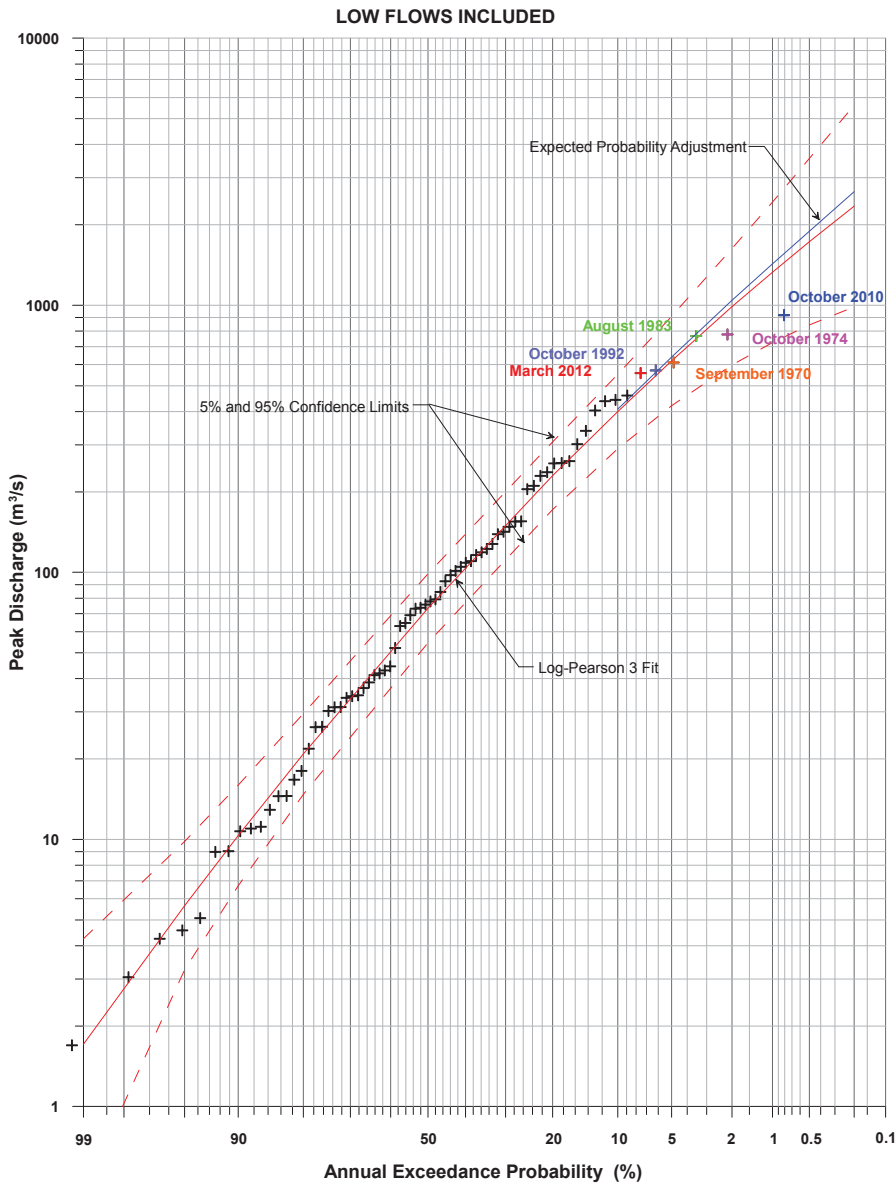
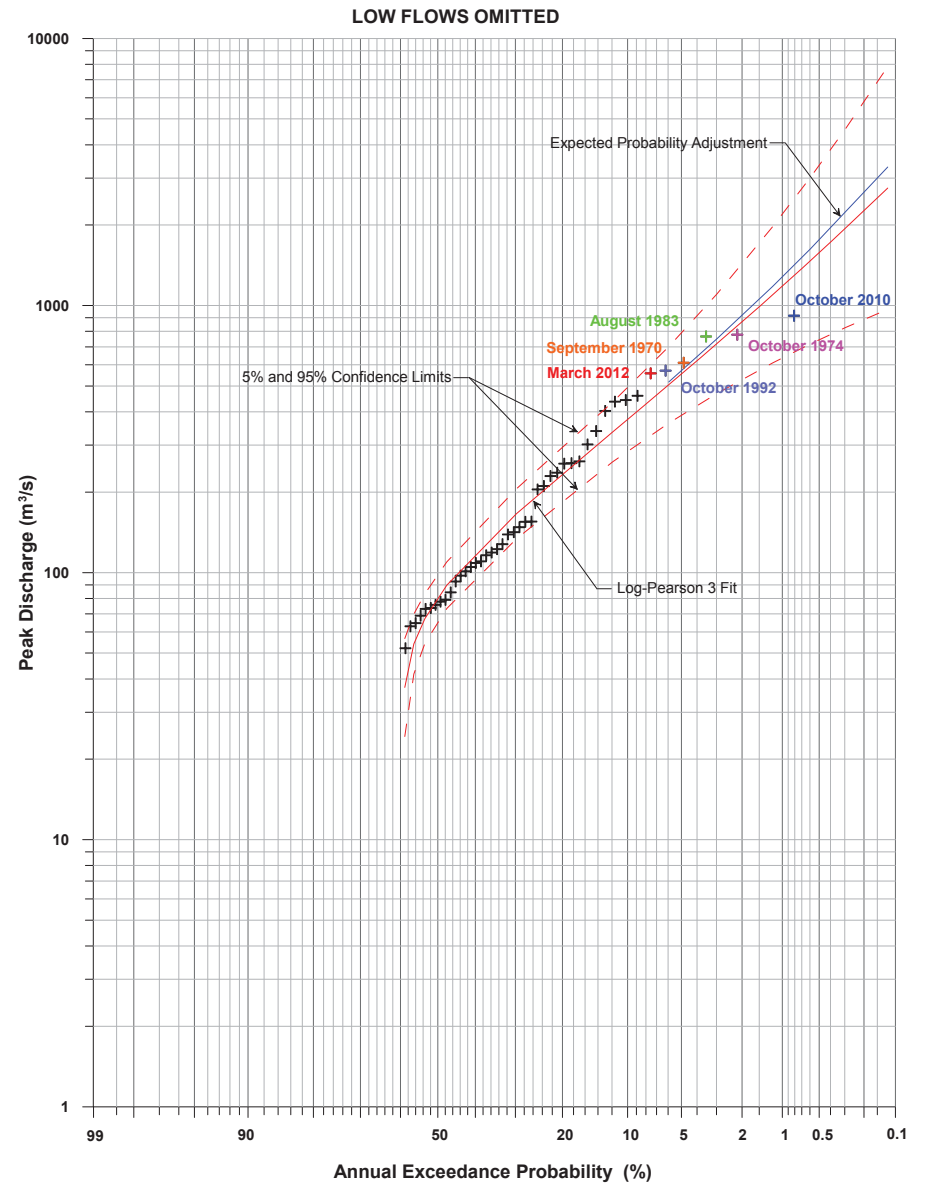
Figure 2.12

FLOOD FREQUENCY RELATIONSHIP  
LOG-PEARSON 3 ANNUAL SERIES  
TARCUTTA CREEK AT OLD BORAMBOLA STREAM GAUGE (GS 410047)

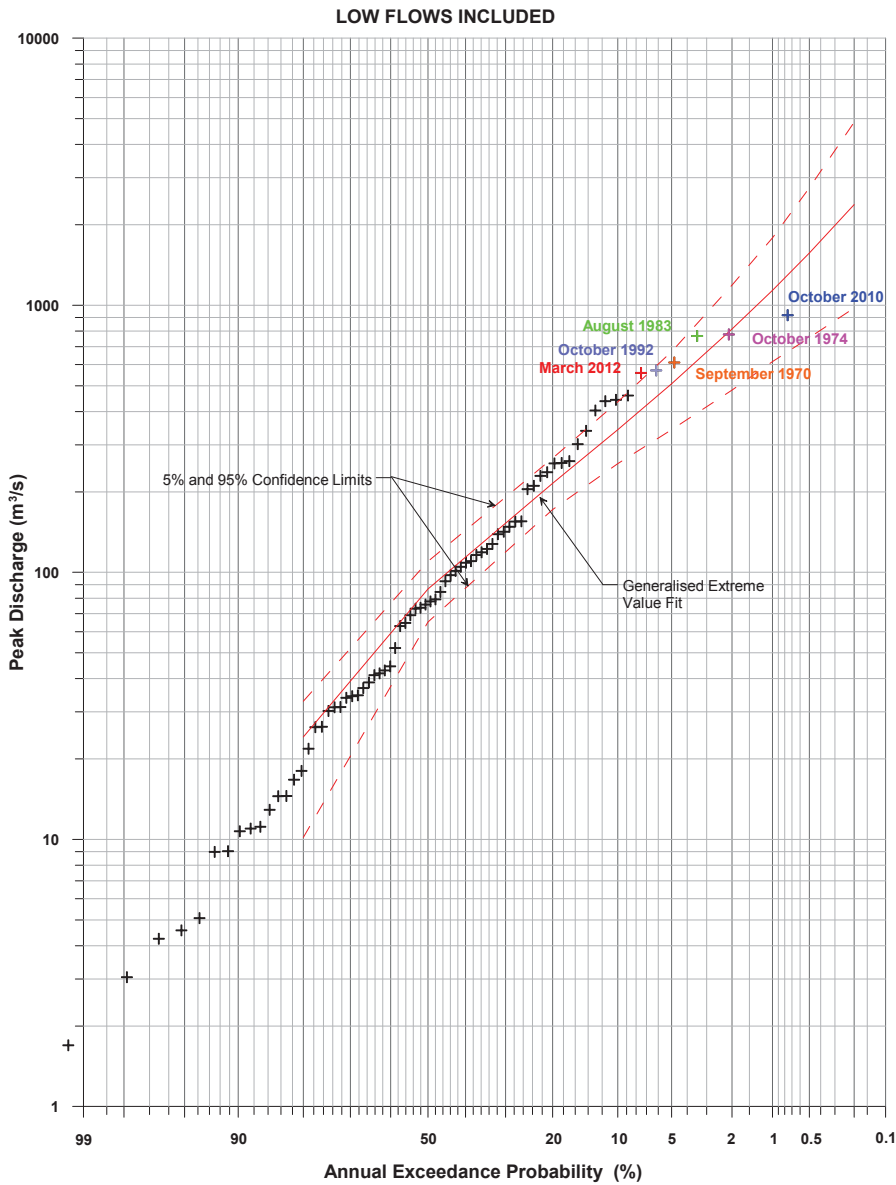
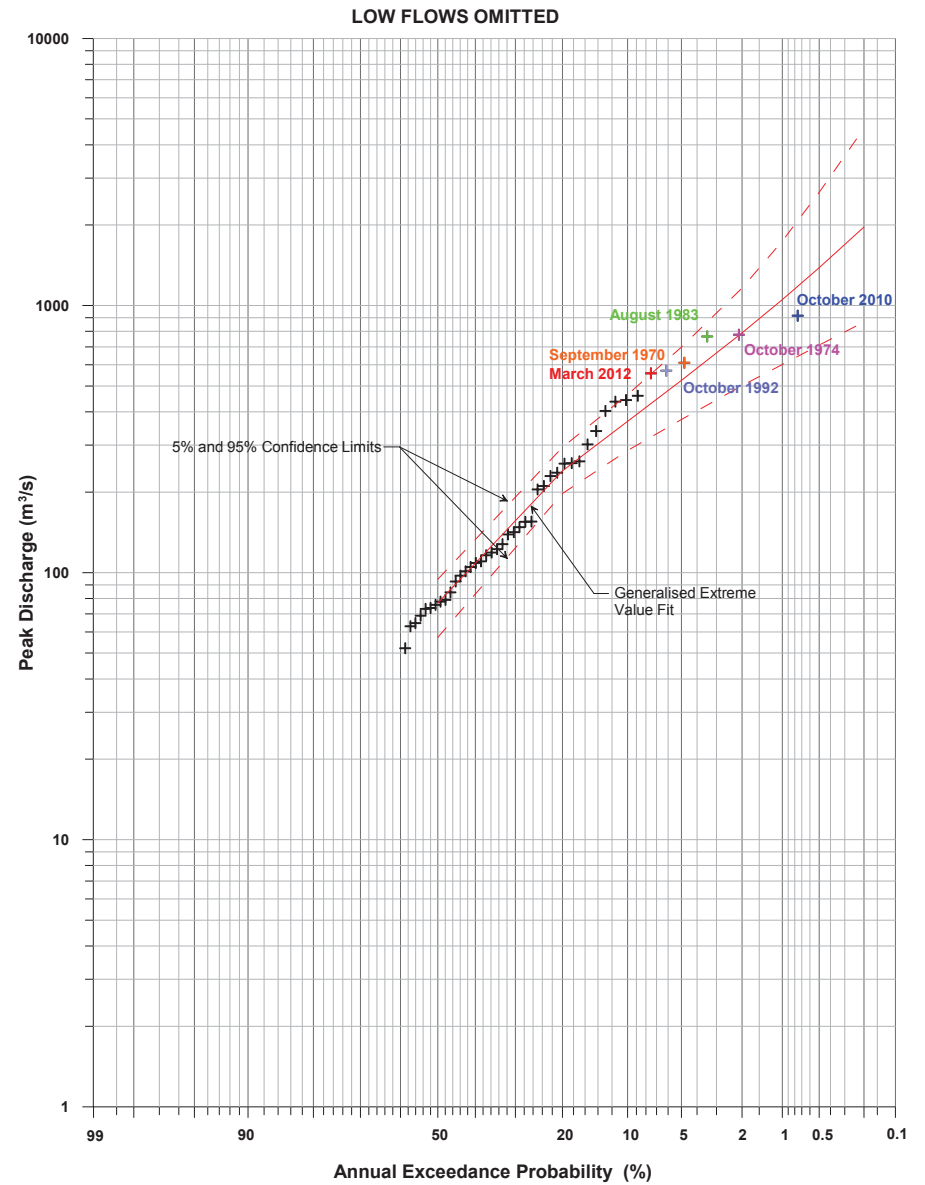
Figure 2.13

FLOOD FREQUENCY RELATIONSHIP  
GENERALISED EXTREME VALUE ANNUAL SERIES  
TARCUTTA CREEK AT OLD BORAMBOLA STREAM GAUGE (GS 410047)

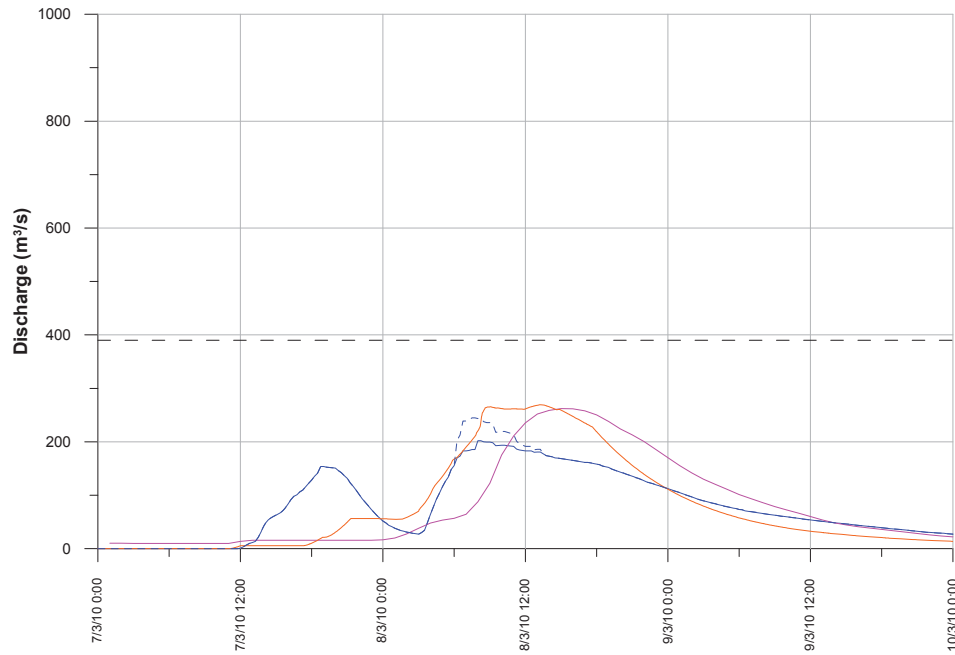
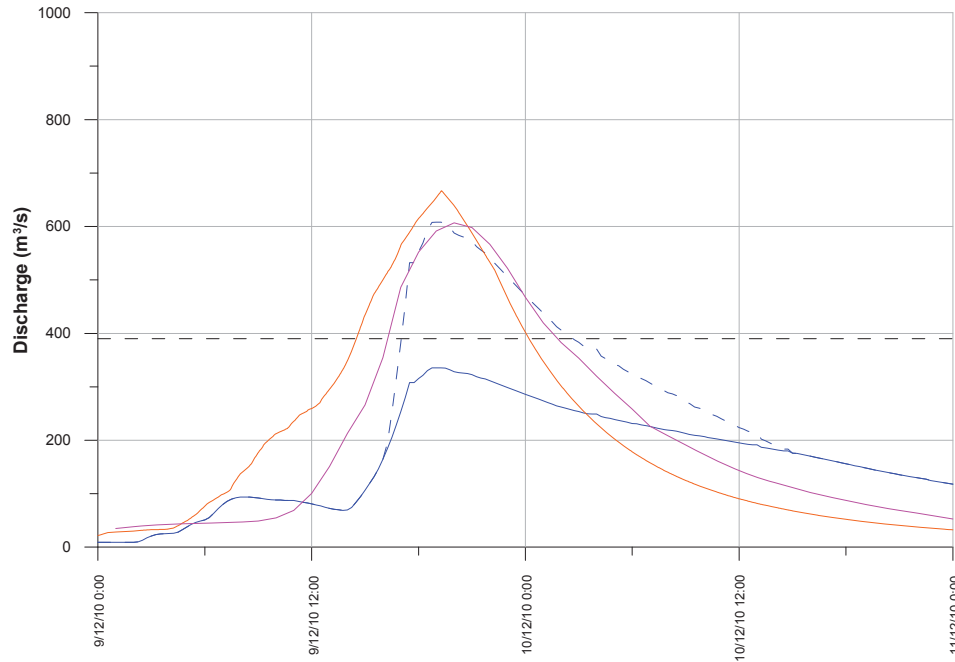
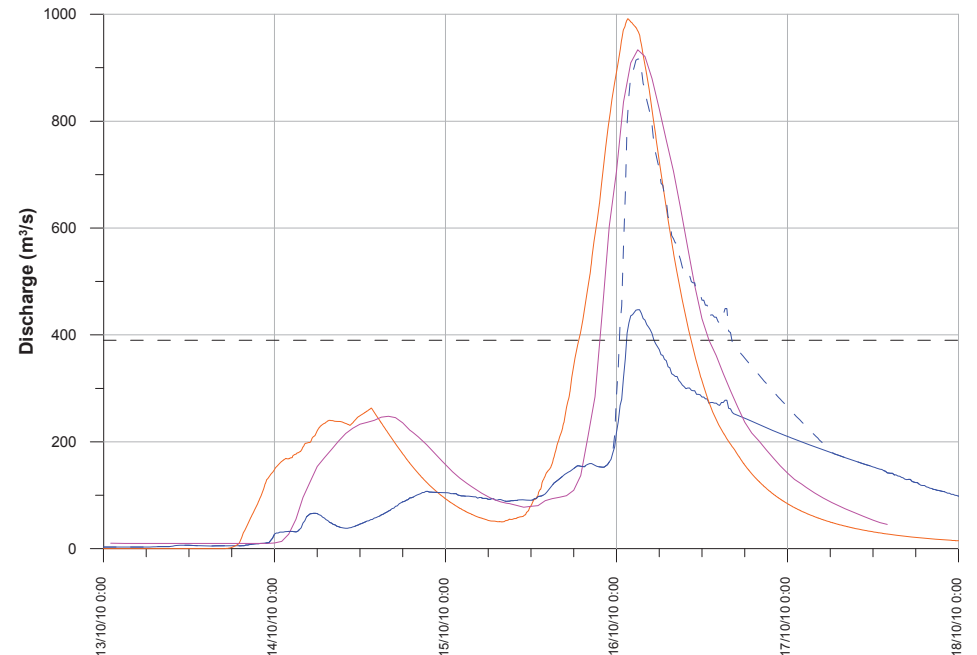
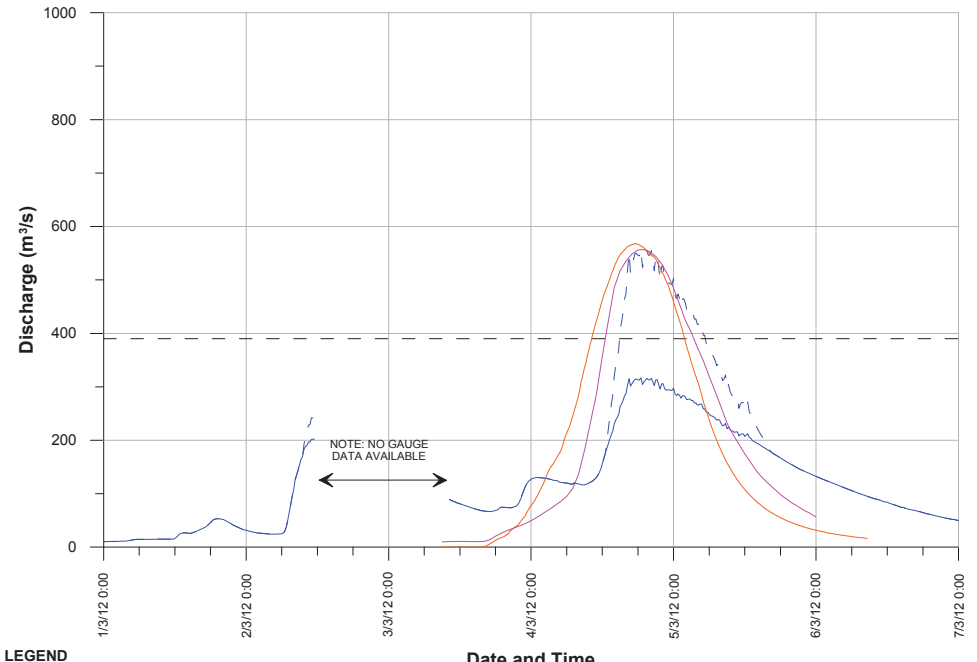
Figure 3.2

- LEGEND**
- Recorded Hydrograph (DPIOW Rating Curve)
  - - - Recorded Hydrograph (Adjusted Rating Curve)
  - Modelled Hydrograph (RAFTS)
  - Modelled Hydrograph (UNET)
  - - - Max. Gauged Discharge

TARCUTTA CREEK HISTORIC FLOWS AT OLD BORAMBOLA GAUGE (GS 410047)

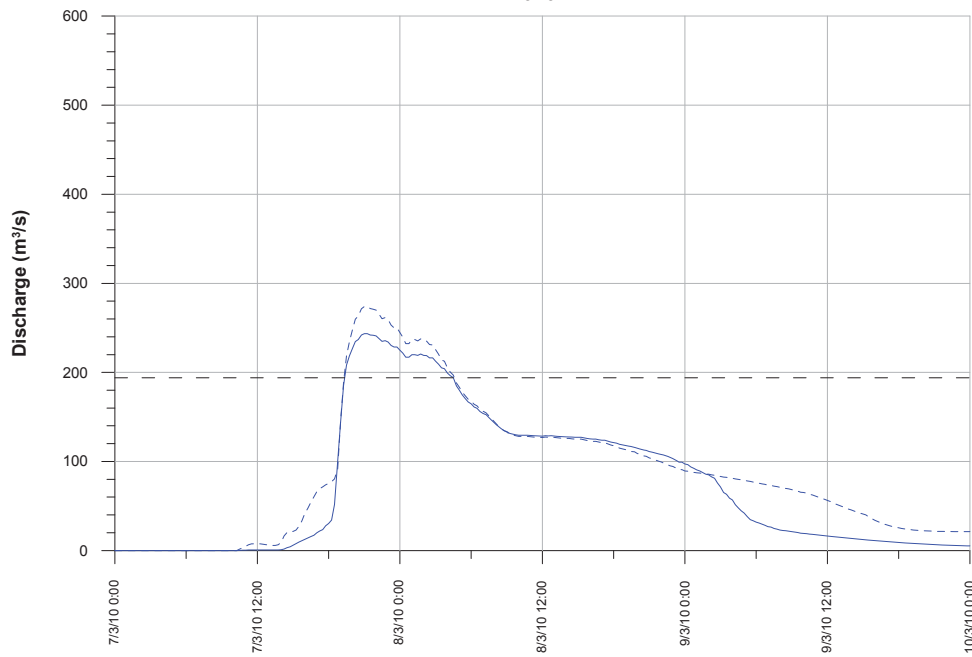
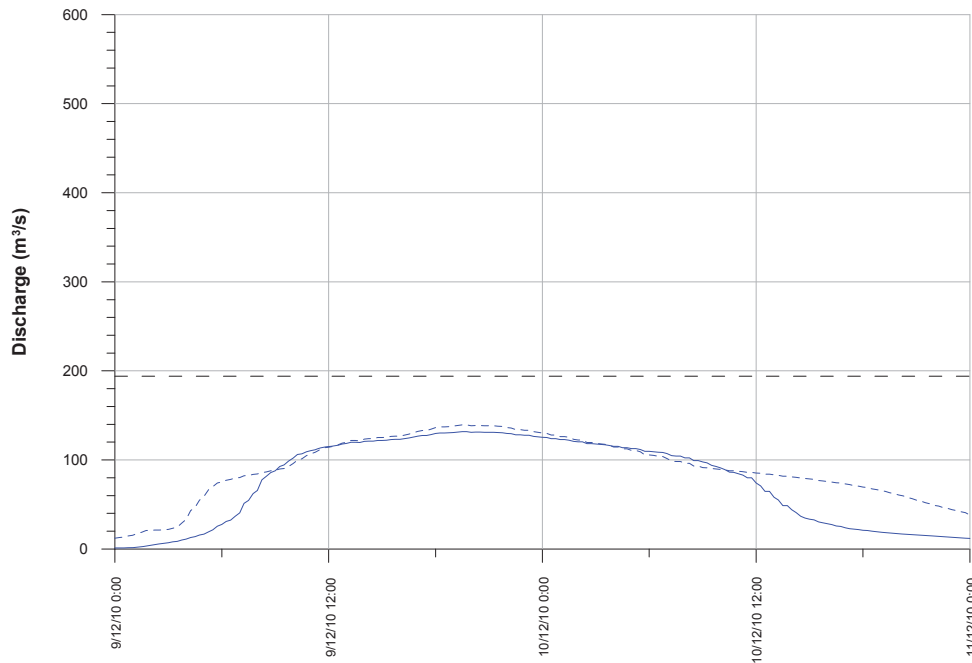
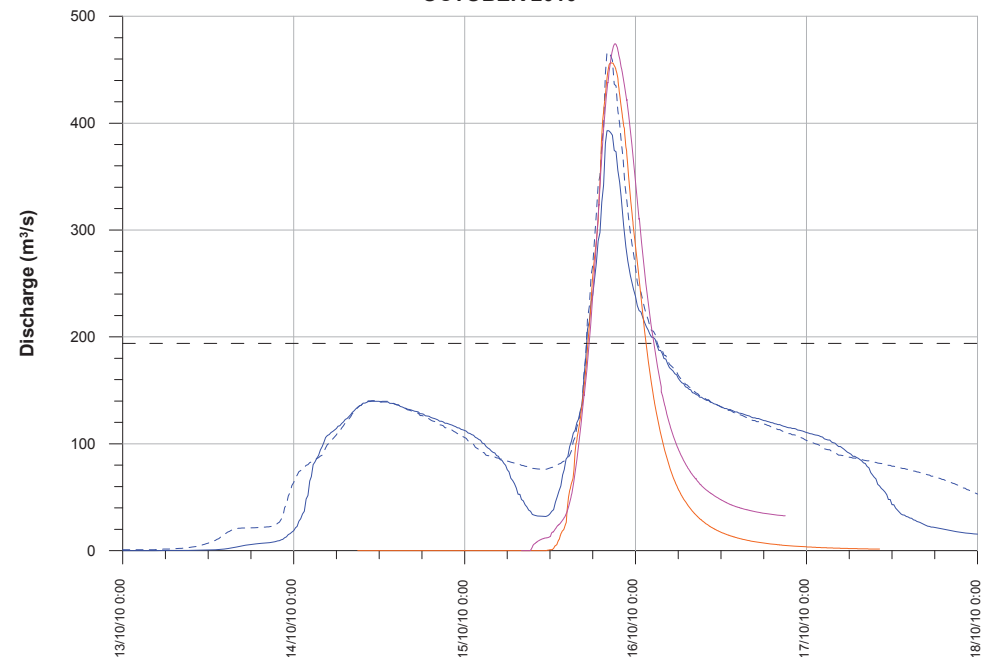
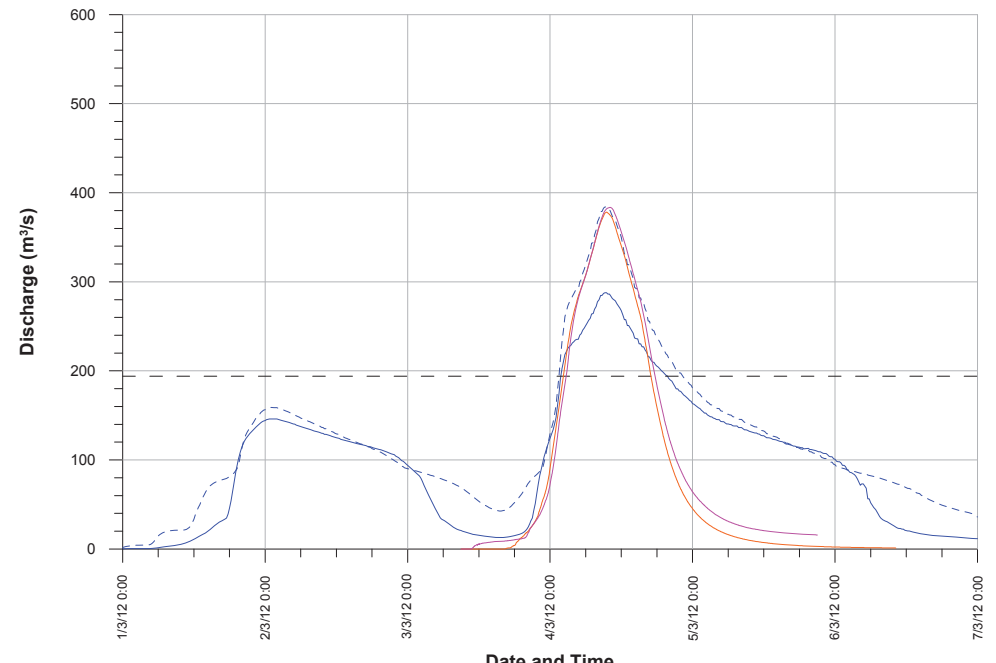
Figure 3.4

- Recorded Hydrograph (DPIOW Rating Curve)
- - - Adjusted Hydrograph (Adjusted Rating Curve)
- Modelled Hydrograph (RAFTS)
- TUFLOW Hydrograph (TUFLOW)
- - - Max. Gauge Discharge

KYEAMBA CREEK HISTORIC FLOWS AT LADYSMITH GAUGE (GS 410048)

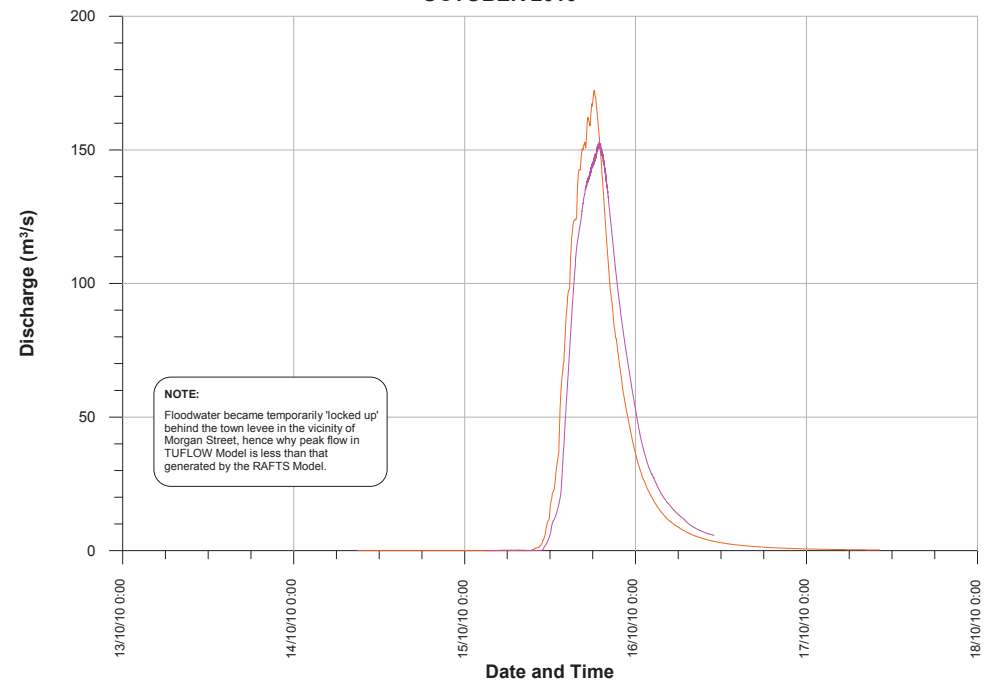
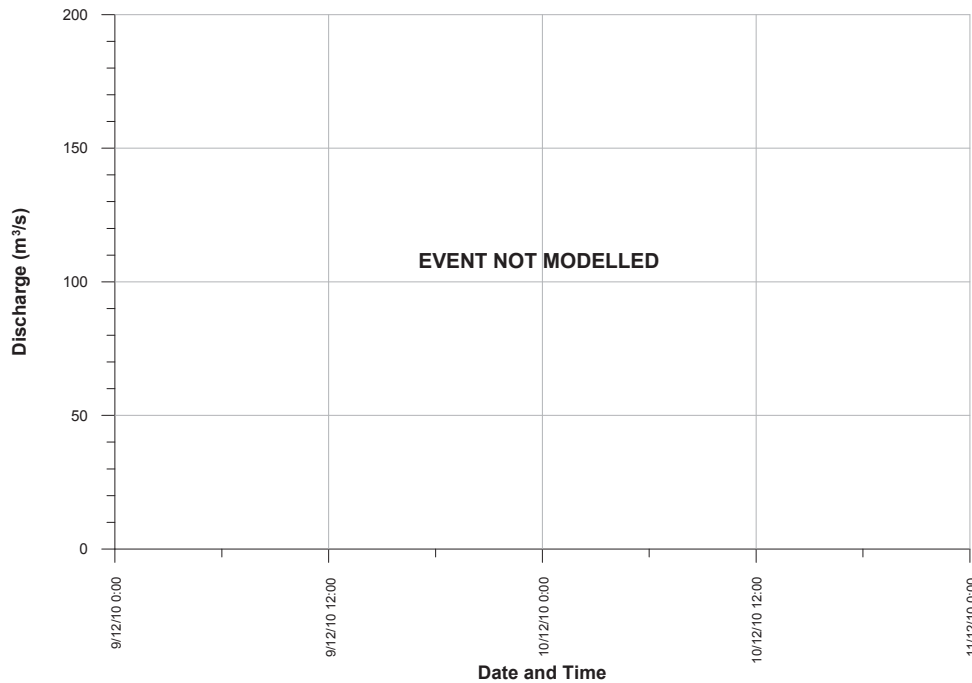
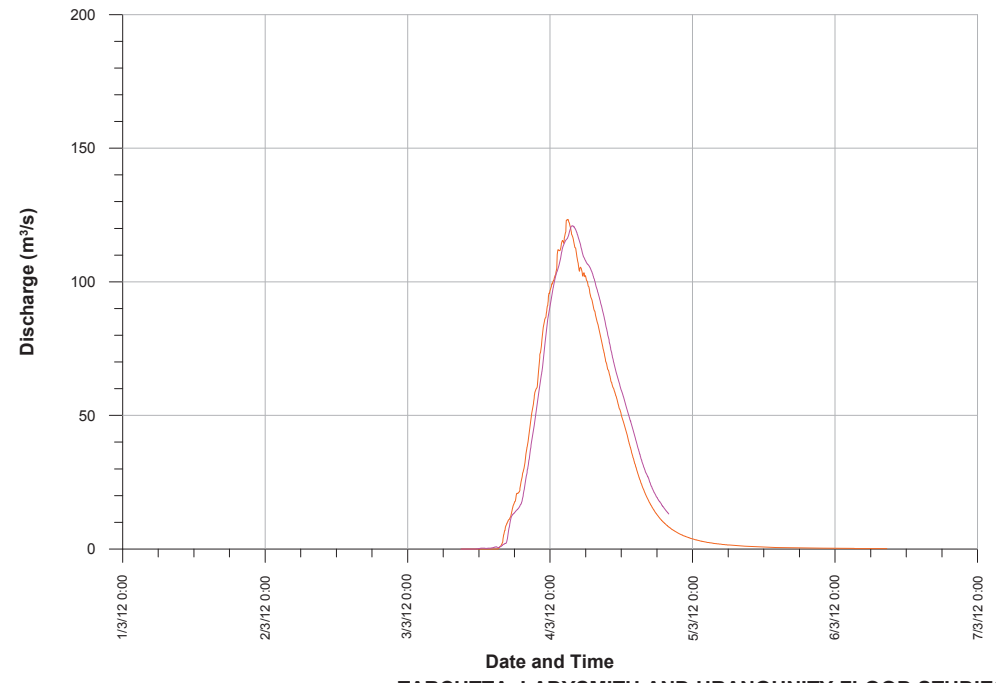
Figure 3.6

SANDY CREEK HISTORIC FLOWS AT OLYMPIC HIGHWAY

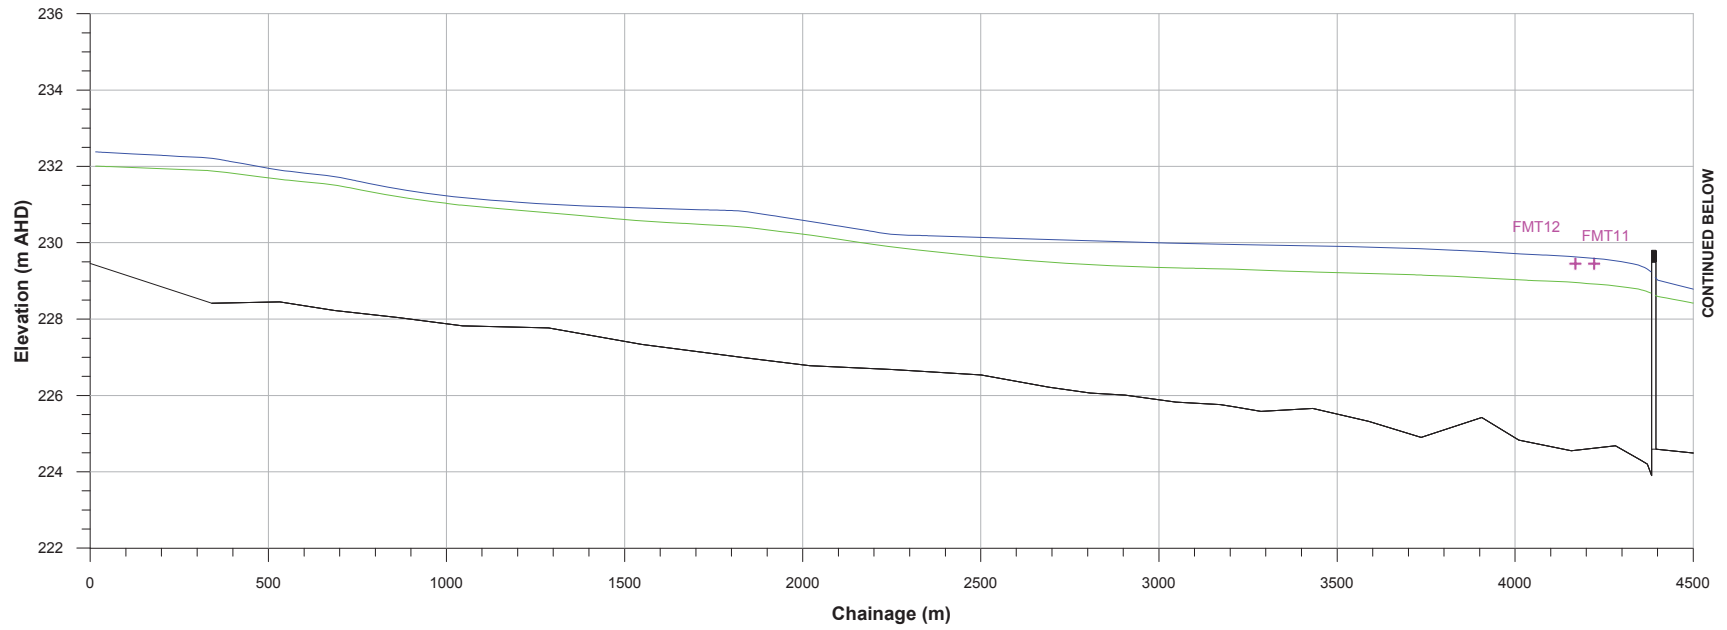
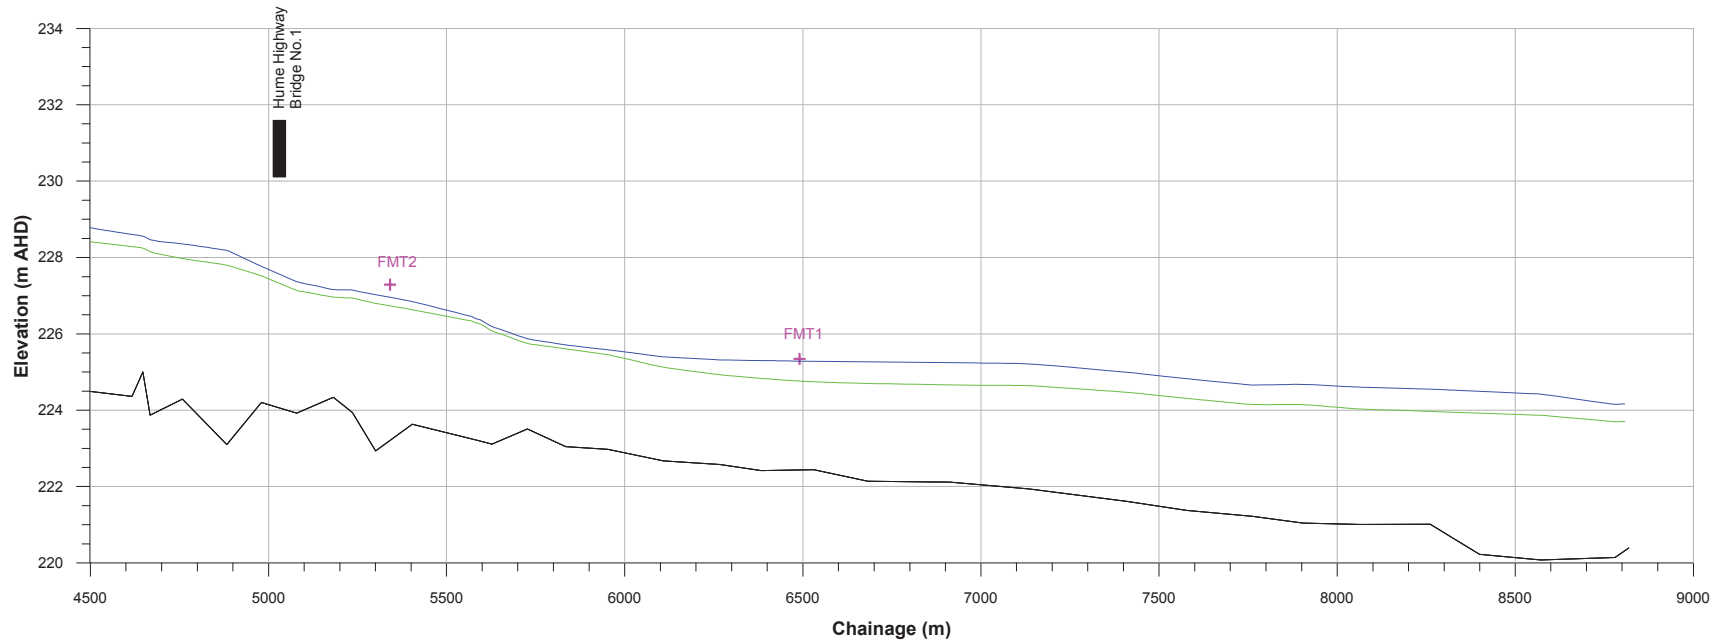
Figure 4.5  
Sheet 1 of 2

**NOTE:**  
Only flood marks located along the main arm of Tarcutta Creek shown.

TARCUTTA CREEK HISTORIC WATER SURFACE PROFILES

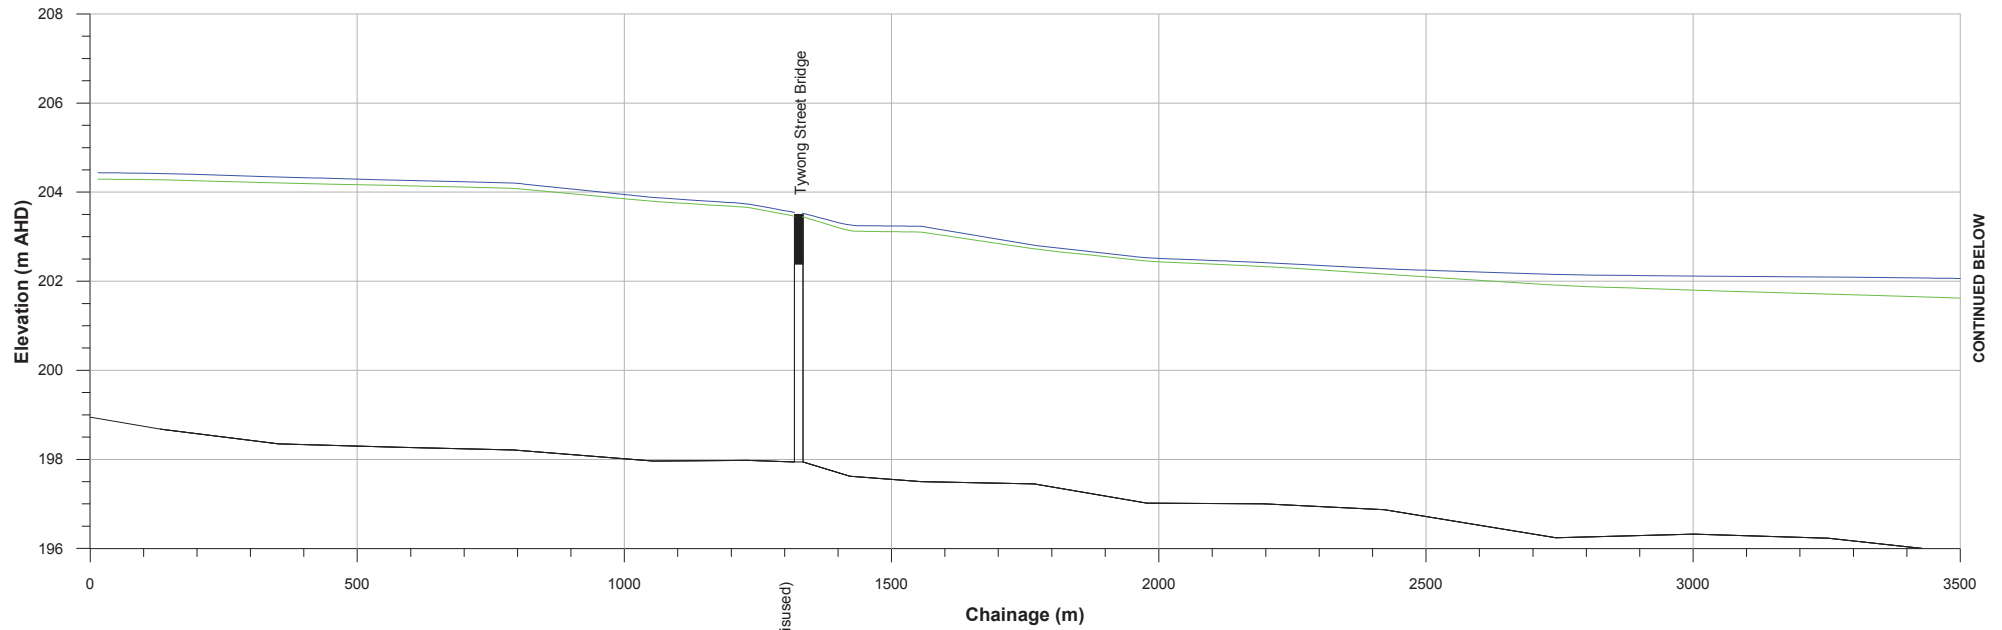
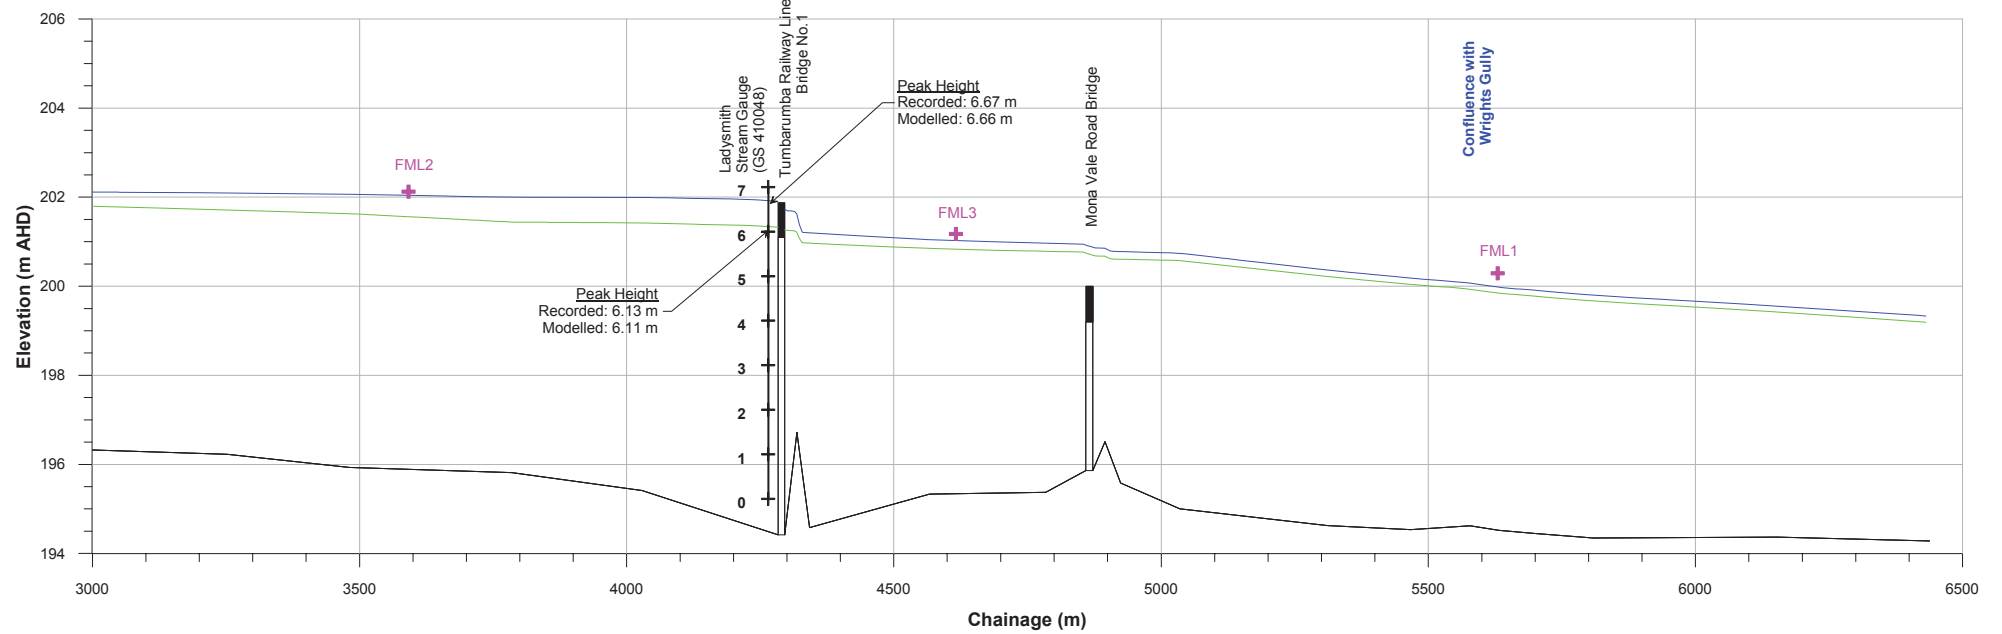
Figure 4.8

- NOTES:**
1. Only flood marks located along main arm of Kyeamba Creek shown.
  2. Location of Ladysmith stream gauge approximate only.
  3. Gauge zero on Ladysmith stream gauge = 195.224 m AHD

KYEAMBA CREEK HISTORIC WATER SURFACE PROFILES

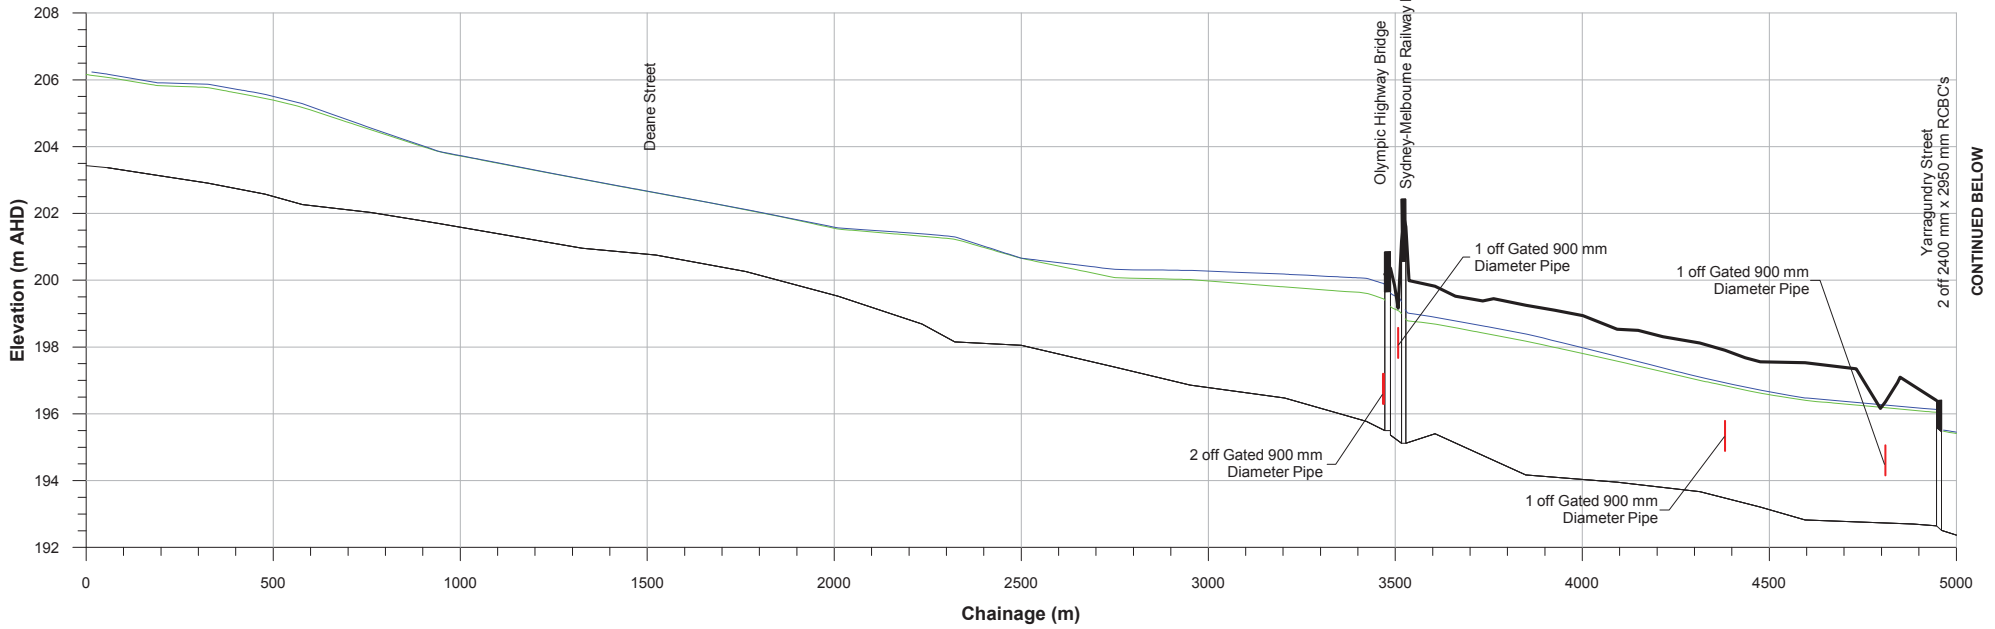
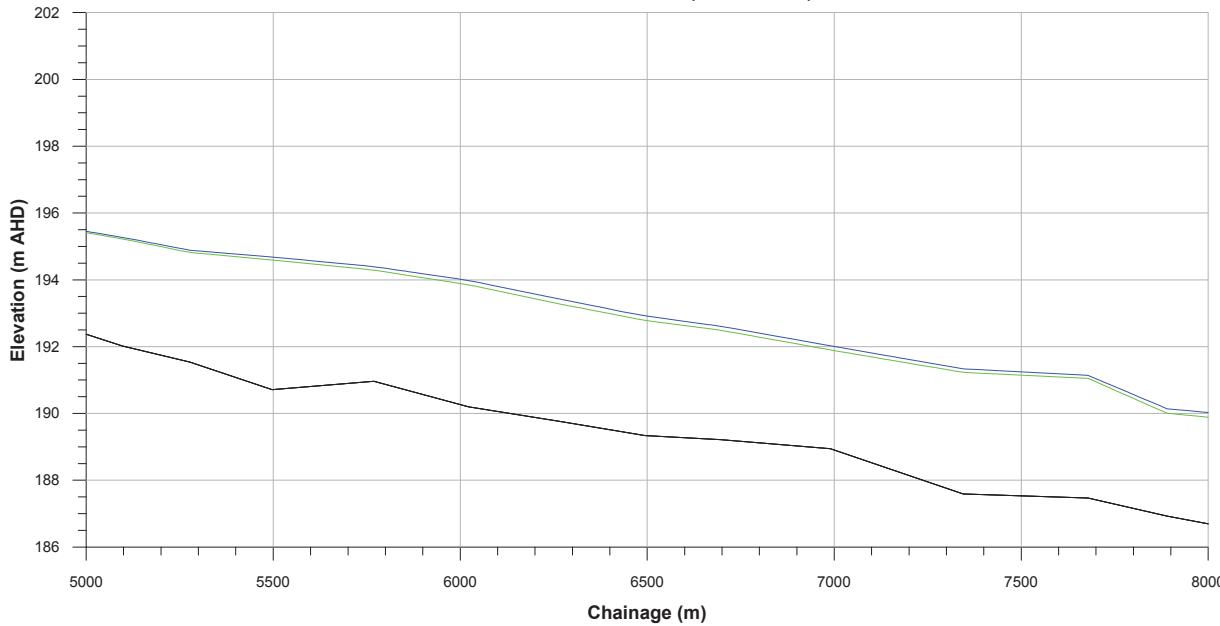
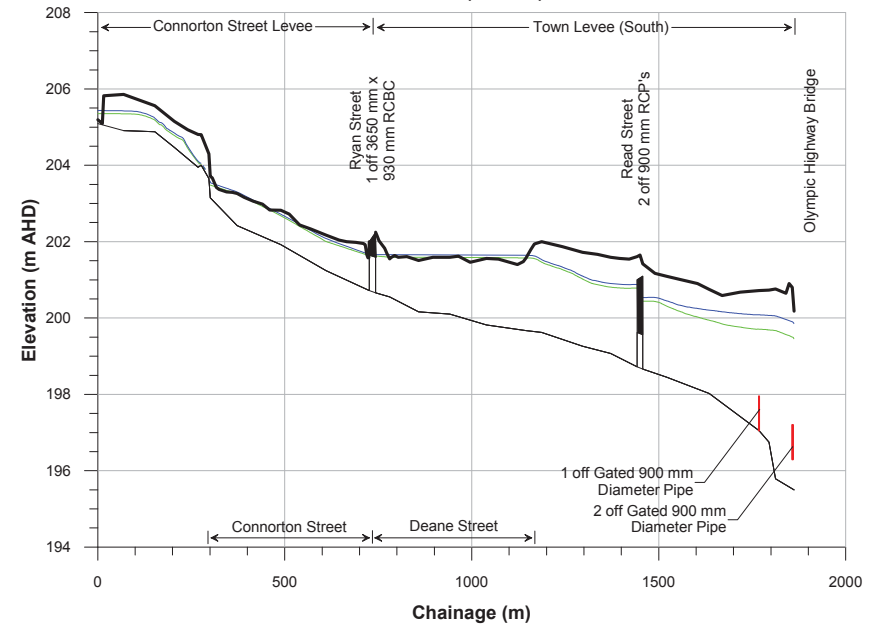
Figure 4.11

SANDY CREEK HISTORIC WATER SURFACE PROFILES
