**TARCUTTA, LADYSMITH AND URANQUINTY  
FLOOD STUDIES**

**DEVELOPMENT AND TESTING  
OF FLOOD MODELS**

**VOLUME 2 – FIGURES AND APPENDICES**

**FINAL REPORT**

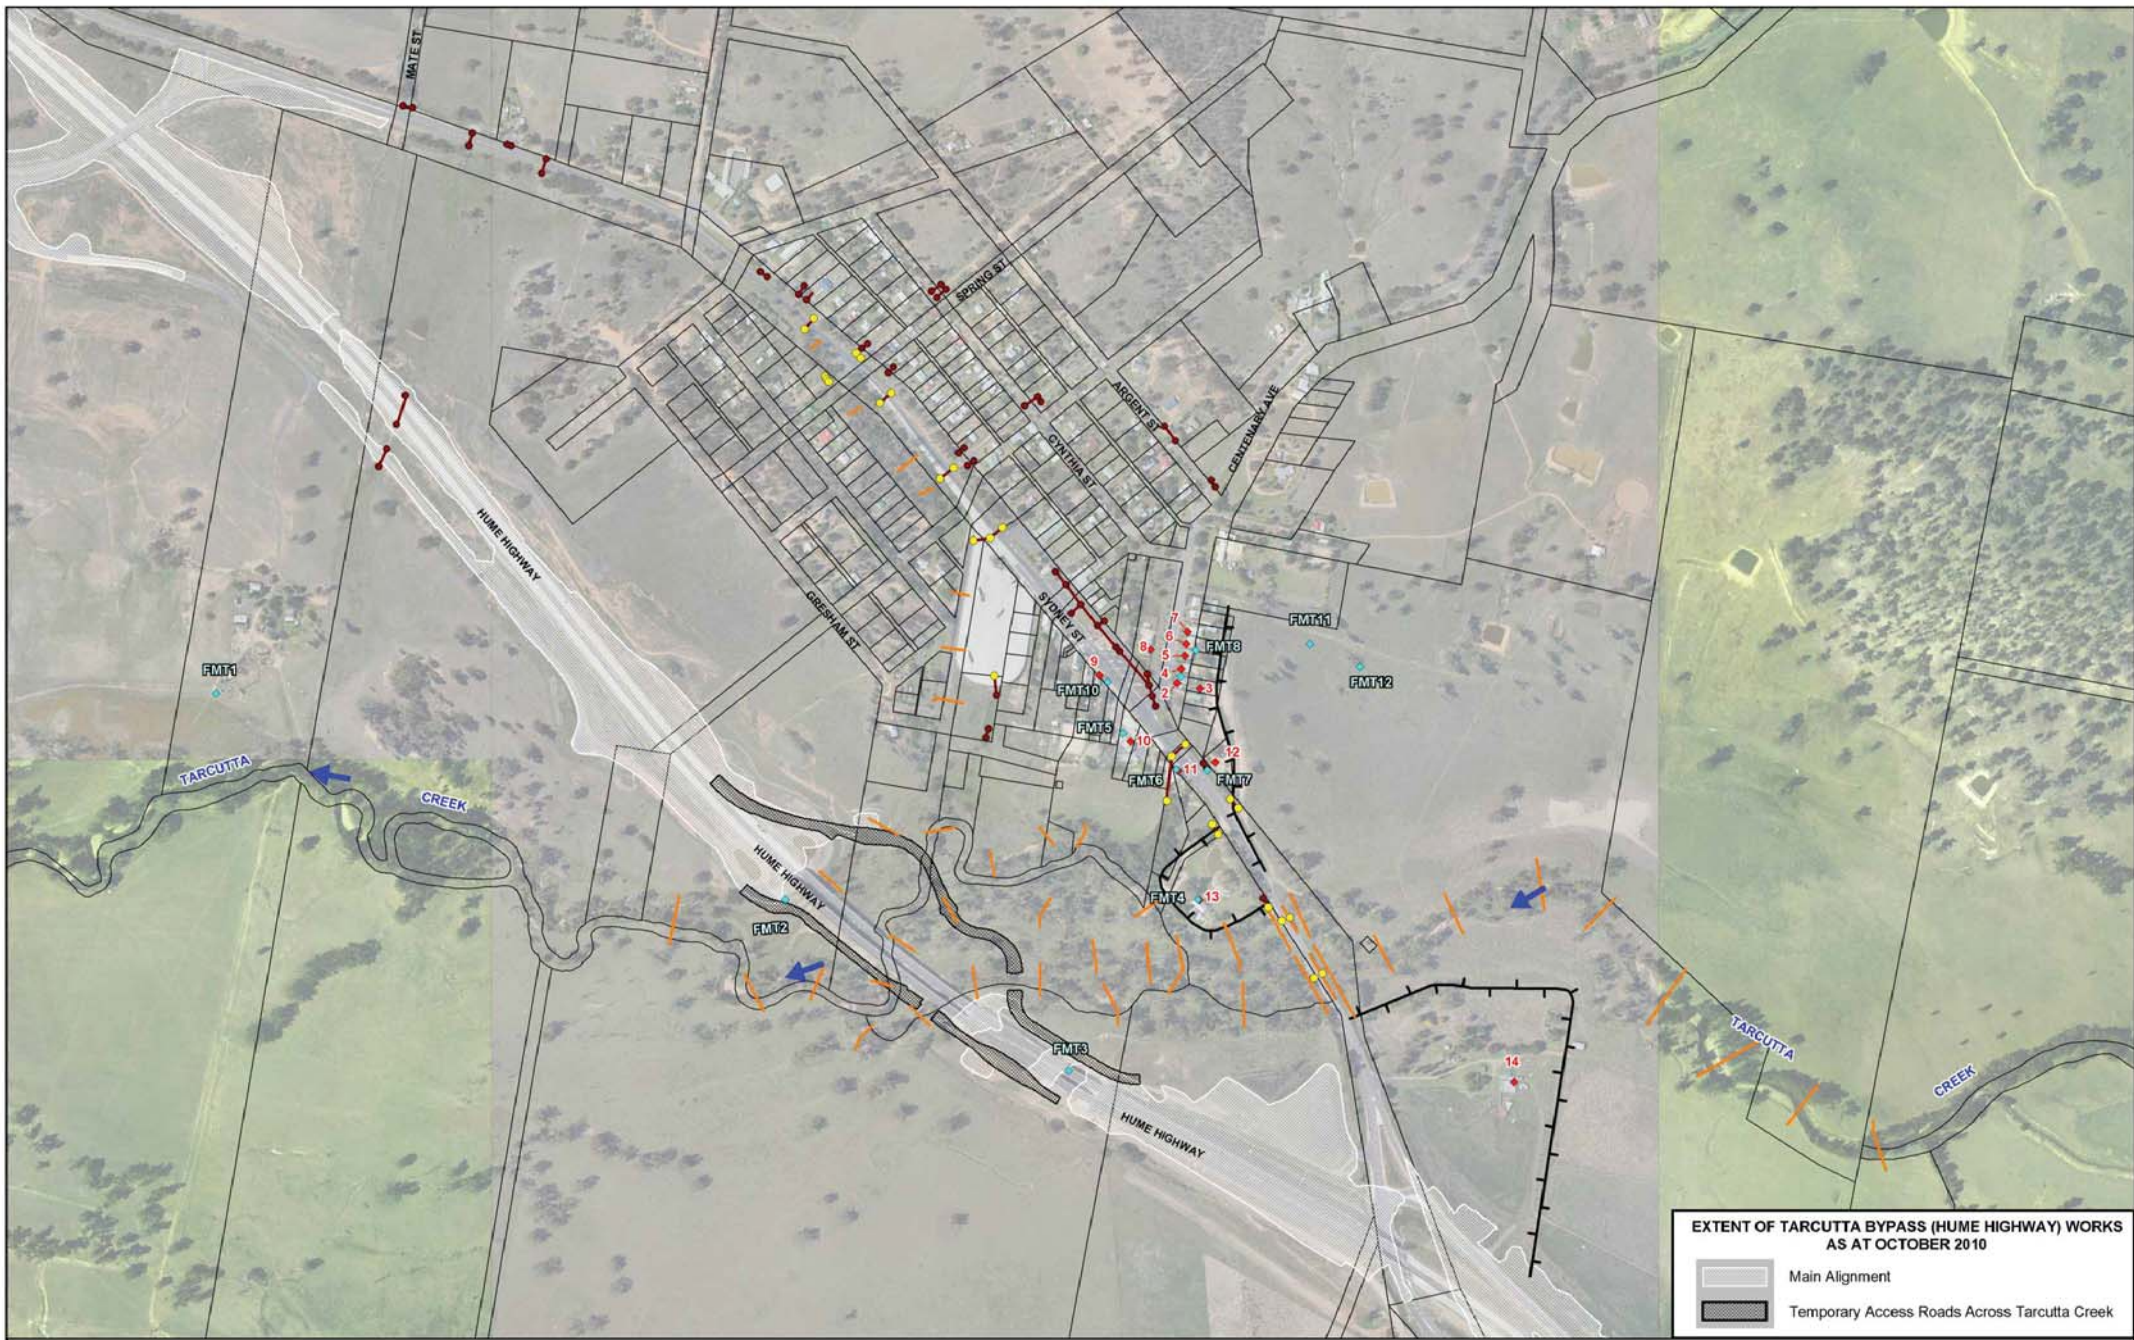
Figure A1

SURVEY DATA AT TARCUTTA

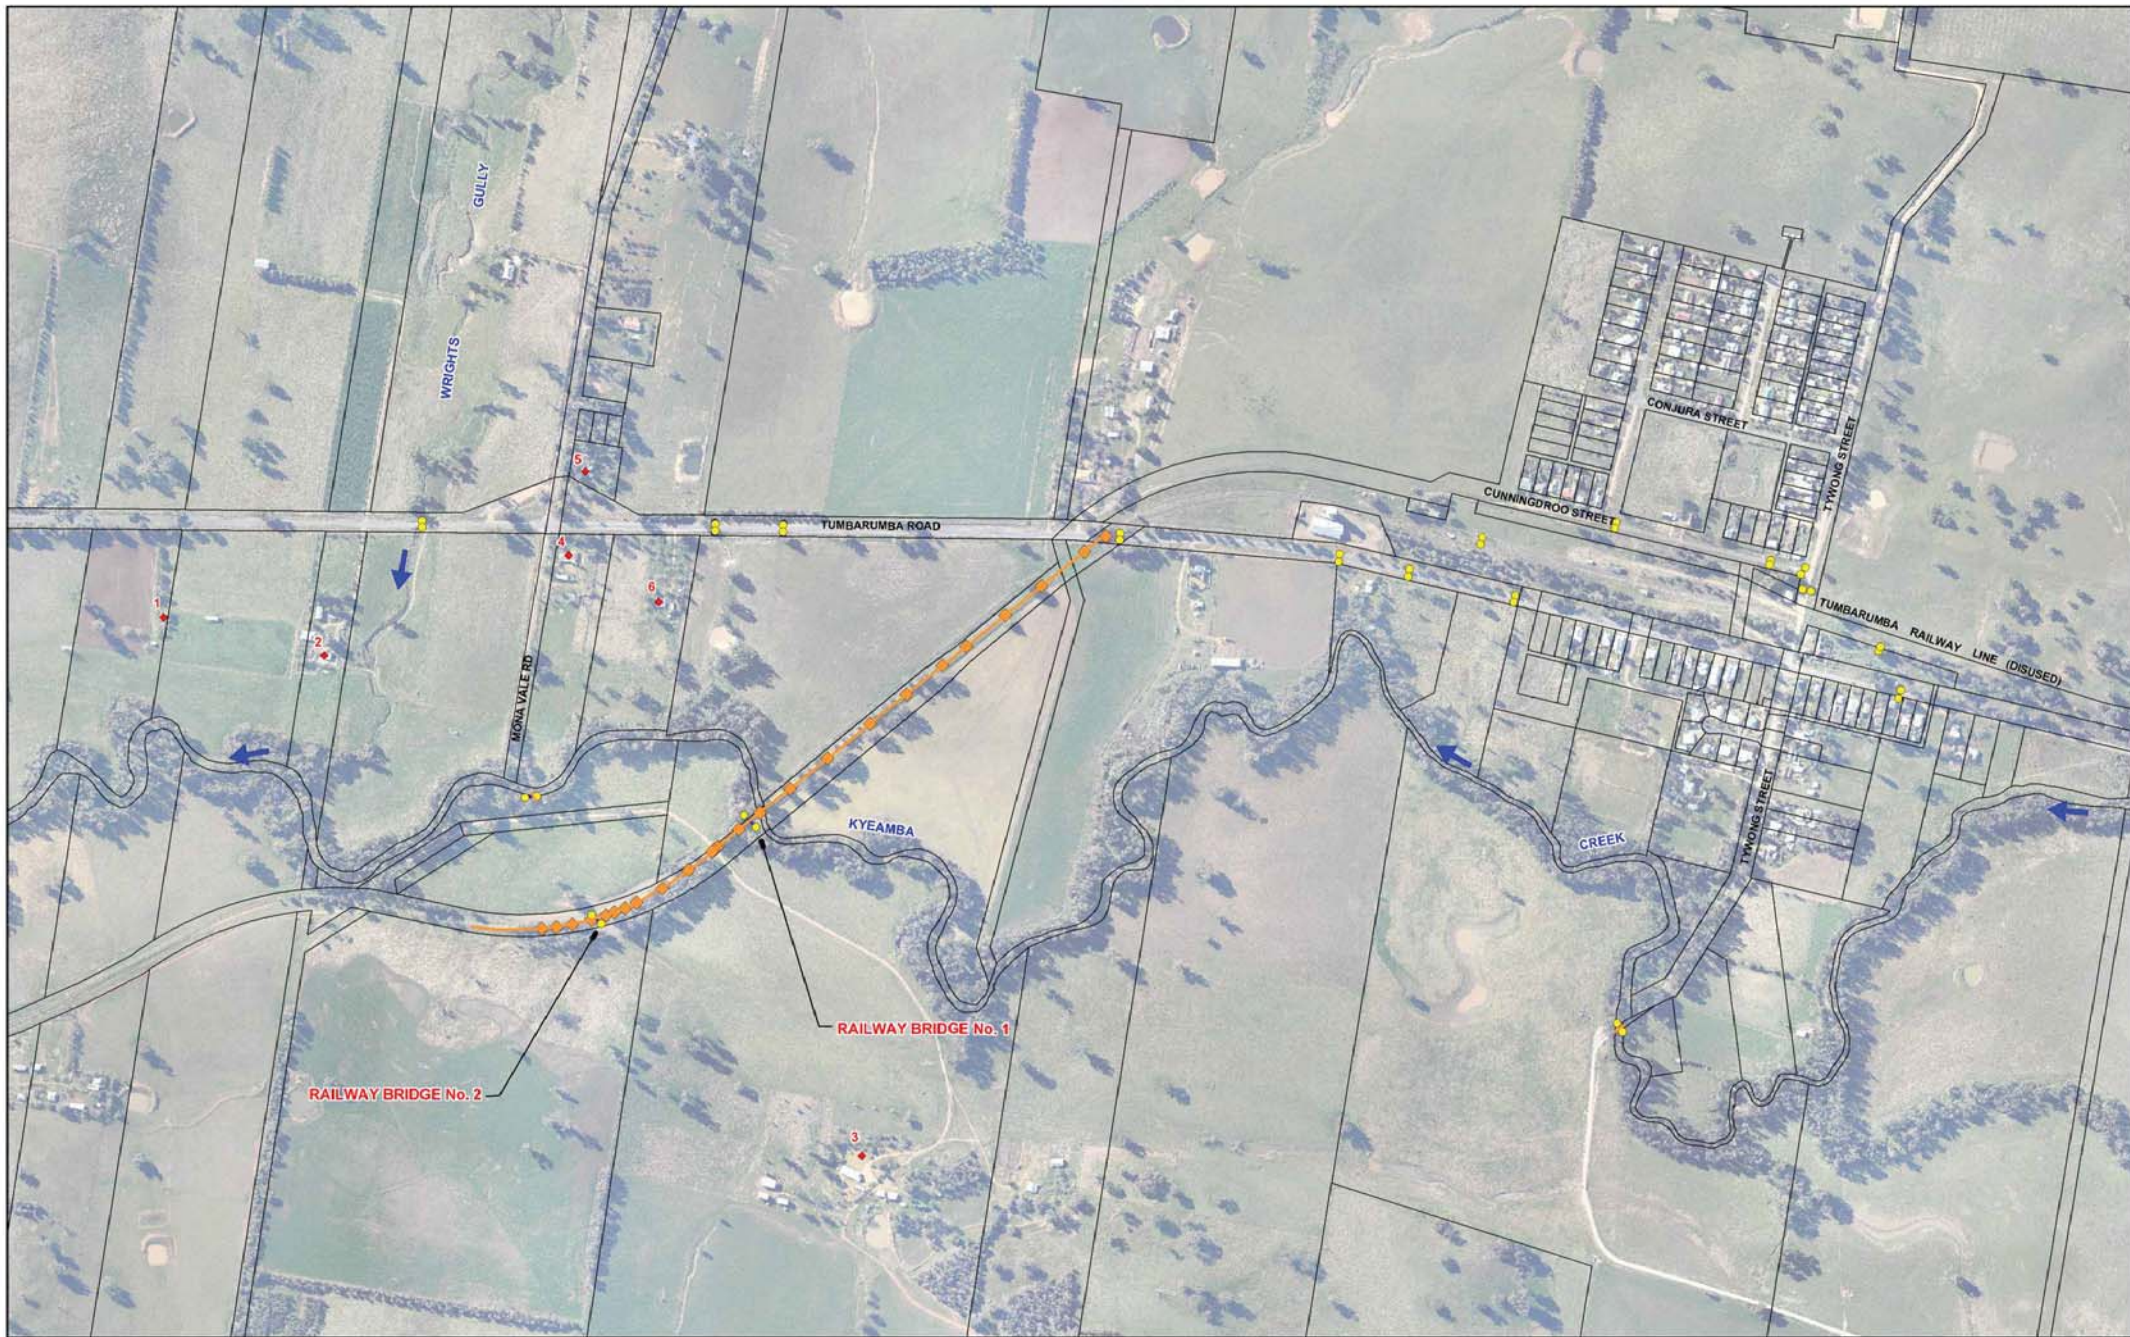
Figure A2

SURVEY DATA AT LADYSMITH

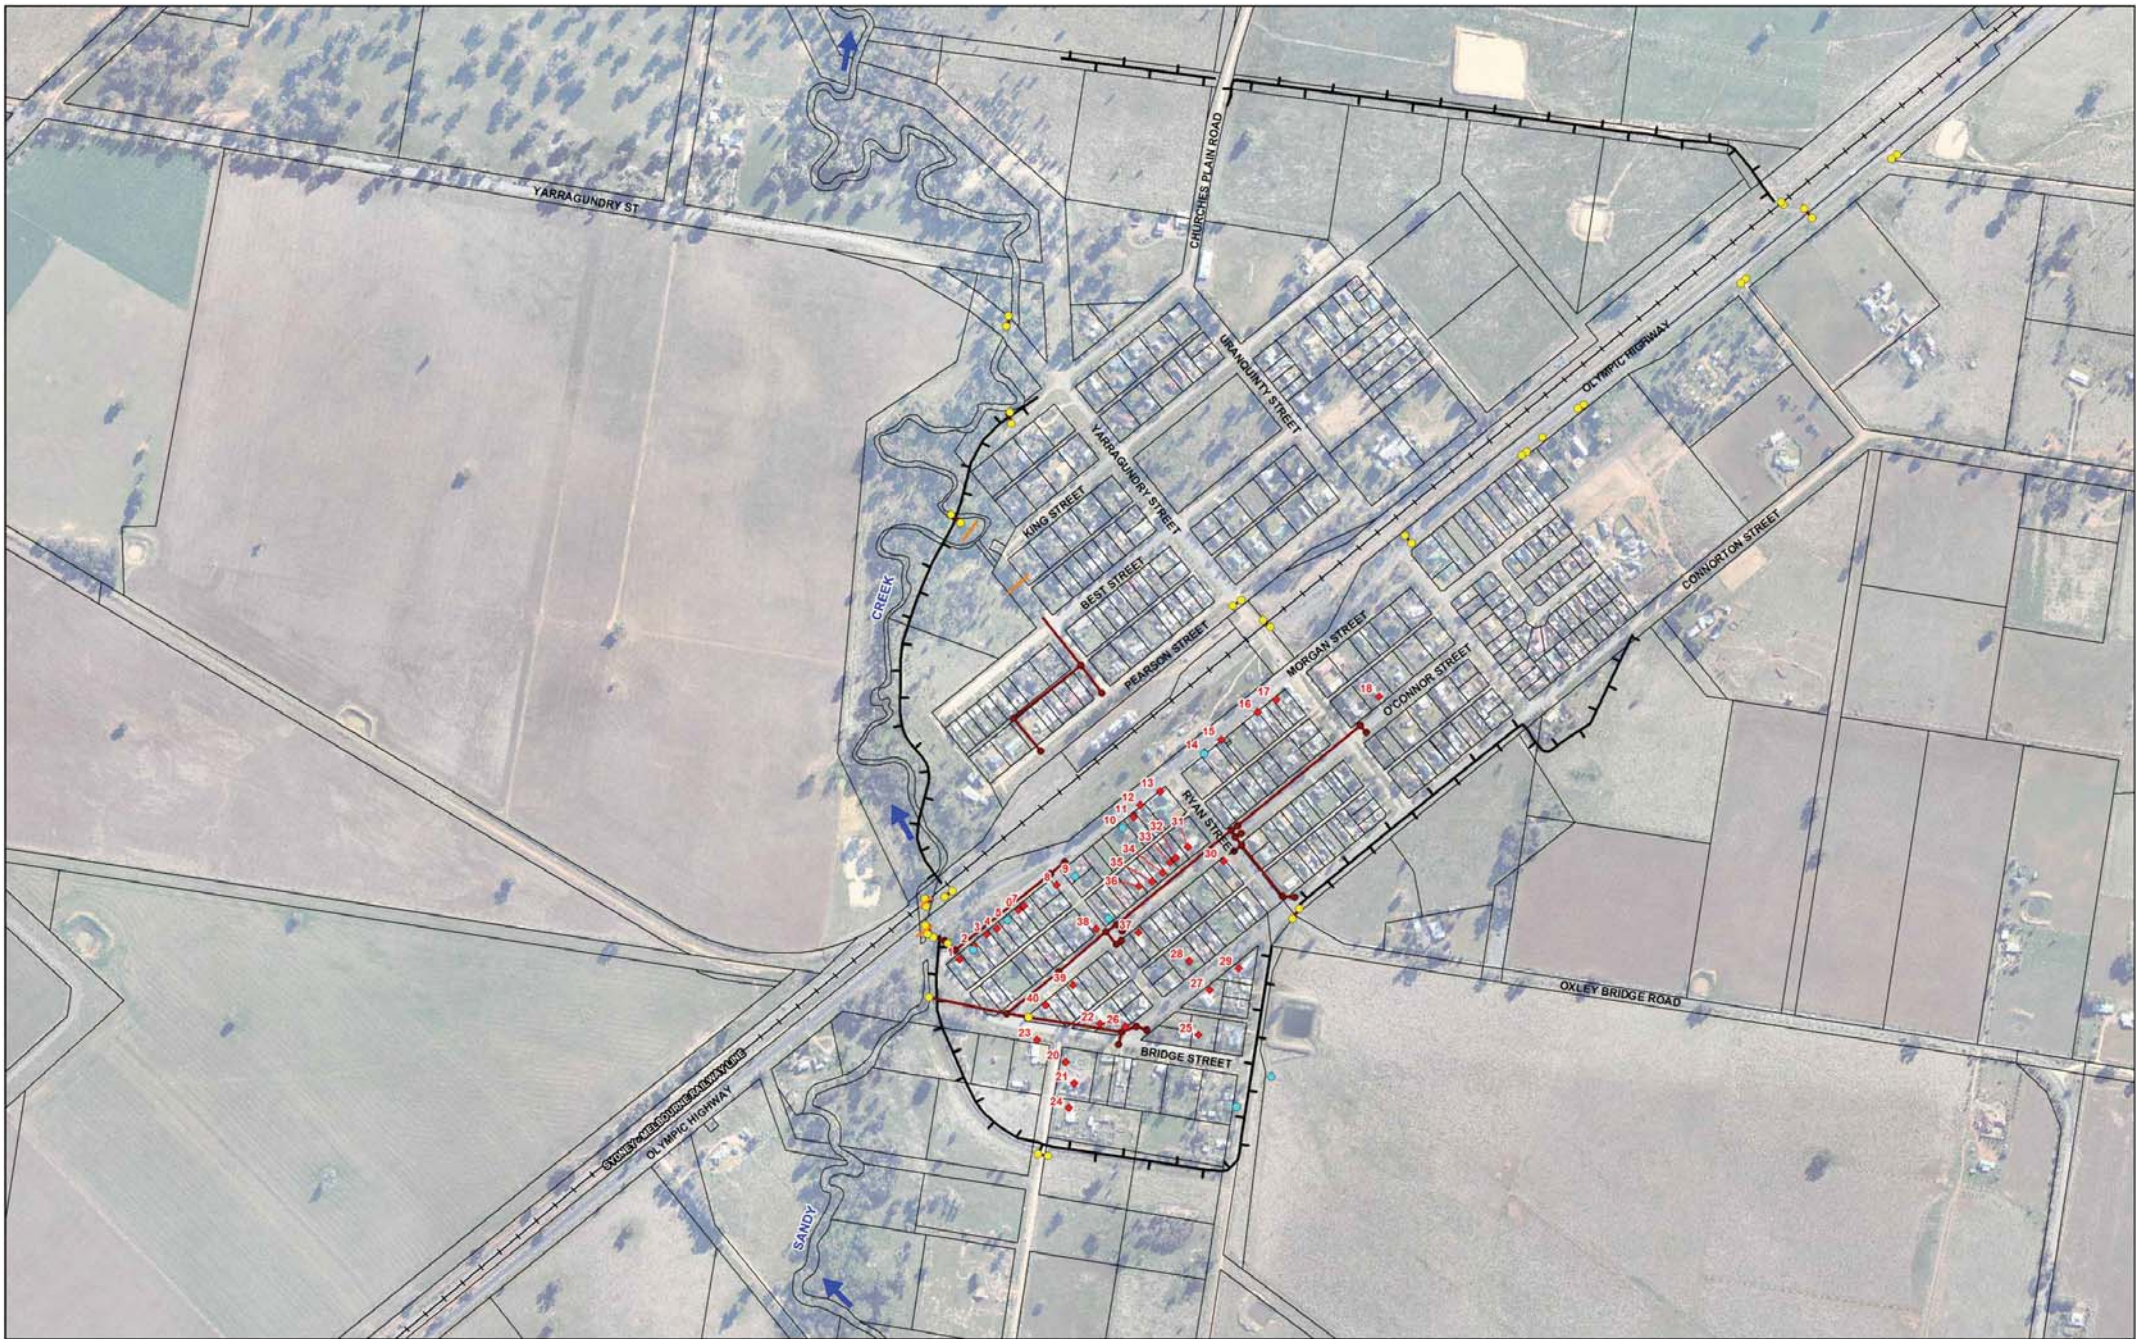
Figure A3

SURVEY DATA AT URANQUINTY

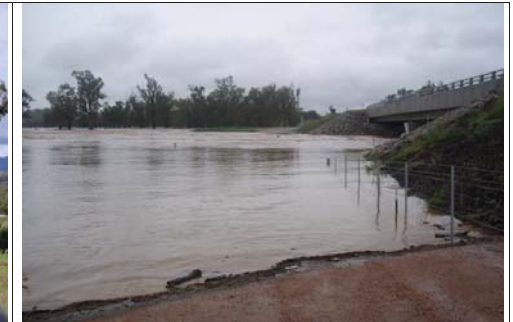
**Plate 28** - Downstream Side of Hume Highway Bridge No. 2  
(04/03/12 11:51)  
(Source: Corey Parnaby)
