THE COUNCIL OF THE CITY OF WAGGA WAGGA

**MURRUMBIDGEE RIVER
WAGGA WAGGA
FLOOD STUDY**

SEPTEMBER 2004

WEBB, McKEOWN & ASSOCIATES PTY LTD

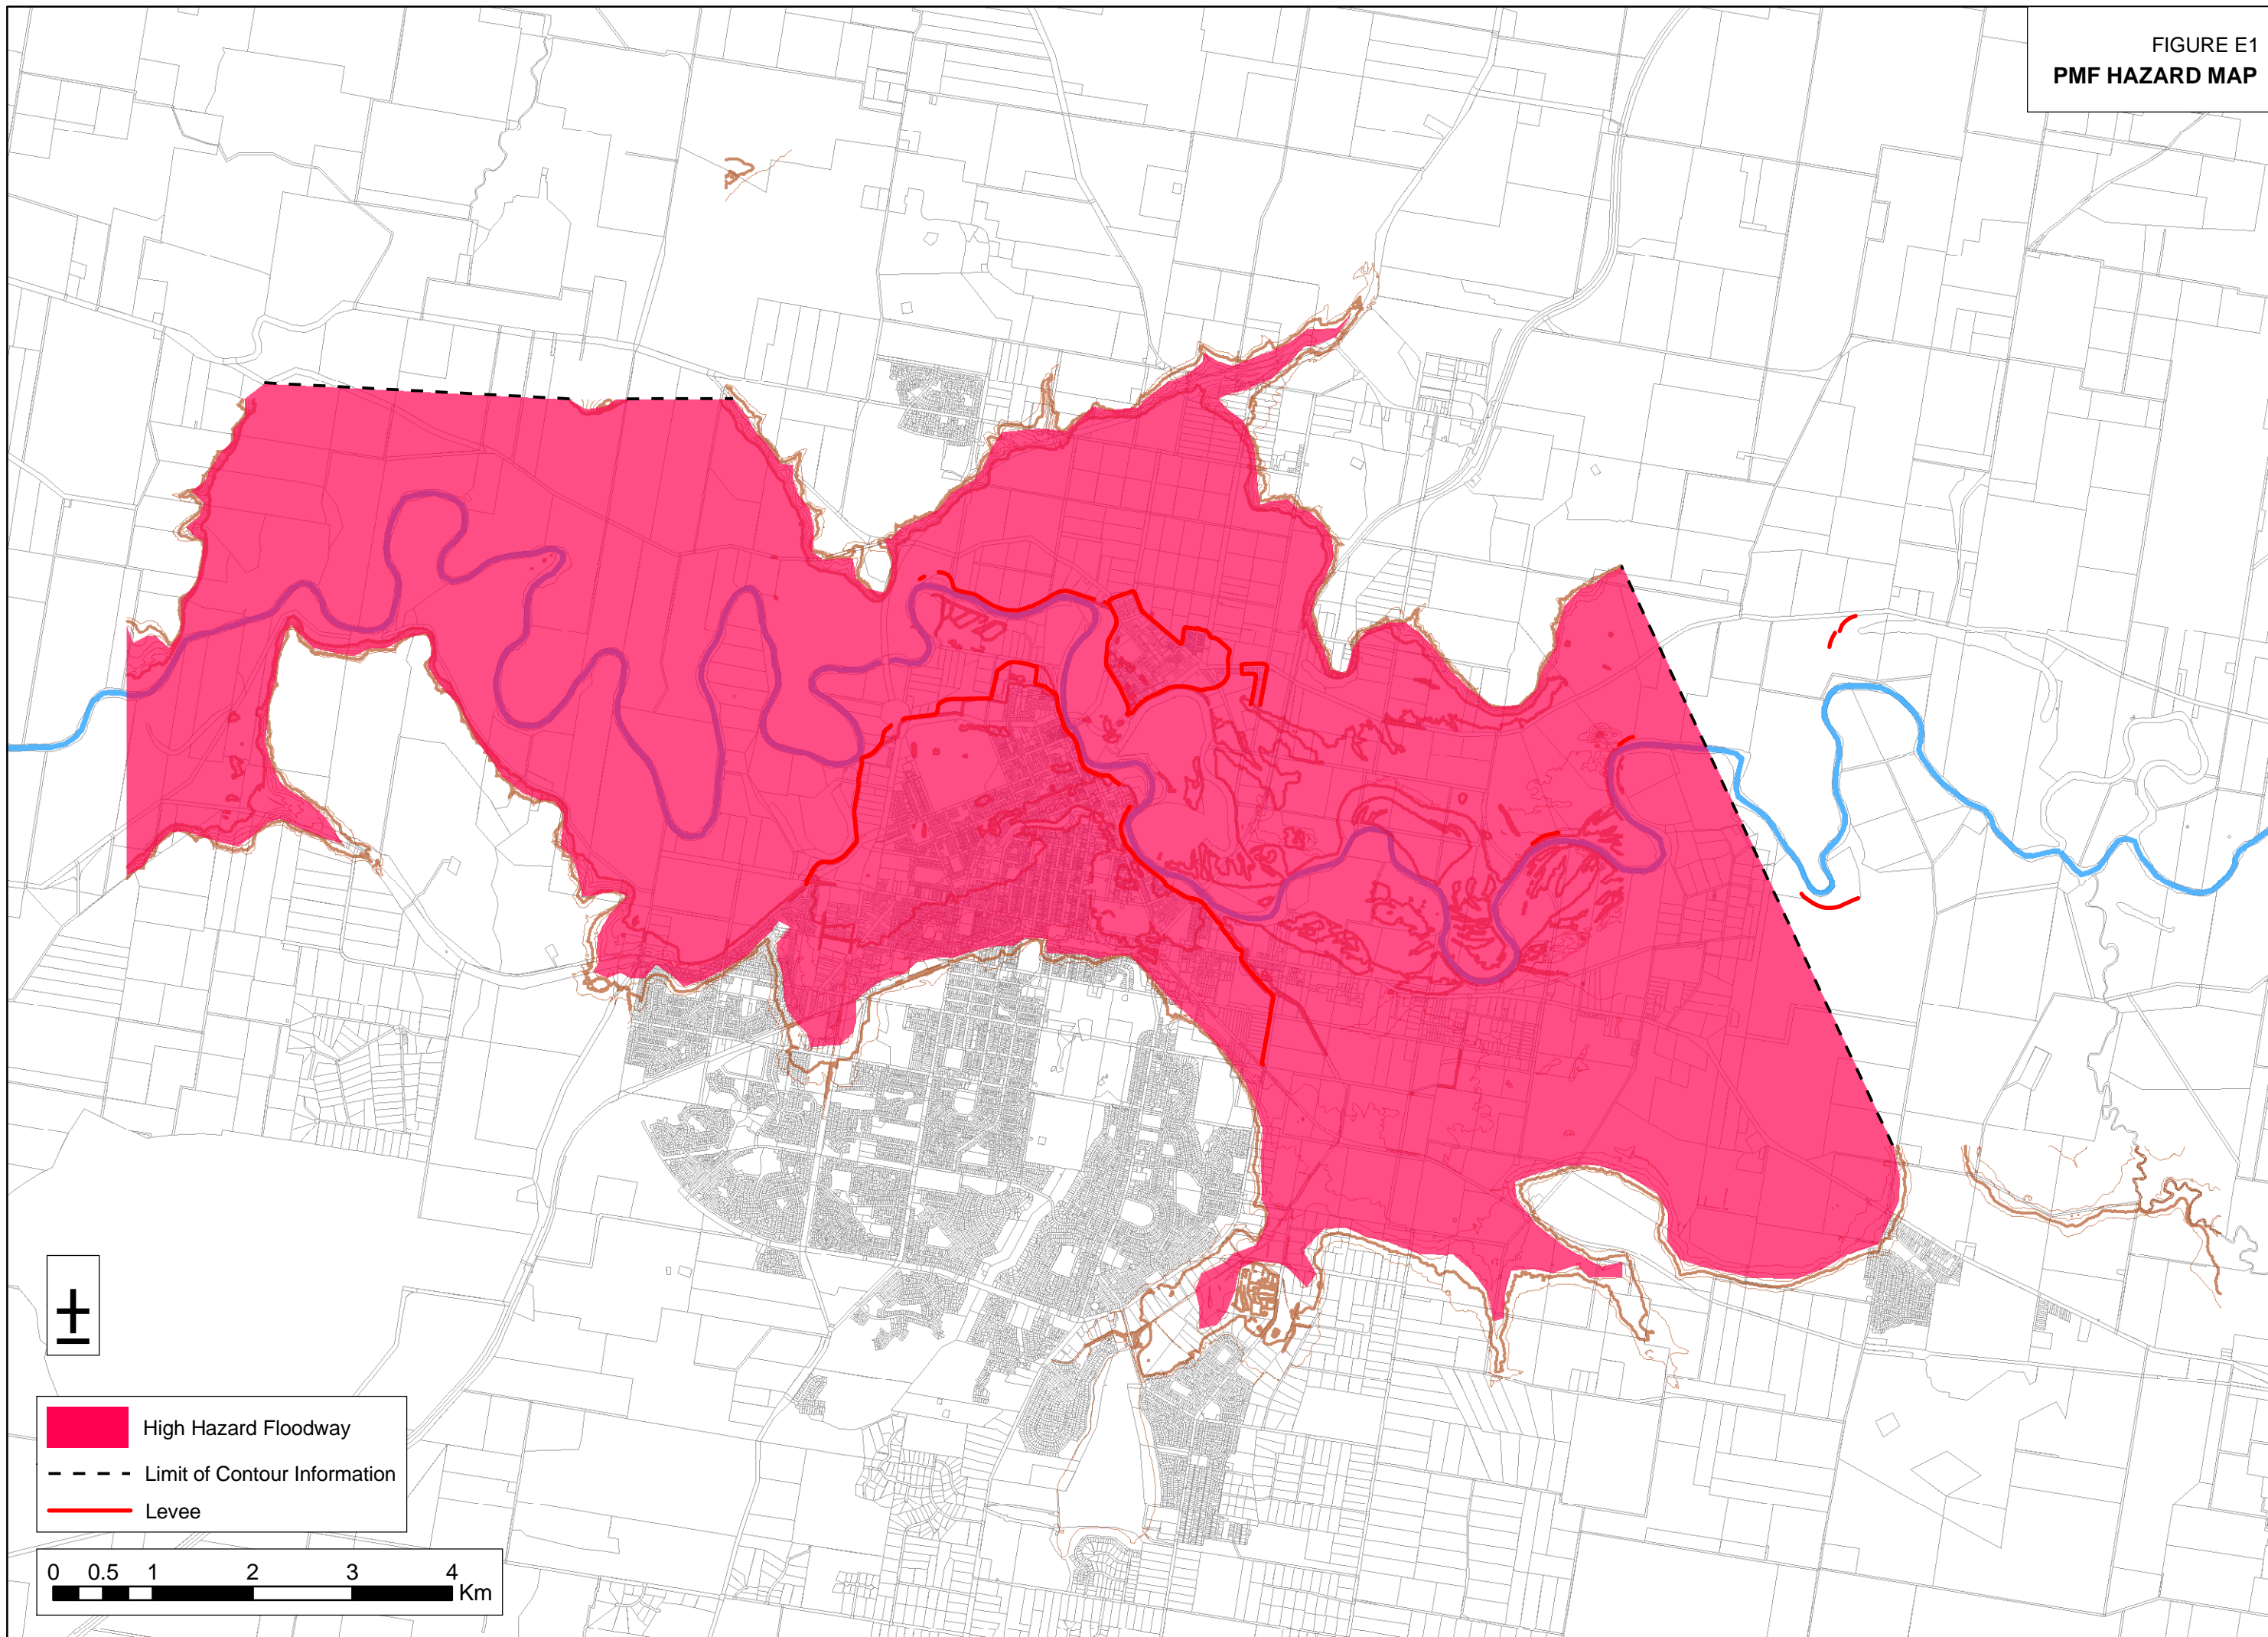
FIGURE E1
PMF HAZARD MAP

- High Hazard Floodway
- Limit of Contour Information
- Levee

Full hazard mapping of the floodplain would require a DTM to be developed requiring detailed survey of the whole floodplain. The large costs involved are not justified at this time. Instead indicative hazard mapping only is presented in Figures E1 and E2 for the PMF and the 1 in 100 ARI events. These figures show broad zones of hazard only - where a more definitive hazard category was required at a future date, e.g. for a proposed development, detailed survey could be collected at that time and the maps refined.
