FIGURE 13  
 WAGGA WAGGA - MODEL DERIVED RATINGS  
 1853, 1870 EVENTS LARGER THAN THE 1925 EVENT WITH 52 YEARS BELOW  
 TRUNCATED SERIES (93 Events < 1000 m³/s)  
 LP3 ANALYSIS - BAYESIAN THRESHOLD

FIGURE 14  
HYDRAULIC MODEL FEATURES

FIGURE 20  
**PEAK FLOOD LEVEL PROFILE**  
**HISTORICAL AND DESIGN EVENTS**

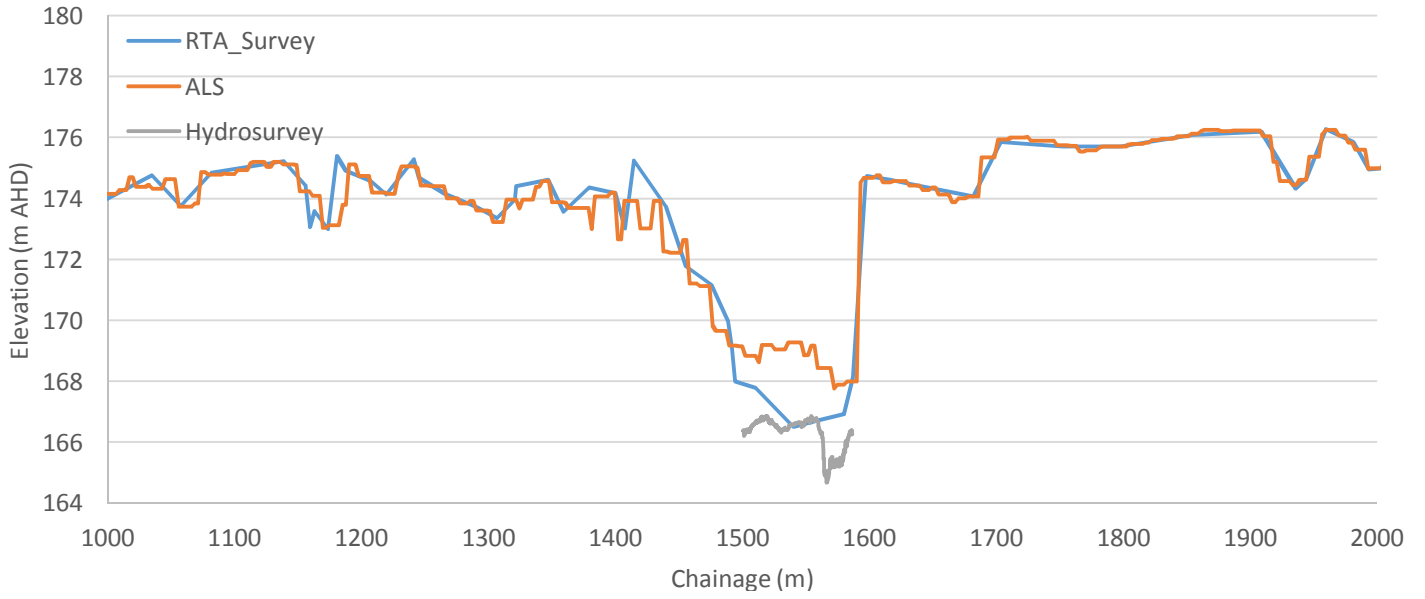
### RTA-Xs1

FIGURE 5  
RTA CROSS SECTION  
HYDROSURVEY COMPARISON

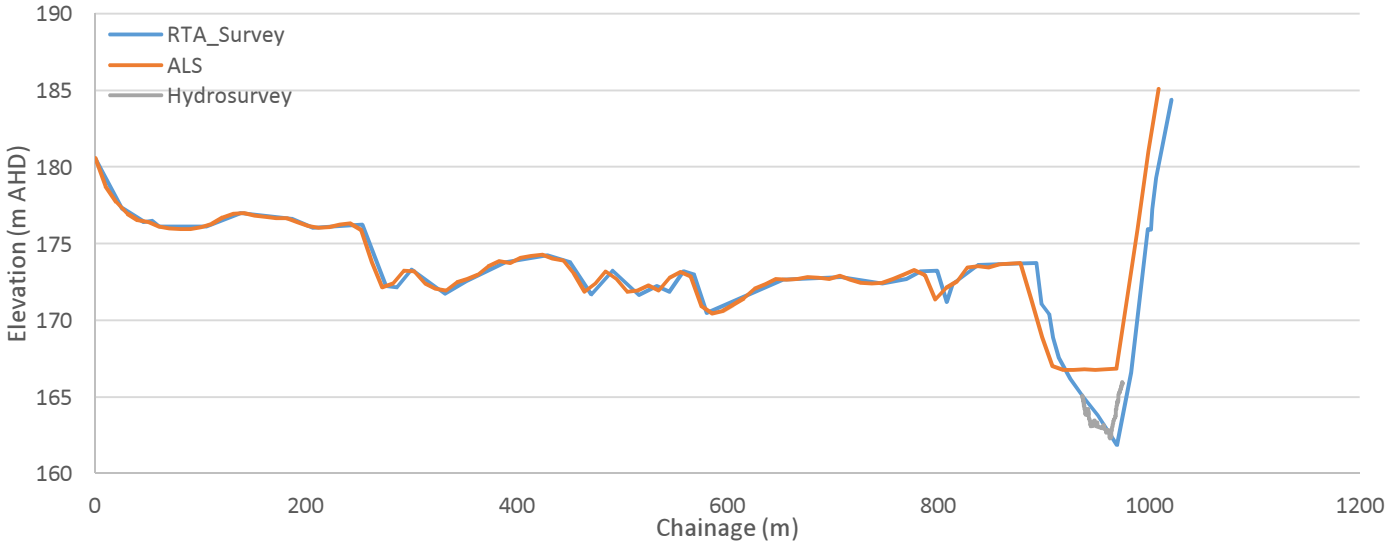
### RTA-Xs4

FIGURE 6  
RTA CROSS SECTION  
HYDROSURVEY COMPARISON

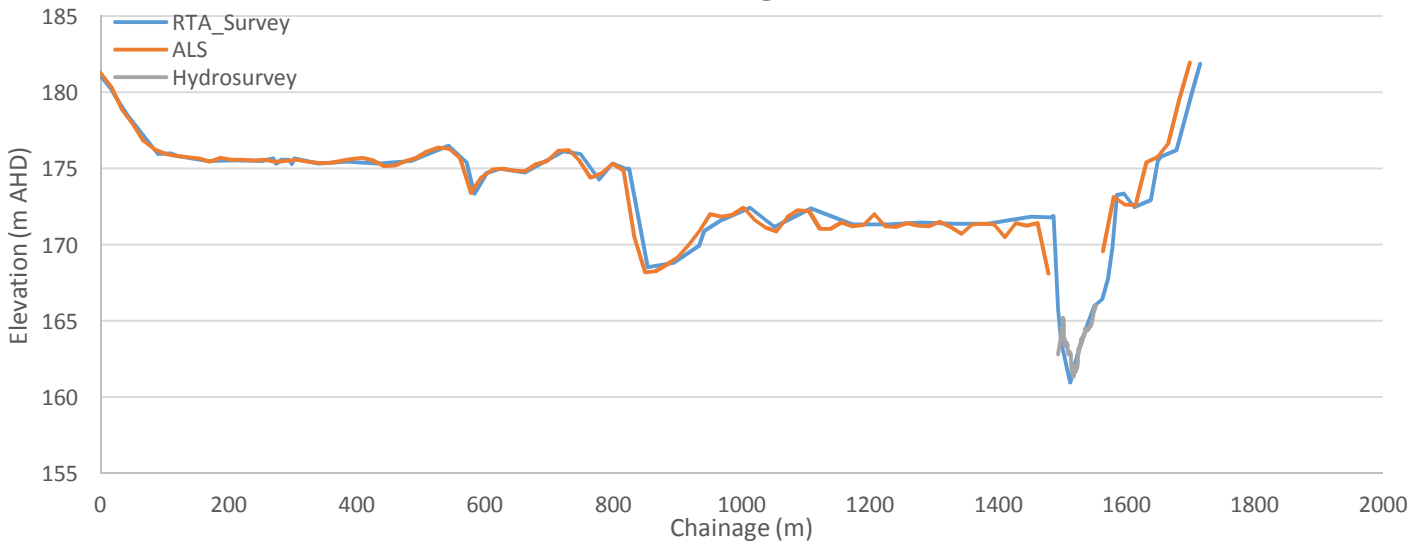
### RTA-Xs7

FIGURE 7  
RTA CROSS SECTION  
HYDROSURVEY COMPARISON

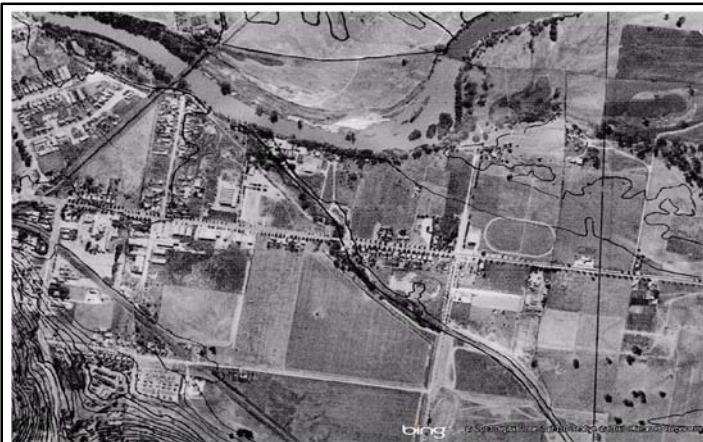
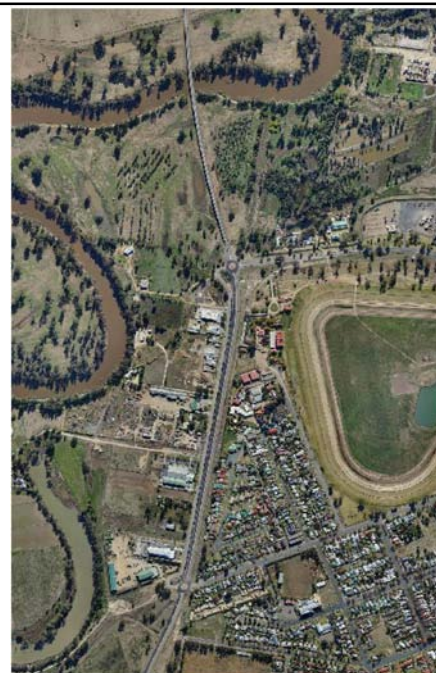
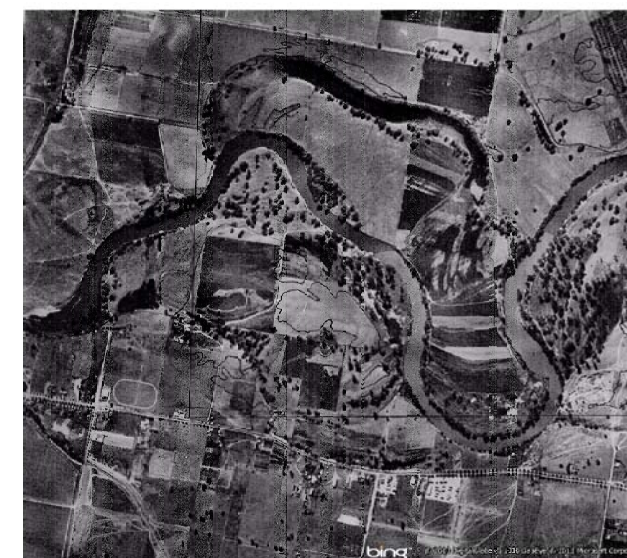
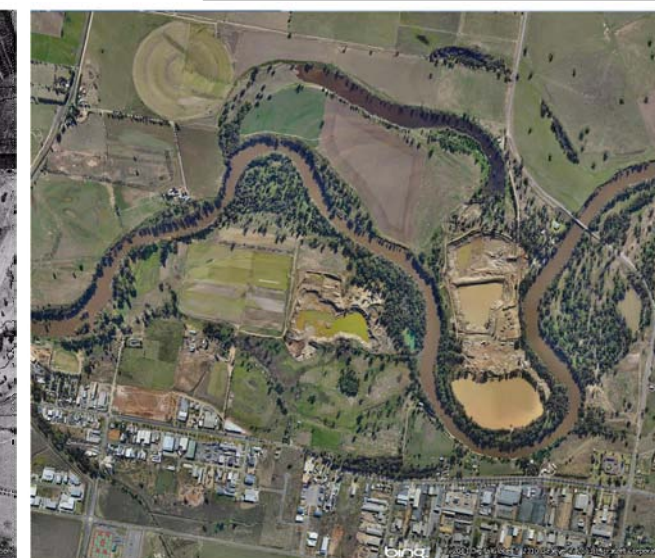
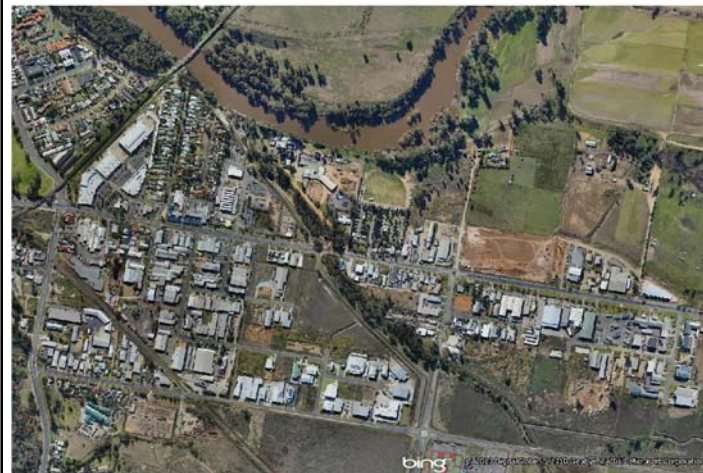
Wiradjuri Reserve  
July 2012\* v April 1971\*  
Evident increase in River Red Gum and Yellow Box tree density on floodplain between Wagga Wagga and the Murrumbidgee River.

Eunony Lagoon and East Wagga Wagga  
July 2012\* v April 1971\*  
Evident increase in River Red Gum and Yellow Box tree density.

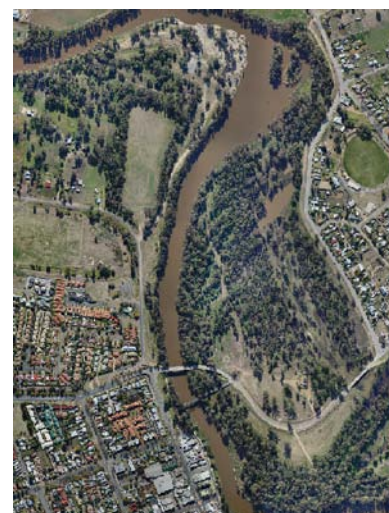
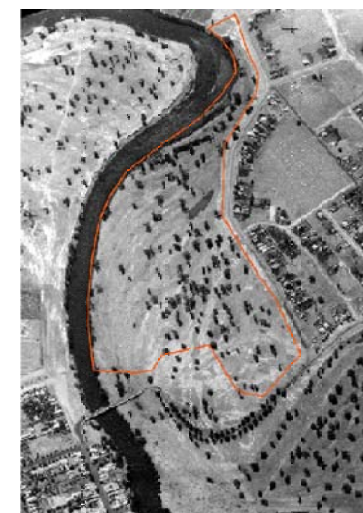
North Wagga Flats  
July 2012\* v April 1971\* v March 1944\*  
Significant reduction in tree density on the banks adjacent the Murrumbidgee River and North Wagga floodplain

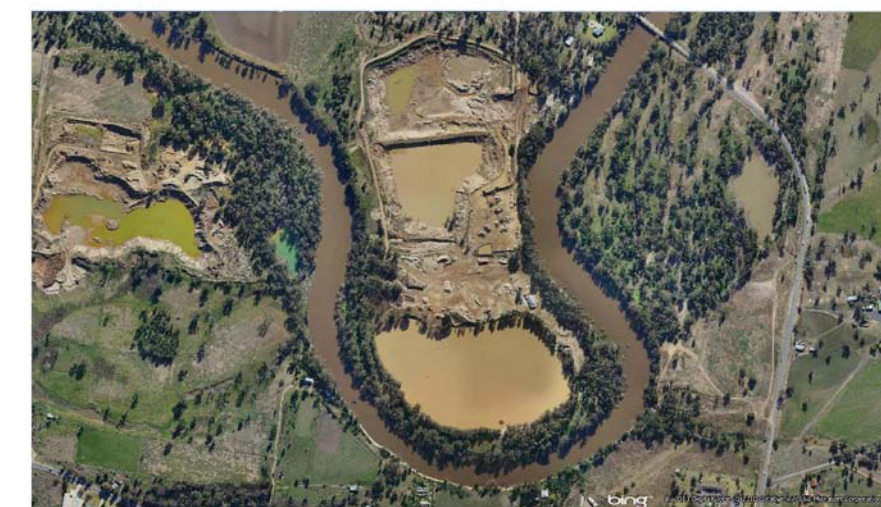
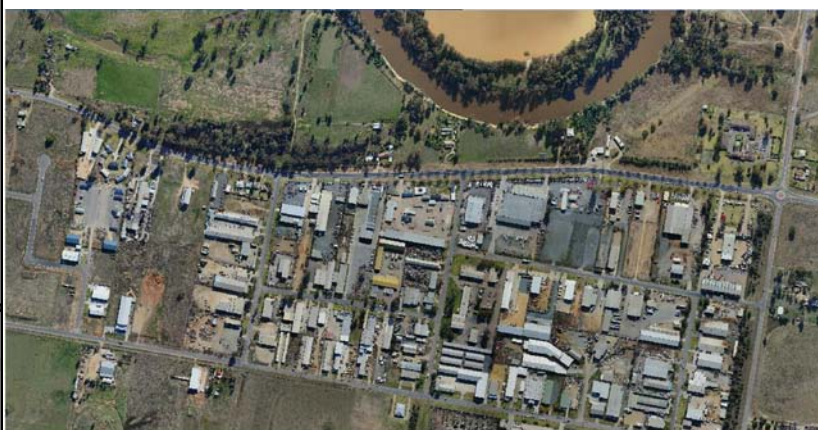
East Wagga Wagga Industrial Area  
July 2012\* v April 1971\*  
Flat cropping area with low development replaced with dense industrial zone removing the area from the effective conveyance floodplain.

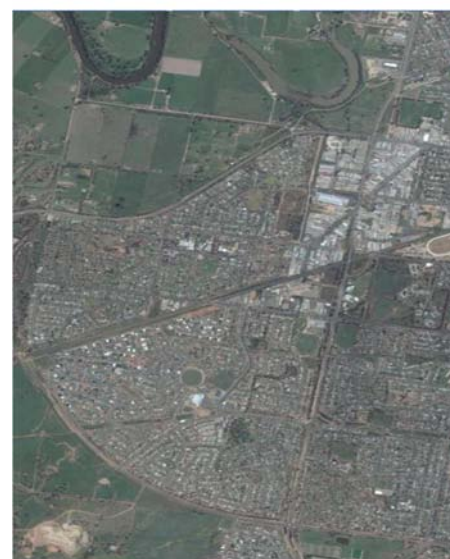
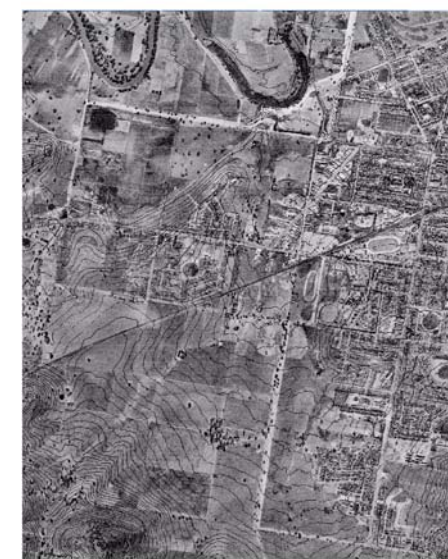
West Wagga Wagga  
Cropping area with low tree cover replaced with expansive residential area - Outside of 1974 of extent so unlikely to be affected by flooding.

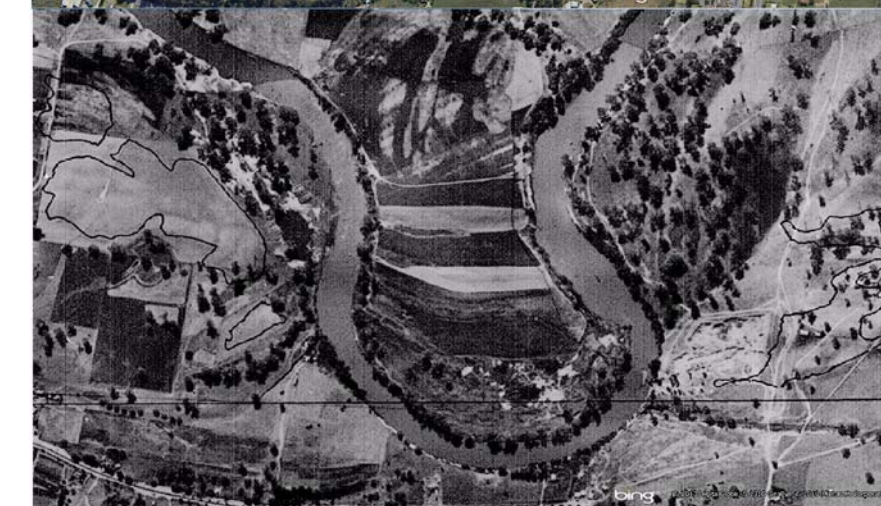
Eunony Bridge and Quarry  
July 2012\* v April 1971\*  
Eunony Bridge not completed until 1975. Quarries and perimeter temporary levees not present during 1974 event.
