**2010-
2011**

Wagga Wagga Urban Salinity Status Report

Prepared by the Directorate of
Environmental and Community Services
WAGGA WAGGA CITY COUNCIL

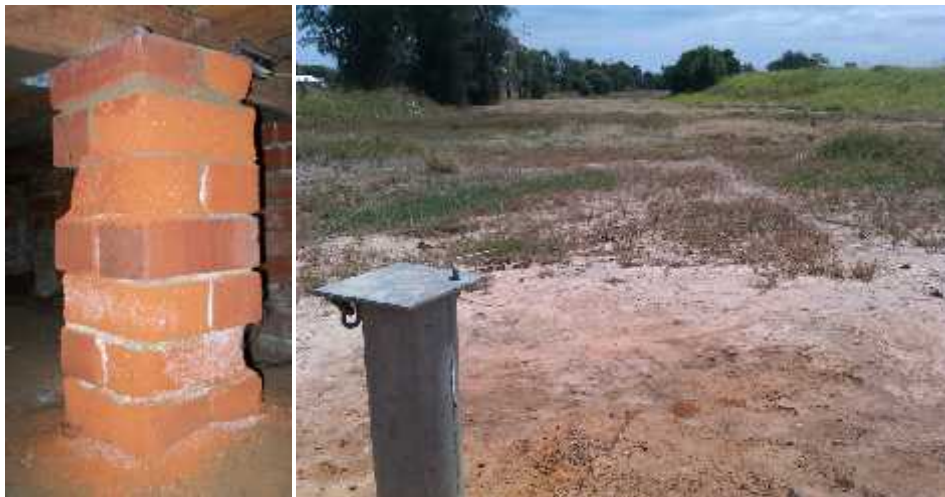
- Damage to houses, buildings and other structures caused by the weakening of brick (Figure 1), mortar and concrete due to saline water crystallising in the brickwork;

- Septic tank failures due to high water tables can lead to other environmental and health concerns;
- Loss of amenity in recreational areas such as parks, gardens and sporting fields due to salt and waterlogging causing salt scalds and bare patches where vegetation fails to grow (Figure 1); and

Figure 1: Salt damage to footings (left) and salt scalding (right), Turvey Park, Wagga Wagga.

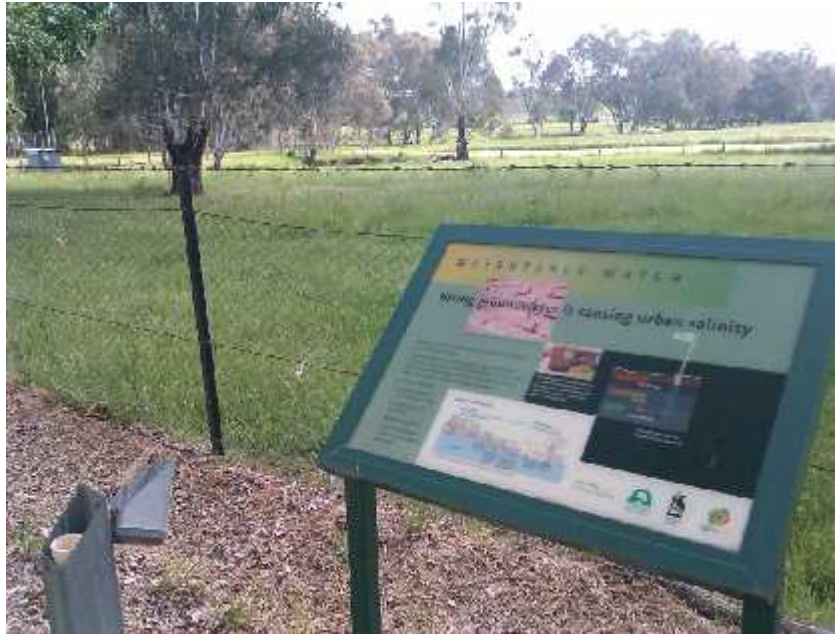
Figure 2: Information sign adjacent to a piezometer in Humula village.

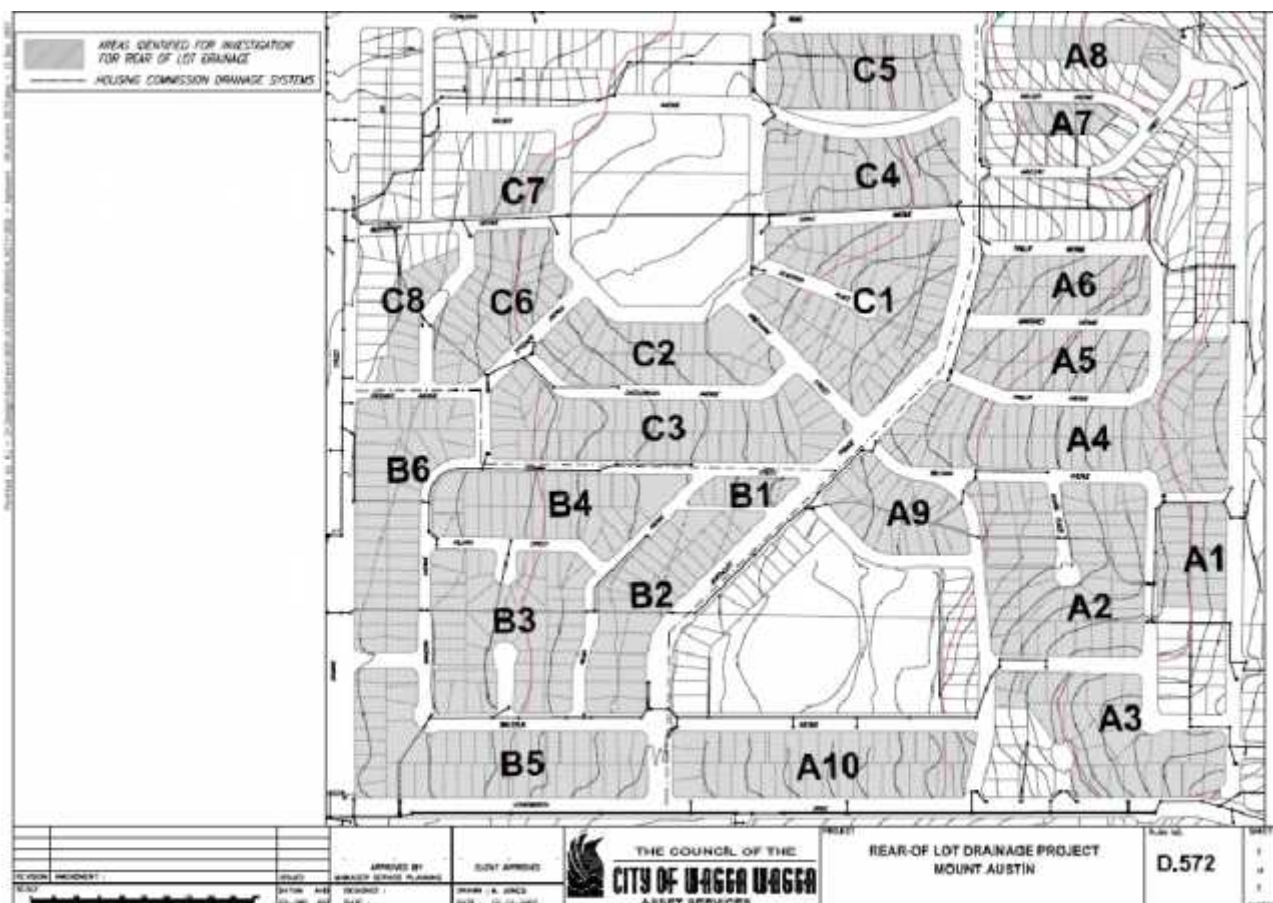
Figure 4: Map of Mount Austin showing the locations of works to be completed during the Rear of Block Drainage Scheme.

The investigation of sections B1 to B4 was completed in 2010/11. A total of 116 properties were inspected where it was found that rubble pits existed in 39 blocks (B1-nil, B2-14, B3-18 and B4-7) and would be included in the scheme.

No construction work on rear of block drainage was undertaken in the 2010/11. Work is due to commence on section B2 in September 2011 with commencement of work on the remaining blocks expected in 2012/13, as funding permits.

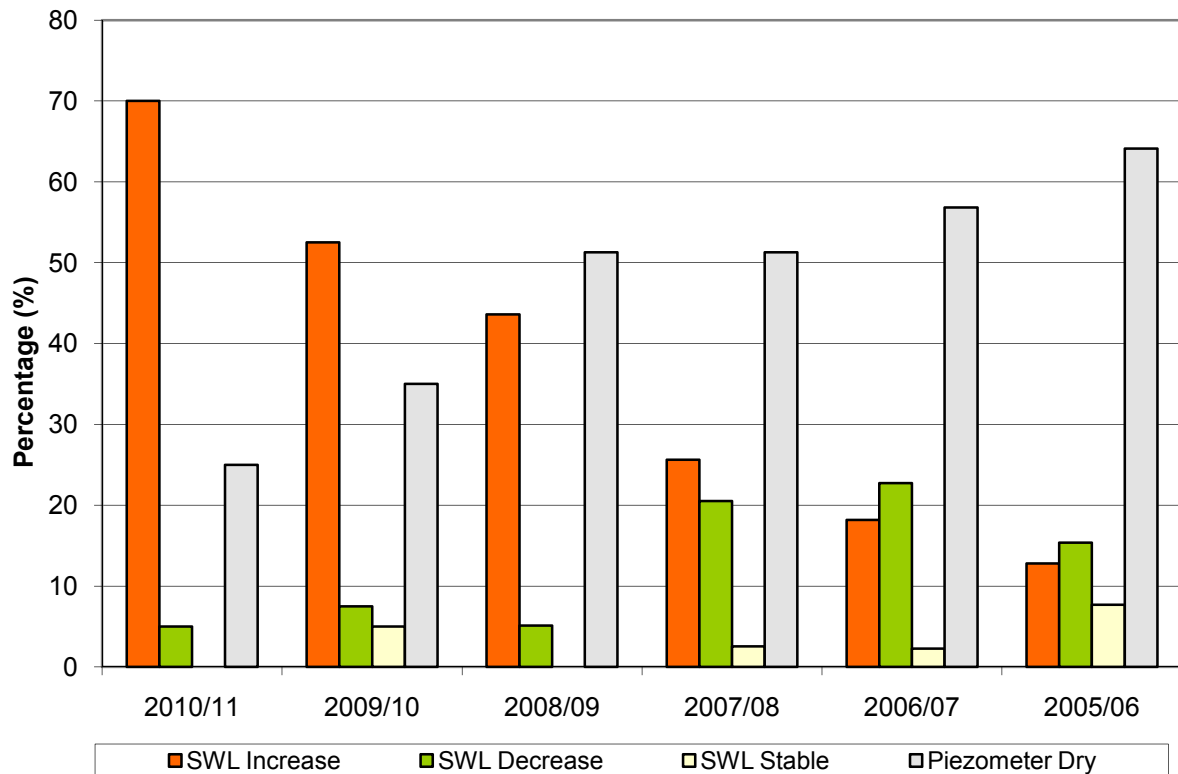
Figure 5: A comparison between changes in SWL category in the Intensive Borefield from 2005/06 to 2010/11.

The change in SWL over the last six reporting periods is presented in Figure 5. The figure shows an almost lineal upward trend in the number of increasing SWL piezometers since 2005/06. The number of increasing piezometers has risen significantly since the turning off of the dewatering bores in June 2008. It must be noted that the dewatering bores were previously switched off between February 23 to March 30, 2007.

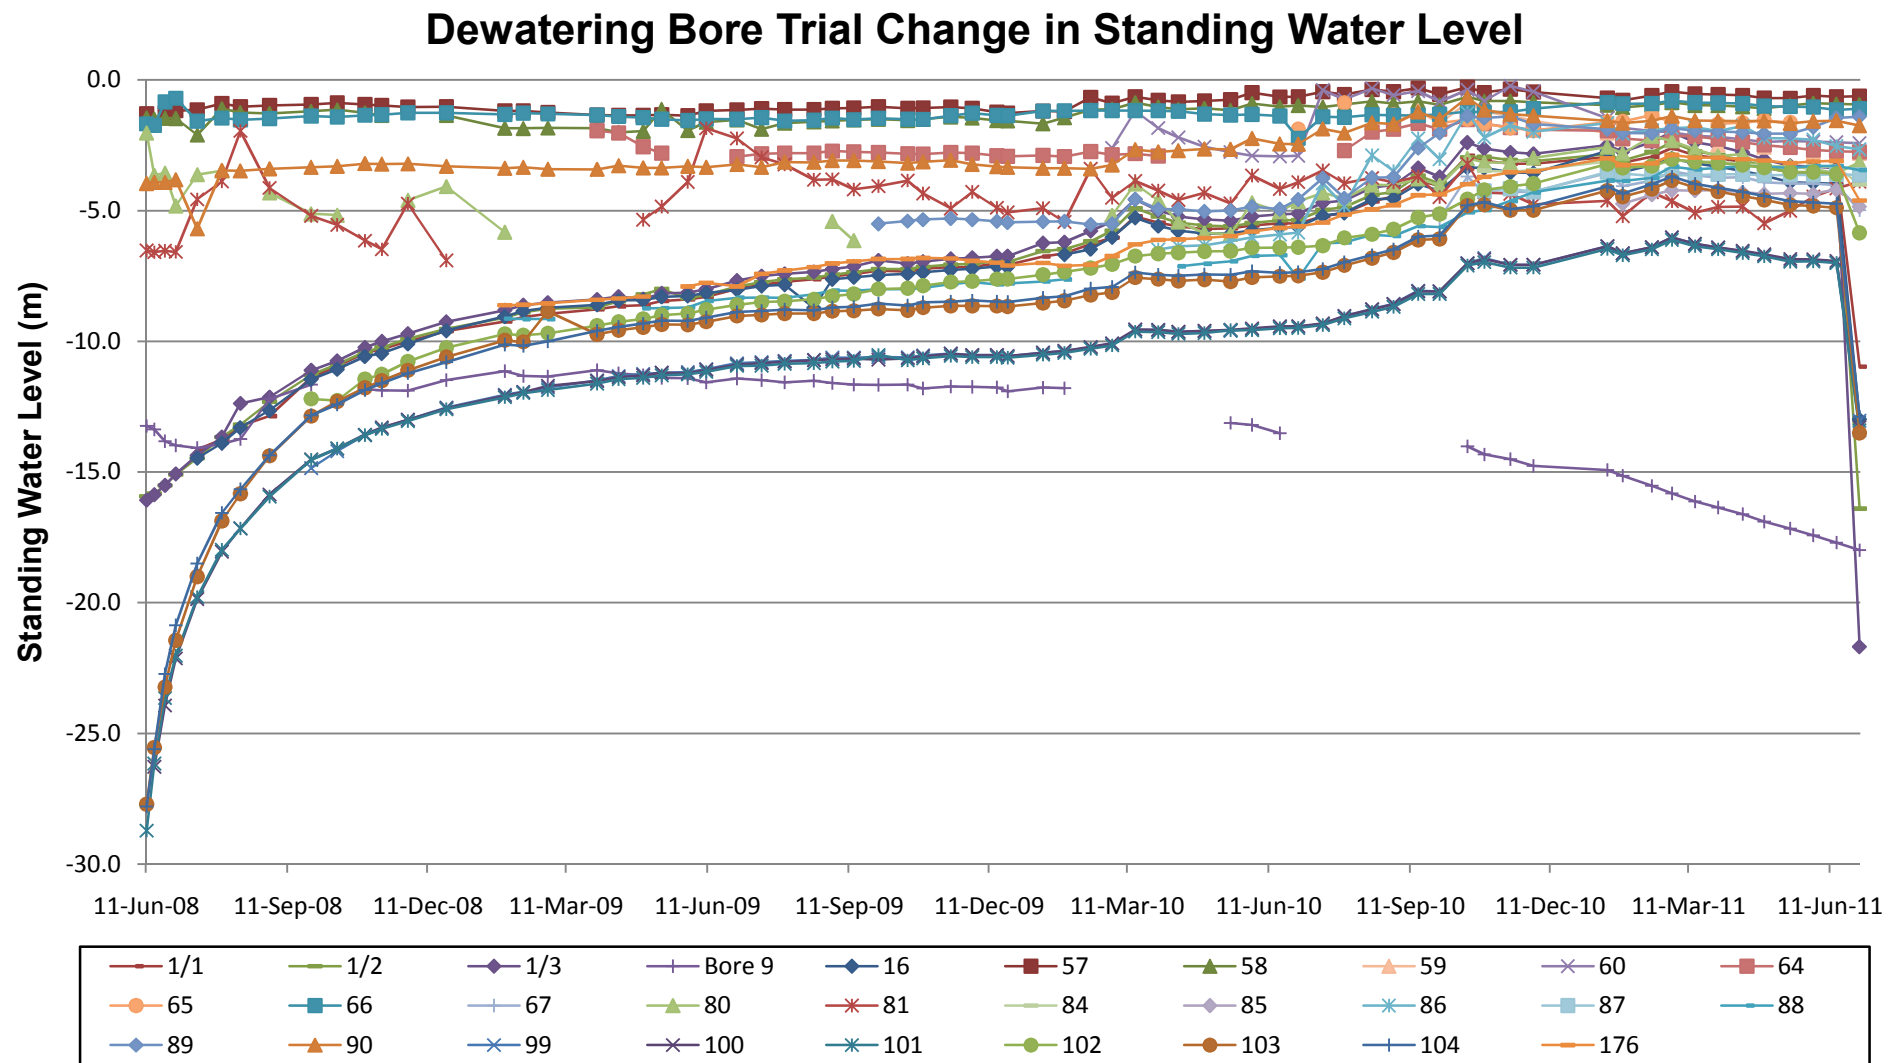
A graph depicting the response from water bearing piezometers in the intensive borefield to the dewatering trial are shown in Figure 6. Two groups can be distinguished from the figure. The first group incorporates shallow piezometers and the graph shows no distinct change in groundwater levels caused by the switching off of the dewatering bores. The three piezometers (no. 57, no.58 and no.66) unaffected by the switching off of the dewatering

Figure 6: The change in SWL for water bearing piezometers in the intensive borefield during the dewatering trial.

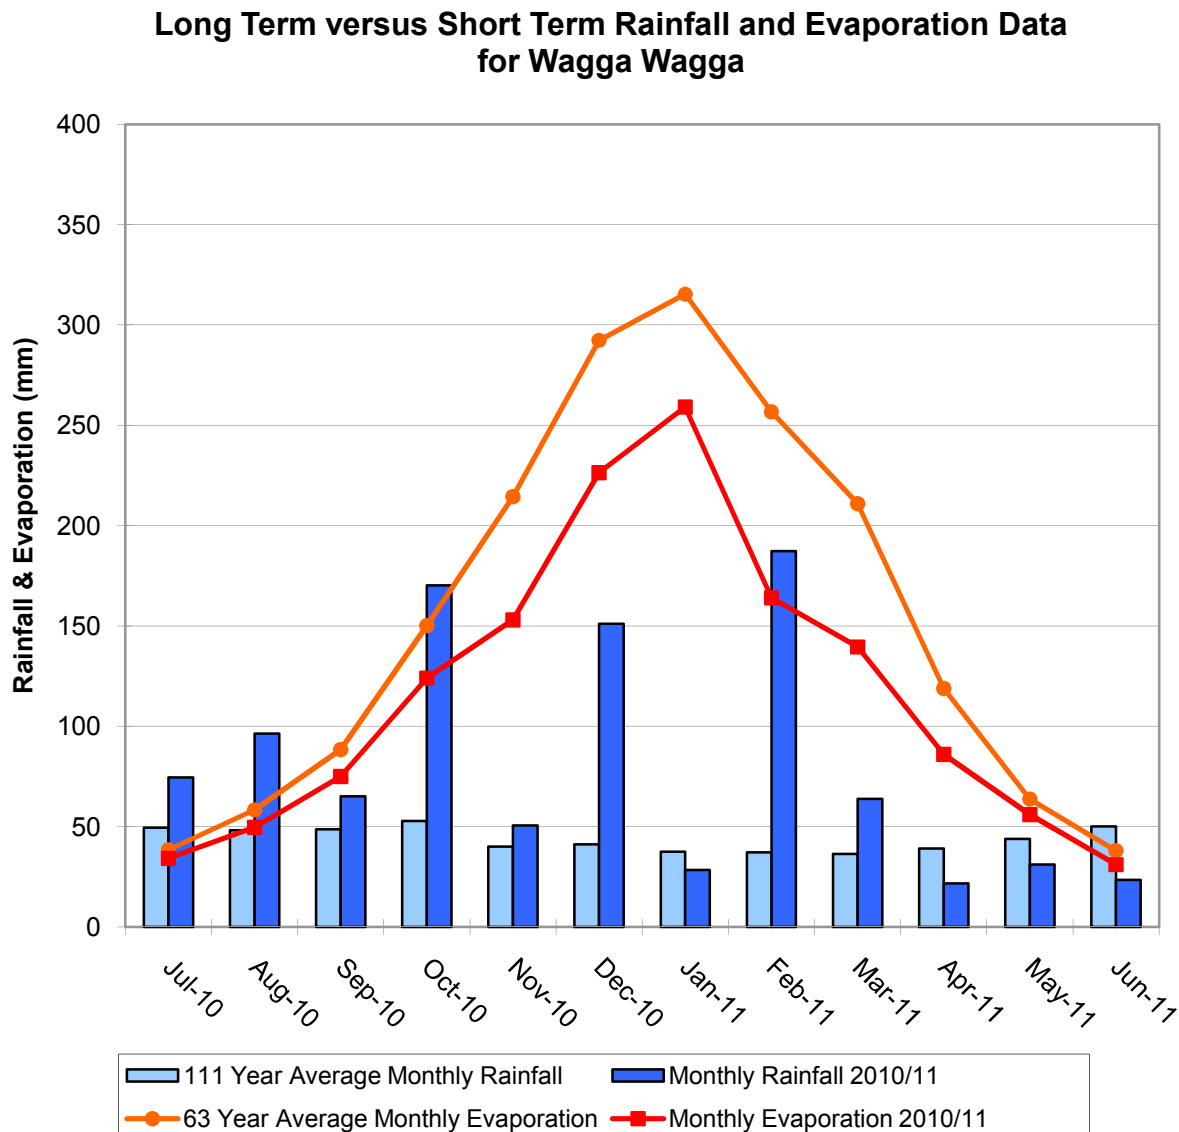
Long term monthly rainfall averages were exceeded on eight occasions during 2010/11 (Figure 7), with October 2010, December 2010 and February 2011 recording 118mm, 110mm and 150mm respectively. These widespread high summer rainfall events resulted in major flooding throughout the district caused by runoff inundation and high river levels.

Monthly rainfall exceeded evaporation on four occasions including the months of October 2010 and February 2011.

Figure 7: Monthly rainfall and evaporation graph for Wagga Wagga 2010/11.

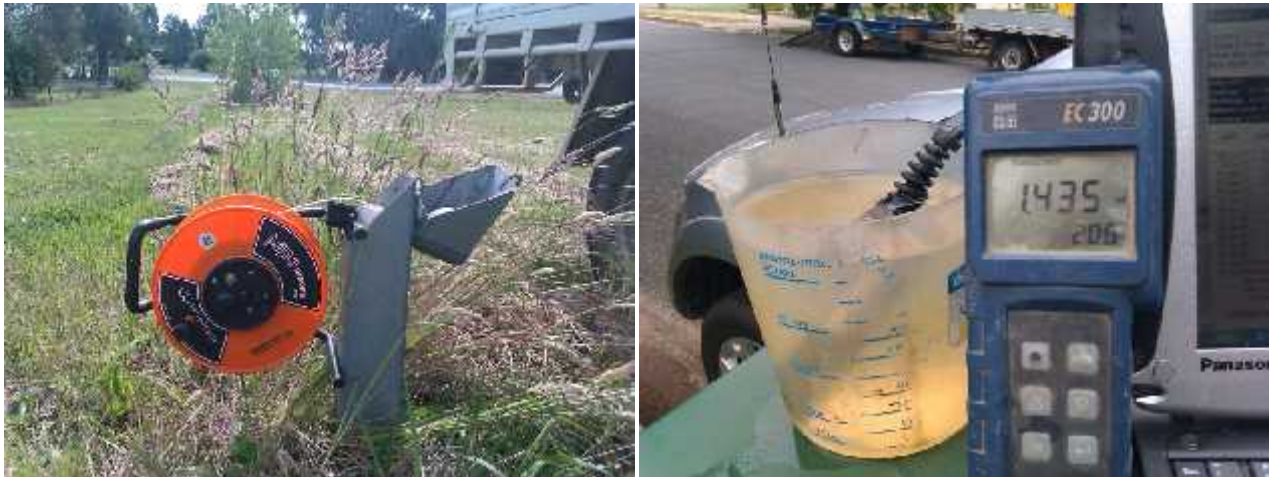
Standing water level (SWL) and electrical conductivity (EC) readings are collected and used to monitor urban salinity. The SWL is measured in metres below the ground surface to the nearest centimetre using a water level meter (Figure 8). Measurements are taken from the height of the piezometer casing and the height of the extension subtracted from the reading. Piezometers at ground level do not require a subtraction. Water is extracted from the piezometer using a bailer to measure for EC. The EC is measured in decisiemens per metre (dS/m) to two decimal places using a handheld conductivity meter (Figure 8).

Figure 8: Measuring standing water level (left) and electrical conductivity (right) of groundwater.

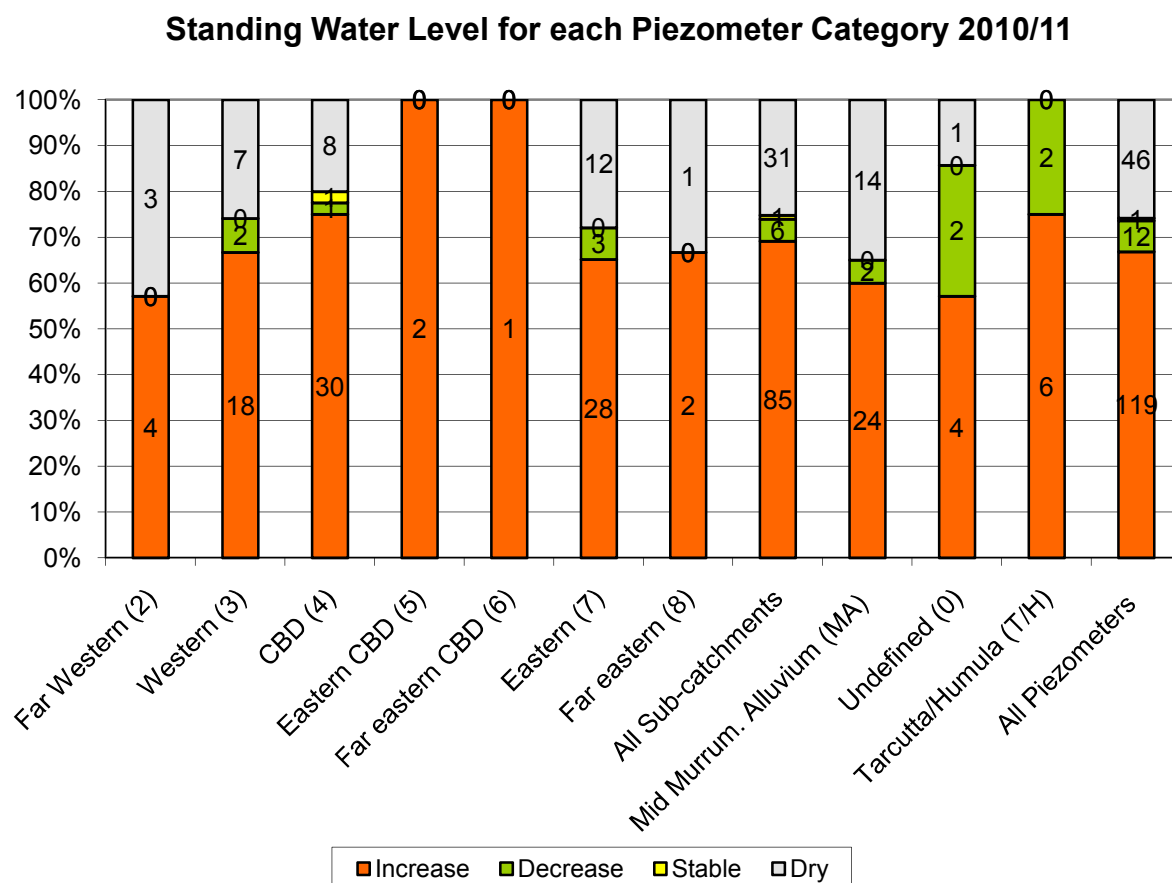
The dataset shows that the greatest number of piezometers, one hundred and nineteen (67%), have increased in standing water level (SWL) when comparing SWL change between 2010/11 and 2009/10. Forty six piezometers (26%) remained dry, with twelve (7%) recording a decrease in SWL during the reporting period. One piezometer remained stable (those with an increase/decrease of 5cm or less). Nineteen newly drilled piezometers were not included in the categories as they did not have a reference value for 2009/10 period. These results are discussed further in the following sections.

Piezometers that contained water in the previous year that are now dry have been included in the 'SWL decreased' category, whereas piezometers that started as dry but now contain groundwater have been included in the 'SWL increased' category. These results were omitted from average increase/decrease calculations. Graphs of individual piezometers containing groundwater are found in Appendix D.

Figure 9: Chart depicting change in Standing Water Levels for each piezometer category

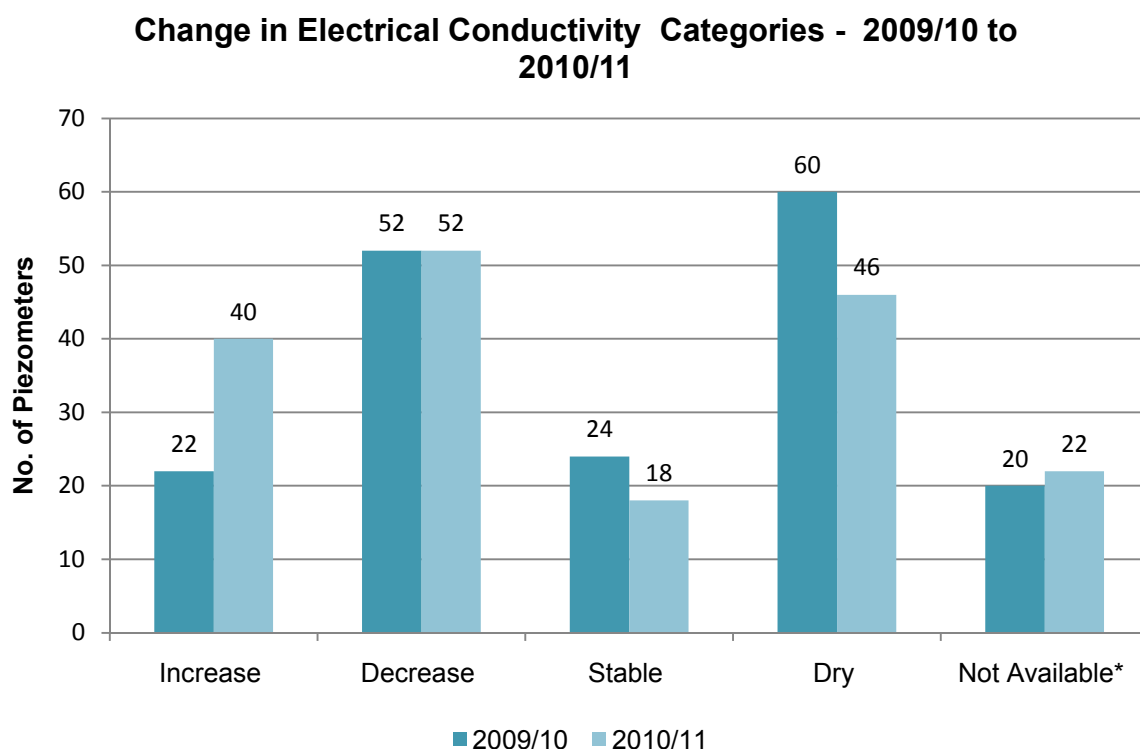
EC samples were taken from one hundred and ten piezometers in the 2010/11 reporting period (Figure 10). Forty samples increased in salt concentration, with fifty two decreasing, when compared to 2009/10 results. Eighteen samples remained stable (± 0.05 dS/m), with forty six piezometers found to be dry.

When comparing 2010/10 EC change with previous reporting period, results show an overall migration from dry and stable EC change categories to an increase in EC, with no change in the number of piezometer samples revealing a decrease in EC.

Figure 10: EC Categories 2009/10 to 2010/11. **Not available refers to a piezometer that did not contain enough water to sample (NETS) or a piezometer that is not able to be bailed.*

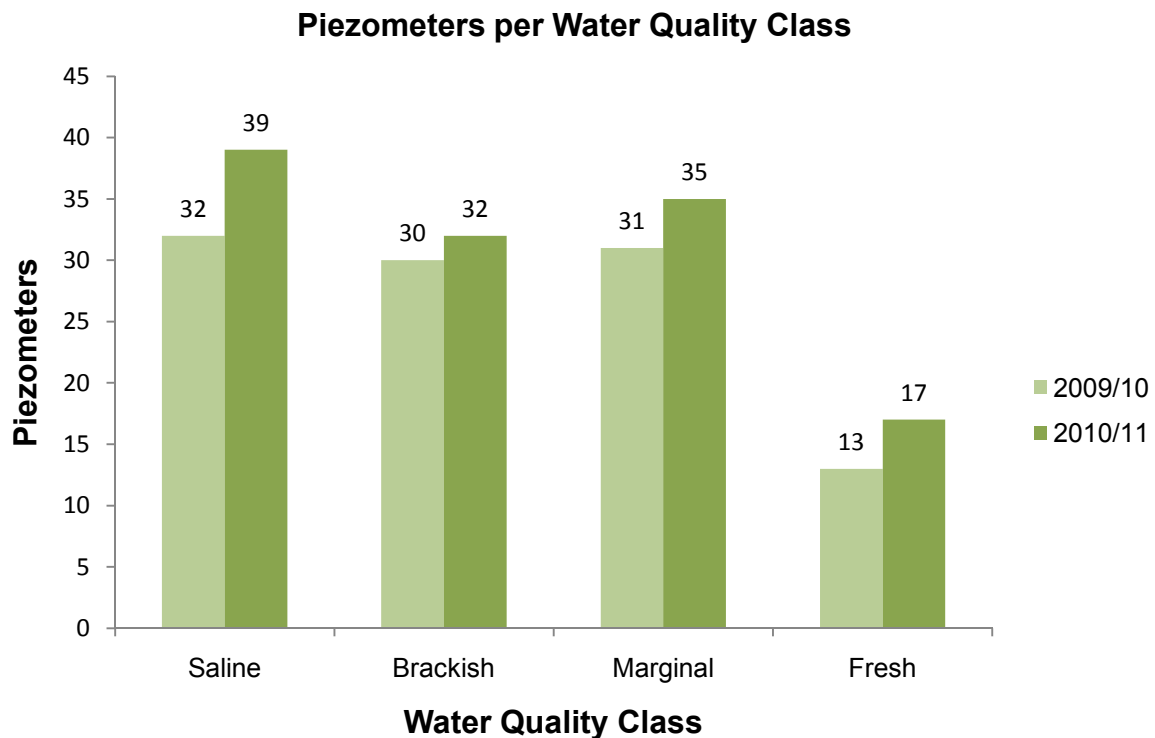
To measure the severity of electrical conductivity results within the Wagga Wagga Local Government Area, EC results were sorted into water quality classes. A comparison between the current and previous reporting periods of the number of piezometers in each water quality class is presented in Figure 11. Similar ratios of piezometers were defined within the saline, brackish and

marginal water quality classes between the two reporting periods, reflecting groundwater testing from the newly drilled piezometers in 2010/11.

Figure 11: Average EC 2009/10 and 2010/11 water quality classes as defined by *Australian Water Resources Council (1976)*. Saline = >4.8 dS/m; Brackish = 1.6-4.8; Marginal = 0.8-1.6; Fresh = <0.8.
