Wagga Wagga Urban Salinity Technical Report 2015/2016

Prepared by the Community
Sector of Wagga Wagga City
Council

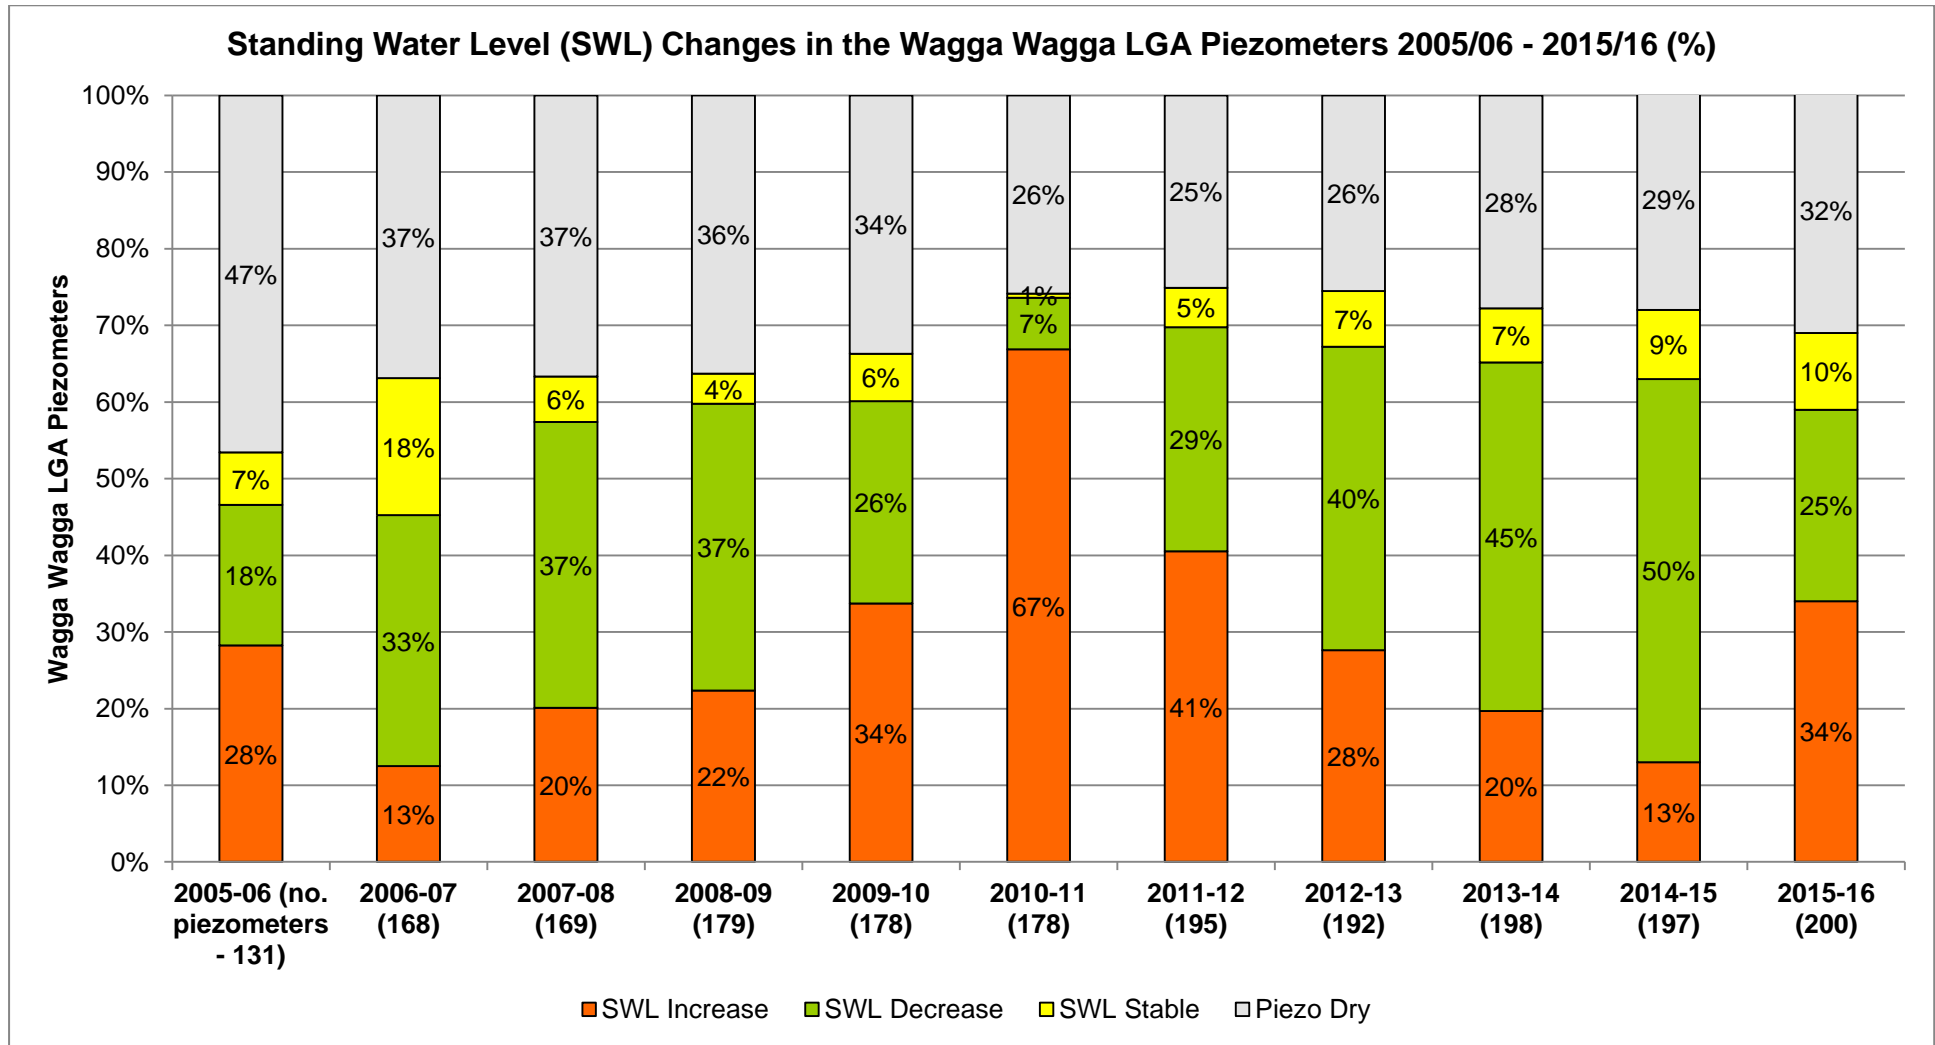
Figure 1: Graph depicting annual change in overall piezometer readings as a percentage of all piezometers in the Wagga Wagga LGA.

Figure 1 shows annual changes (as a percentage) in SWL for all piezometers in the Wagga Wagga LGA for annual reporting periods between 2005/06 – 2015/16. For example, of the two hundred piezometers measured during the 2015/16 reporting period, 34% showed an increase in SWL when compared to the previous years' readings, 25% decreased in SWL, 32% were dry and 10% remained stable. This allows for overall trending of groundwater conditions for the region based on all piezometers recorded.

It can be seen that from 2006/07 to 2010/11 there was a quite steep rise in SWL increase (from 13 - 67% of all piezometers respectively), coinciding with a decline in both SWL decrease (33 - 7%) and piezometers in a dry state (37 - 26%).

For the current reporting period (2015/16), overall piezometers showing a SWL increase rose, reversing a recent trend, from 13 - 34% when comparing results between 2014/15. The majority of these piezometers migrated to a SWL decrease change, decreasing from 50 to 25% of all piezometers, when comparing the two reporting periods.

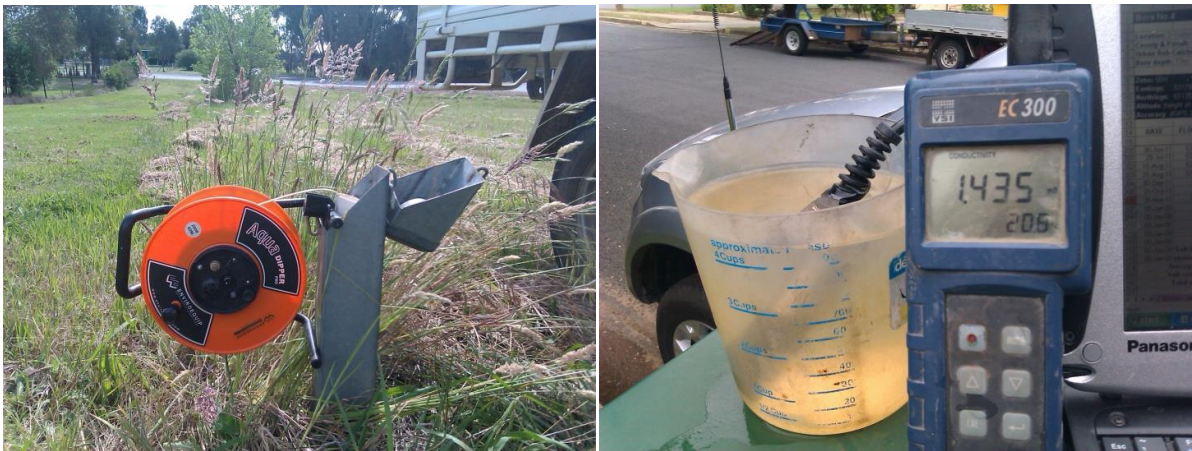
Figure 3: Measuring standing water level (left) and electrical conductivity (right) of groundwater.

Standing water level (SWL) and electrical conductivity (EC) readings are collected and used to monitor urban salinity. The SWL is measured in metres below the ground surface to the nearest centimetre using a water level meter. Measurements are taken from the height of the piezometer casing and the height of the extension subtracted from the reading. Piezometers at ground level do not require a subtraction. Water is extracted from the piezometer using a bailer to measure for EC. The EC is measured in decisiemens per metre (dS/m) to two decimal places using a handheld conductivity meter (Figure 3).

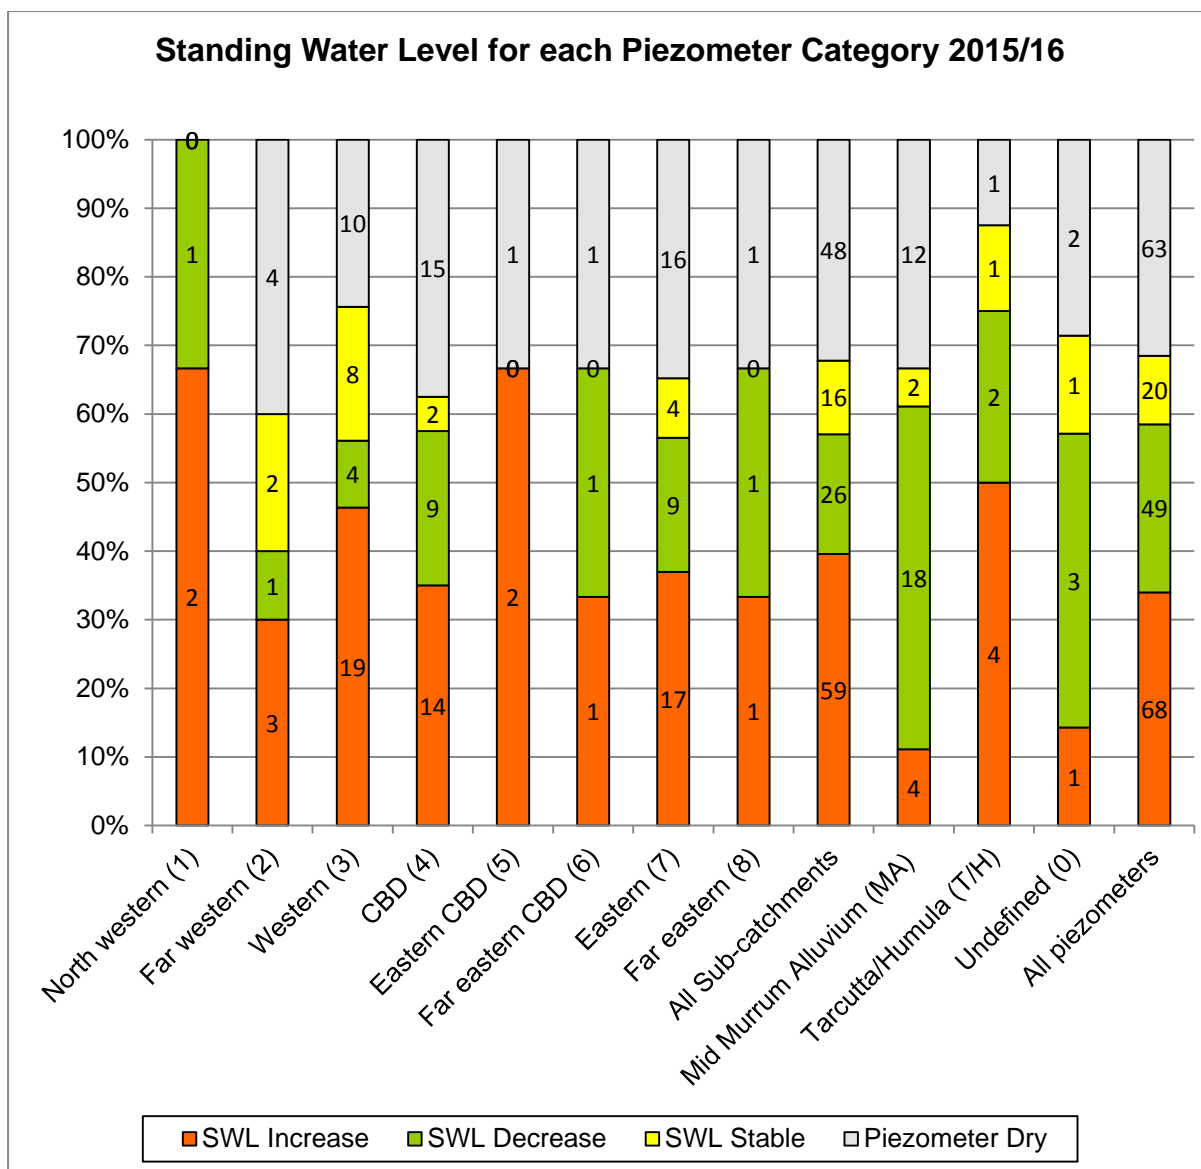
Figure 5: Chart depicting change in Standing Water Levels for each piezometer category

The change in SWL for each piezometer category during 2015/16 is presented in Figure 5.

The dataset shows that the greatest number of piezometers, sixty eight (34%), have increased in standing water level (SWL) when comparing SWL change between 2015/16 and 2014/15. Forty nine (25%) recorded a decrease in SWL with sixty three (32%) piezometers remaining dry, during the reporting period. Twenty (10%) piezometers remained stable (those with an increase/decrease of 5cm or less).
