Wagga Wagga Urban Salinity Technical Report 2013/2014

Prepared by the Directorate
of Environmental and
Community Services

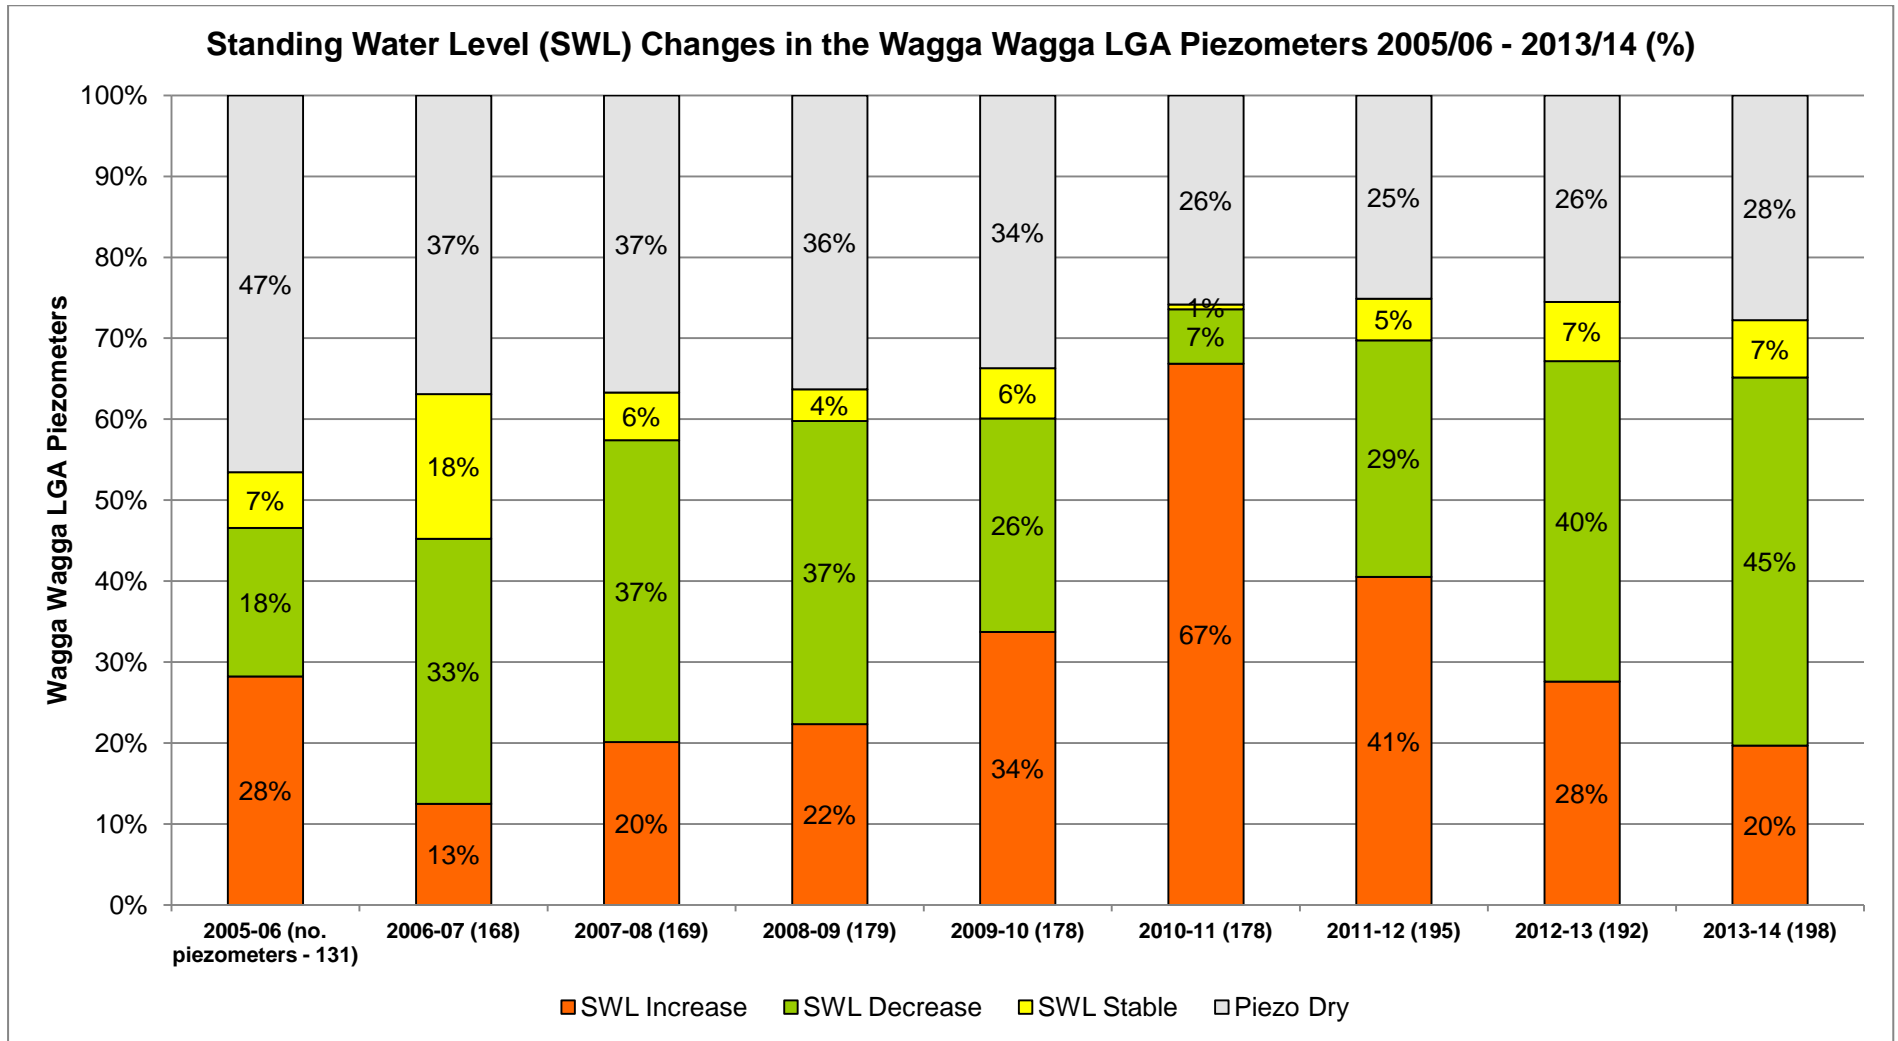
Figure 1: Graph depicting annual change in overall piezometer readings as a percentage of all piezometers in the Wagga Wagga LGA.

Figure 1 shows annual changes (as a percentage) in SWL for all piezometers in the Wagga Wagga LGA for annual reporting periods between 2005/06 - 2013/14. For example, of the one hundred and ninety eight piezometers measured during the 2013/14 reporting period, 45% showed a decrease in SWL when compared to the previous years' readings, 20% increased in SWL, 28% were dry and 7% remained stable. This allows for overall trending of groundwater conditions for the region based on all piezometers recorded.

It can be seen that from 2006/07 to 2010/11 there was a quite steep rise in SWL increase (from 13 - 67% of all piezometers respectively), coinciding with a decline in both SWL decrease (33 - 7%) and piezometers in a dry state (37 - 26%).

For the current reporting period (2013/14), overall piezometers showing a SWL increase dropped, continuing a recent trend, from 28 - 20% when comparing results between 2012/13. The majority of these piezometers migrated to a SWL decrease change, increasing from 40 to 45% of all piezometers, when comparing the two reporting periods.

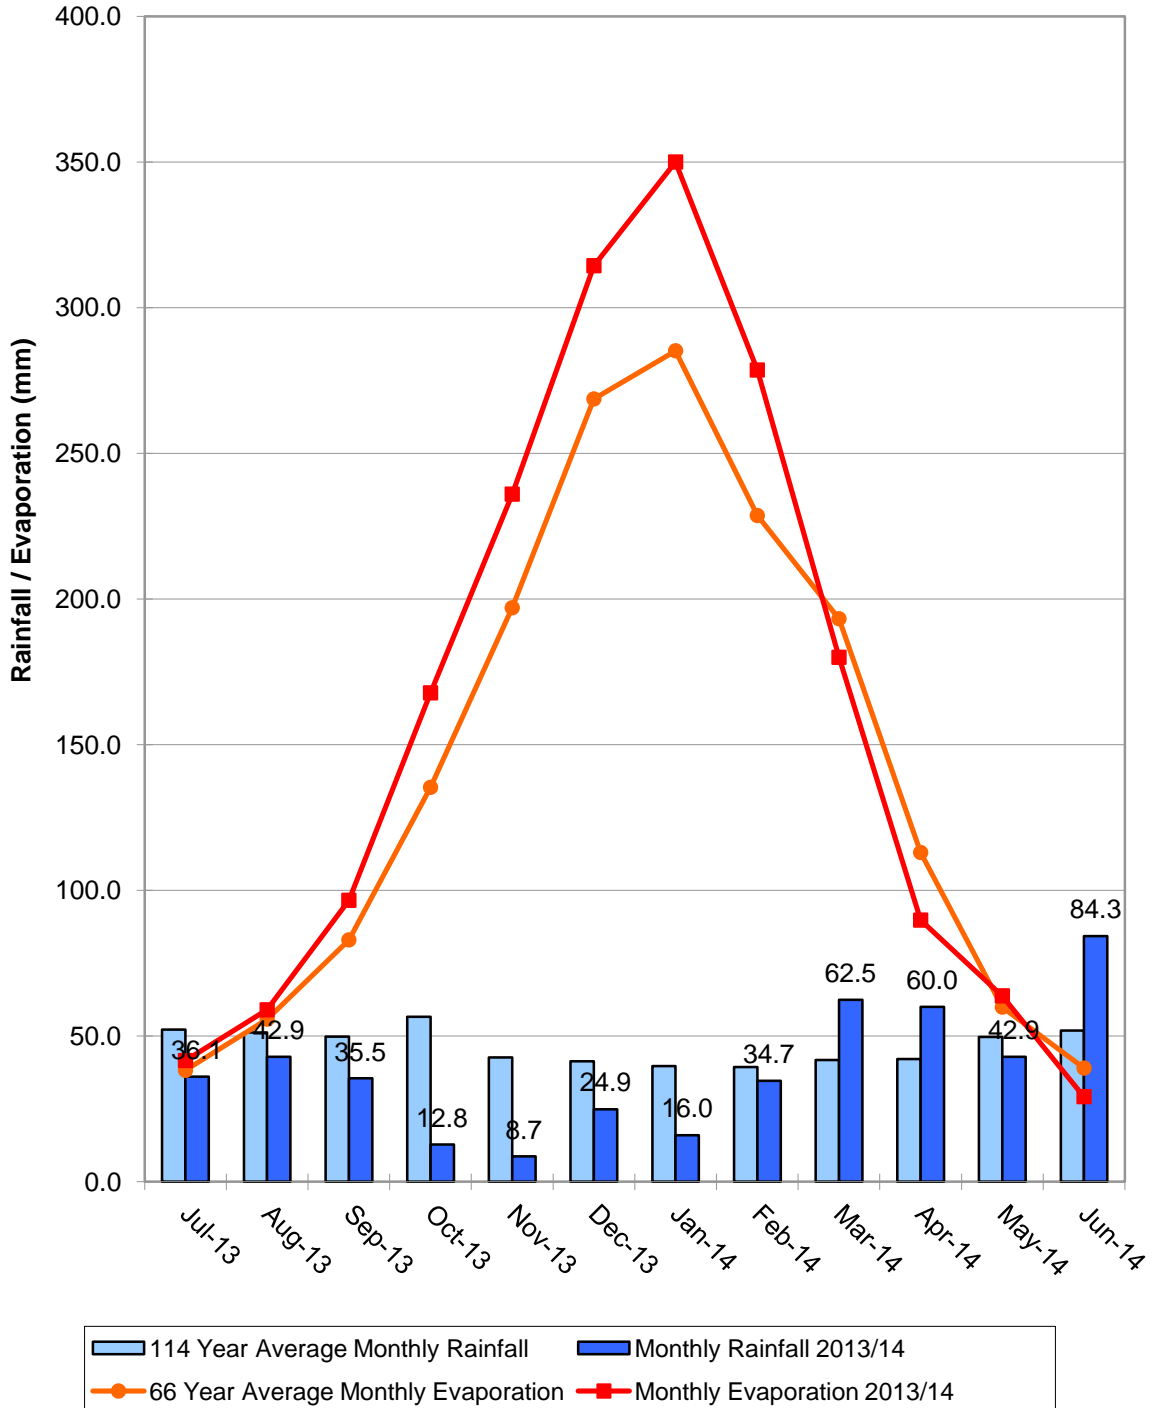
Long Term versus Short Term Rainfall and Evaporation Data for Wagga Wagga

Figure 2: Monthly rainfall and evaporation graph for Wagga Wagga 2013/14

The Bureau of Meteorology field station at Forest Hill, Wagga Wagga recorded rainfall and evaporation data during the period from July 2013 to June 2014. Historical data was gathered from either the 'Forest Hill' or the 'Wagga Wagga Agricultural Institute' field station dependant on the commenced date. Rainfall data from the 'Wagga Wagga Agricultural Institute' field station was used to determine the historical mean rainfall as data collection commenced in 1898 (Figure 2).

The 2013/14 reporting period in Wagga Wagga recorded 461mm of rainfall. This figure represents a 17% decrease on historical average rainfall (559mm).

Long term monthly rainfall averages exceeded monthly rainfall figures on nine occasions during 2013/14, with the warmer months of October 2013, November 2013, December 2013, and January 2014 recording only 13mm, 9mm, 25mm and 16mm respectively.

The 2013/14 reporting period in Wagga Wagga recorded 1907mm of evaporation. This figure represents a 12% increase on historical average evaporation (1697mm). Monthly evaporation readings for 2013/14 were above historical monthly averages on nine occasions. Again, the warmer months of October 2013 to February 2014 saw evaporation figures of between 15-25% higher than historical monthly averages.

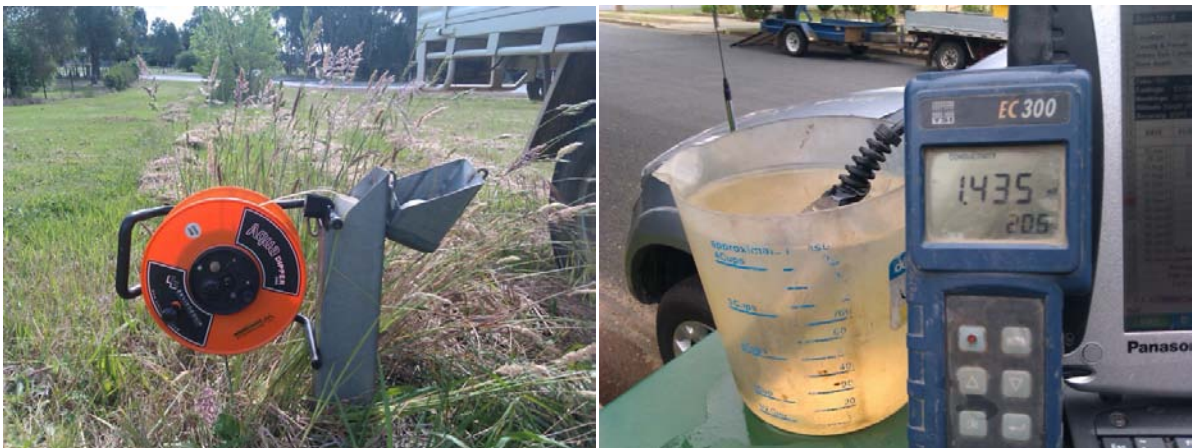
Figure 3: Measuring standing water level (left) and electrical conductivity (right) of groundwater.

Standing water level (SWL) and electrical conductivity (EC) readings are collected and used to monitor urban salinity. The SWL is measured in metres below the ground surface to the nearest centimetre using a water level meter. Measurements are taken from the height of the piezometer casing and the height of the extension subtracted from the reading. Piezometers at ground level do not require a subtraction. Water is extracted from the piezometer using a bailer to measure for EC. The EC is measured in decisiemens per metre (dS/m) to two decimal places using a handheld conductivity meter (Figure 3).

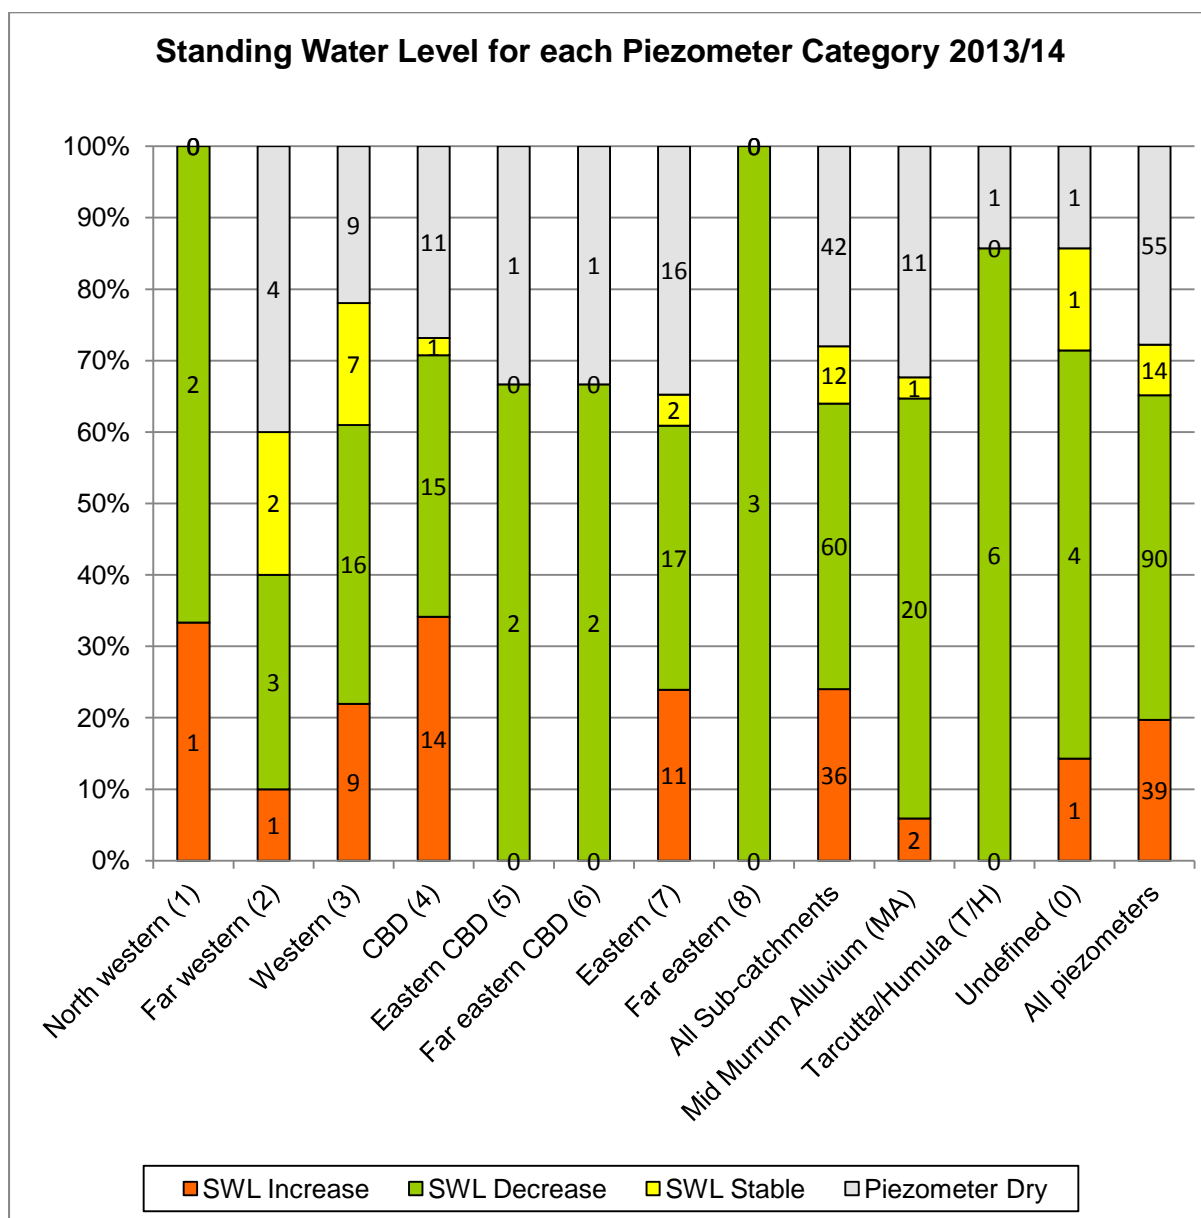
Figure 5: Chart depicting change in Standing Water Levels for each piezometer category

The change in SWL for each piezometer category during 2013/14 is presented in Figure 5.

The dataset shows that the greatest number of piezometers, ninety (45%), have decreased in standing water level (SWL) when comparing SWL change between 2013/14 and 2012/13. Thirty nine (20%) recorded an increase in SWL with fifty five (28%) piezometers remaining dry, during the reporting period. Fourteen (7%) piezometers remained stable (those with an increase/decrease of 5cm or less).
