Wagga Wagga Urban Salinity Technical Report 2016/2017

PREPARED BY THE COMMUNITY DIRECTORATE OF WAGGA
WAGGA CITY COUNCIL

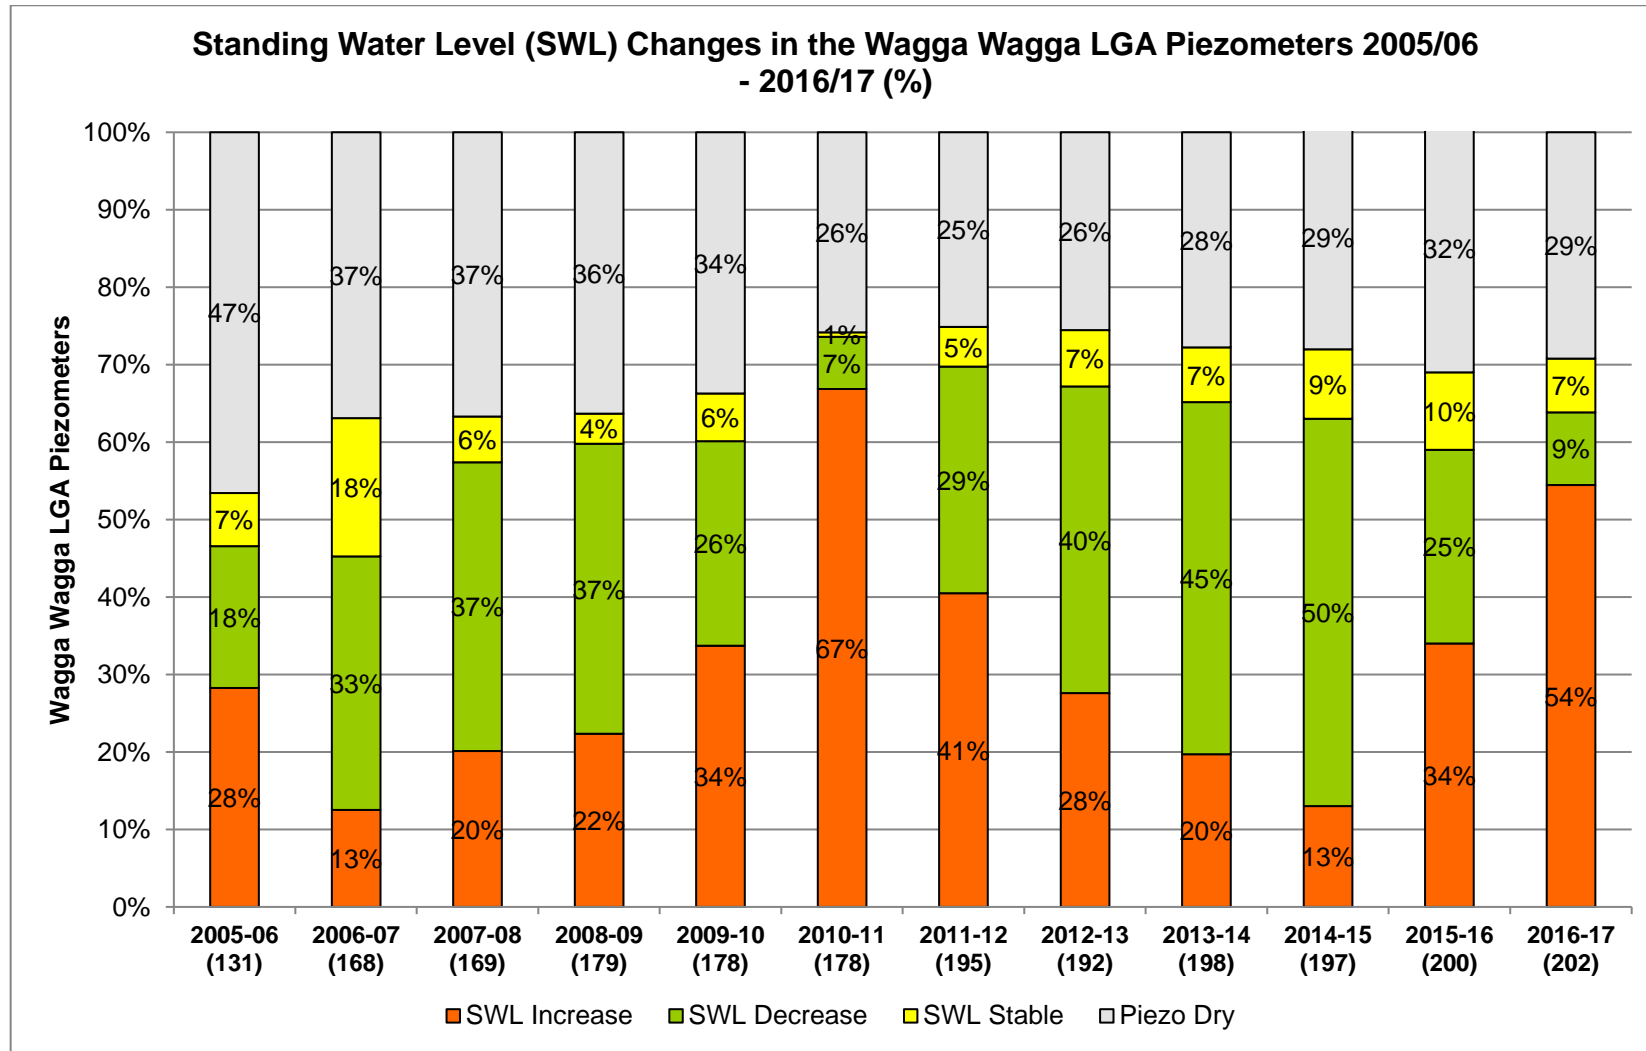
Figure 1 shows annual changes (as a percentage) in SWL for all piezometers in the Wagga Wagga LGA for annual reporting periods between 2005/06 – 2016/17. For example, of the two hundred and two piezometers measured during the 2016/17 reporting period, 54% showed an increase in SWL when compared to the previous years' readings, 9% decreased in SWL, 29% were dry and 7% remained stable. This allows for overall trending of groundwater conditions for the region based on all piezometers recorded.

It can be seen that from 2006/07 to 2010/11 there was a quite steep rise in SWL increase (from 13 - 67% of all piezometers respectively), coinciding with a decline in both SWL decrease (33 - 7%) and piezometers in a dry state (37 - 26%). Following this period, from 2010/11 to 2014/15, there was a steep declining trend in SWL increase (from 67 – 13%), coinciding with an inverse increase in SWL decrease (from 7 – 50%).

Figure 1: Graph depicting annual change in overall piezometer readings as a percentage of all piezometers in the Wagga Wagga LGA.

For the current reporting period (2016/17), overall piezometers showing a SWL increase rose, continuing a recent trend, from 13 - 54% when comparing results from 2014/15. The majority of these piezometers migrated to a SWL decrease change, decreasing from 50 to 9% of all piezometers, when comparing the reporting periods.

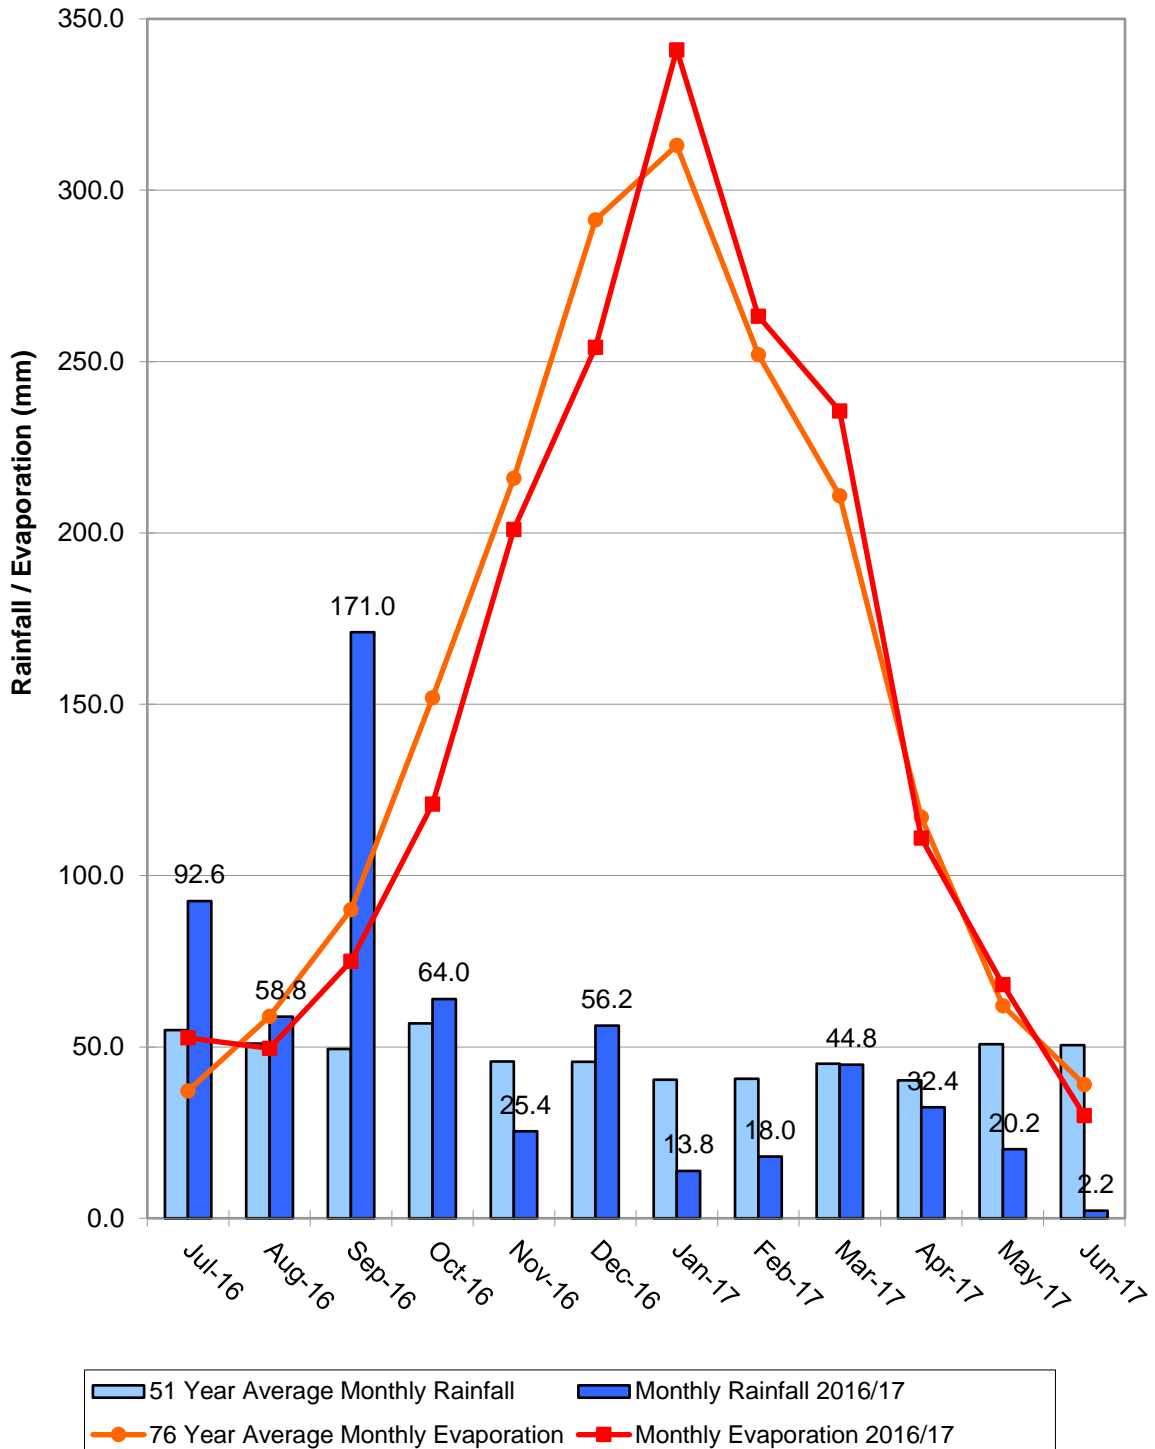
Long Term versus Short Term Rainfall and Evaporation Data for Wagga Wagga

The Bureau of Meteorology field station at Forest Hill, Wagga Wagga recorded historical averages and annual monthly rainfall and evaporation data during the period from July 2016 to June 2017 (Figure 2).

Figure 2: Monthly rainfall and evaporation graph for Wagga Wagga 2016/17.

The 2016/17 reporting period in Wagga Wagga recorded 599mm of rainfall, an decrease of 52mm compared to 2015/16 total of 651mm. This figure represents a 5% increase on historical average rainfall (571mm). Long term monthly rainfall averages exceeded monthly rainfall figures on seven occasions during 2016/17, with major rainfall events occurring in July and September. The months from January to June 2017 saw below average rainfall.

The 2016/17 reporting period in Wagga Wagga recorded 1802mm of evaporation. This figure is equal to historical averages, and fractionally below the 2015/16 reporting period evapotranspiration total of 1860mm.

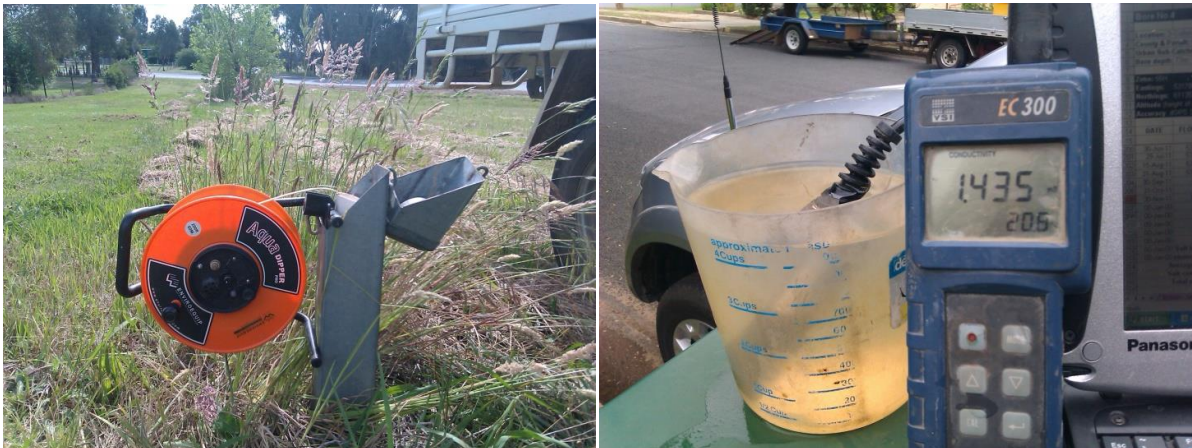
Standing water level (SWL) and electrical conductivity (EC) readings are collected and used to monitor urban salinity. The SWL is measured in metres below the ground surface to the nearest centimetre using a water level meter. Measurements are taken from the height of the piezometer casing and the height of the extension subtracted from the reading. Piezometers at ground level do not require a subtraction. Water is extracted from the piezometer using a bailer to measure for EC. The EC is measured in decisiemens per metre (dS/m) to two decimal places using a handheld conductivity meter (Figure 3).

Figure 3: Measuring standing water level (left) and electrical conductivity (right) of groundwater.

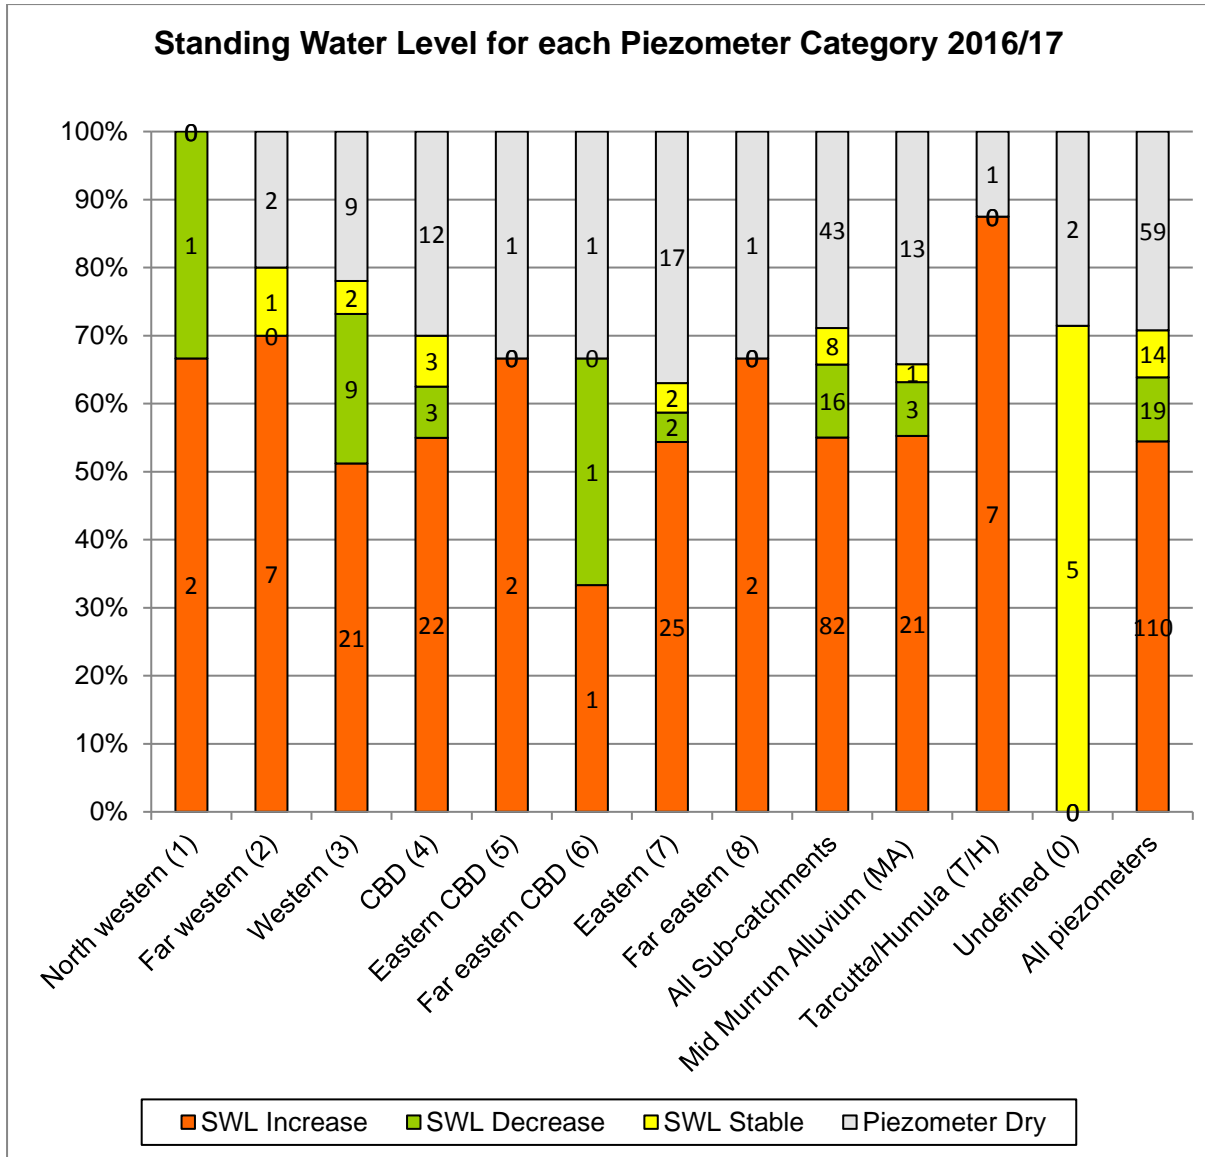
The change in SWL for each piezometer category during 2016/17 is presented in Figure 5.

Figure 5: Chart depicting change in Standing Water Levels for each piezometer category

The dataset shows that the greatest number of piezometers, one hundred and ten (54%), have increased in standing water level (SWL) when comparing SWL change between 2016/17 and 2015/16. Nineteen (9%) recorded a decrease in SWL with fifty-nine (29%) piezometers remaining dry, during the reporting period. Fourteen (7%) piezometers remained stable (those with an increase/decrease of 5cm or less).

Piezometers that contained water in the previous year that are now dry have been included in the 'SWL decreased' category, whereas piezometers that started as dry but now contain groundwater have been included in the 'SWL increased' category. These results were omitted from average increase/decrease calculations. Graphs of individual piezometers containing groundwater have been placed in Appendix D.

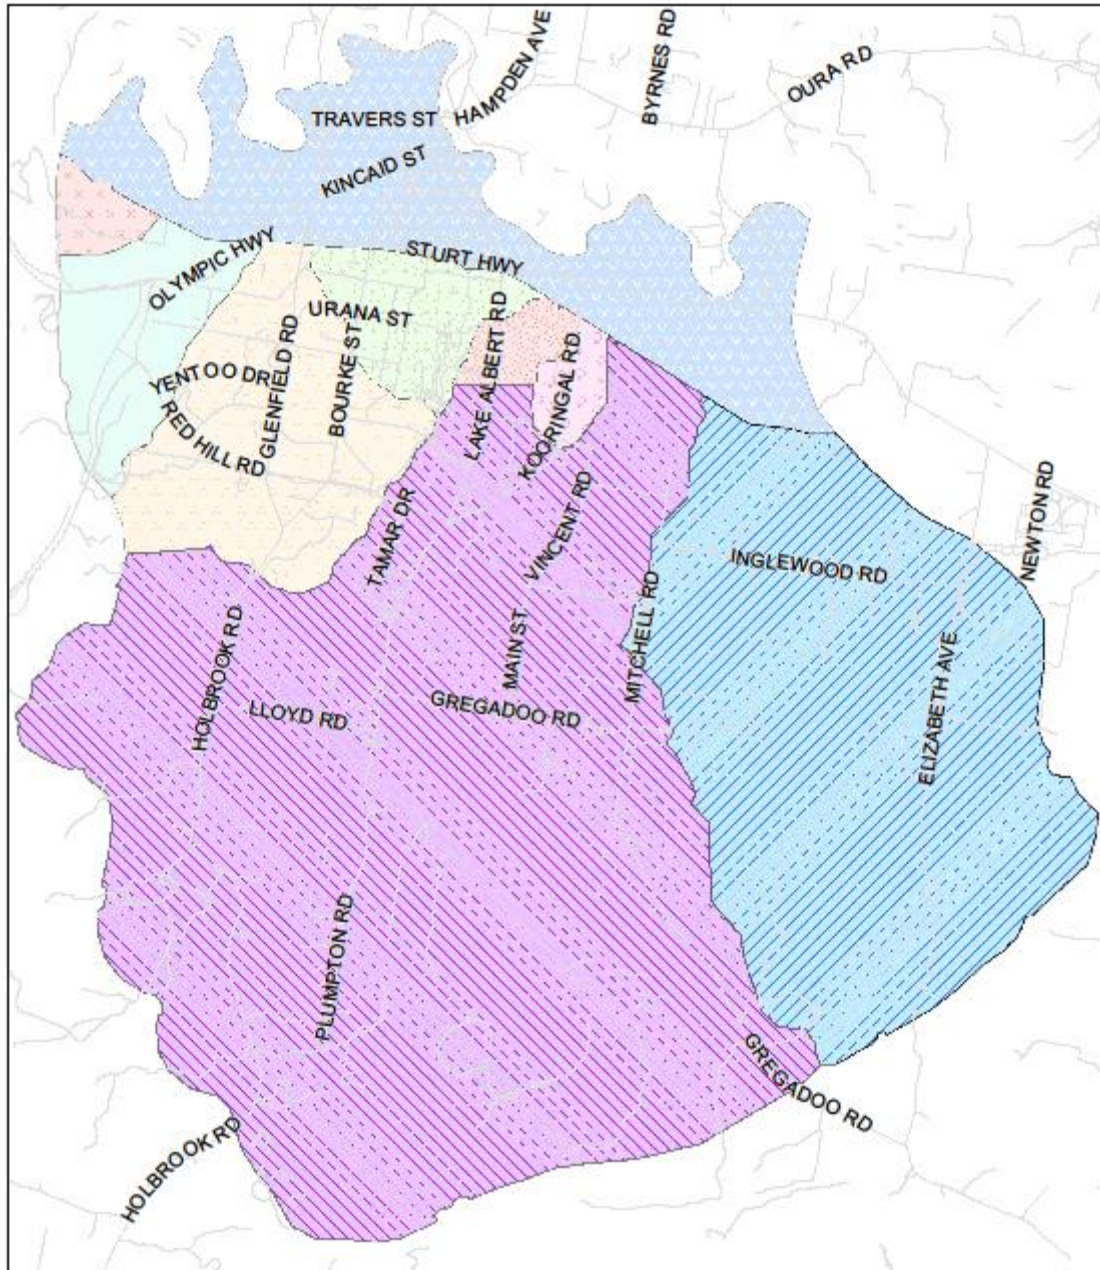
Wagga Wagga Major Urban Sub-catchments

Please note that the 'Undefined' and 'Tarcutta/Humula' piezometer categories are not presented on this map.

To allow for meaningful interpretation of the data piezometers are grouped into eleven categories. Nine categories are based on the major sub-catchments identified by Golder (2007). Two additional groups (Undefined and Tarcutta/Humula) have been added to accommodate for piezometers outside the area recognised in the Golder (2007) study.
