# Wagga Wagga Urban Salinity Technical Report 2017/2018

Prepared by the Community  
Sector of Wagga Wagga City  
Council

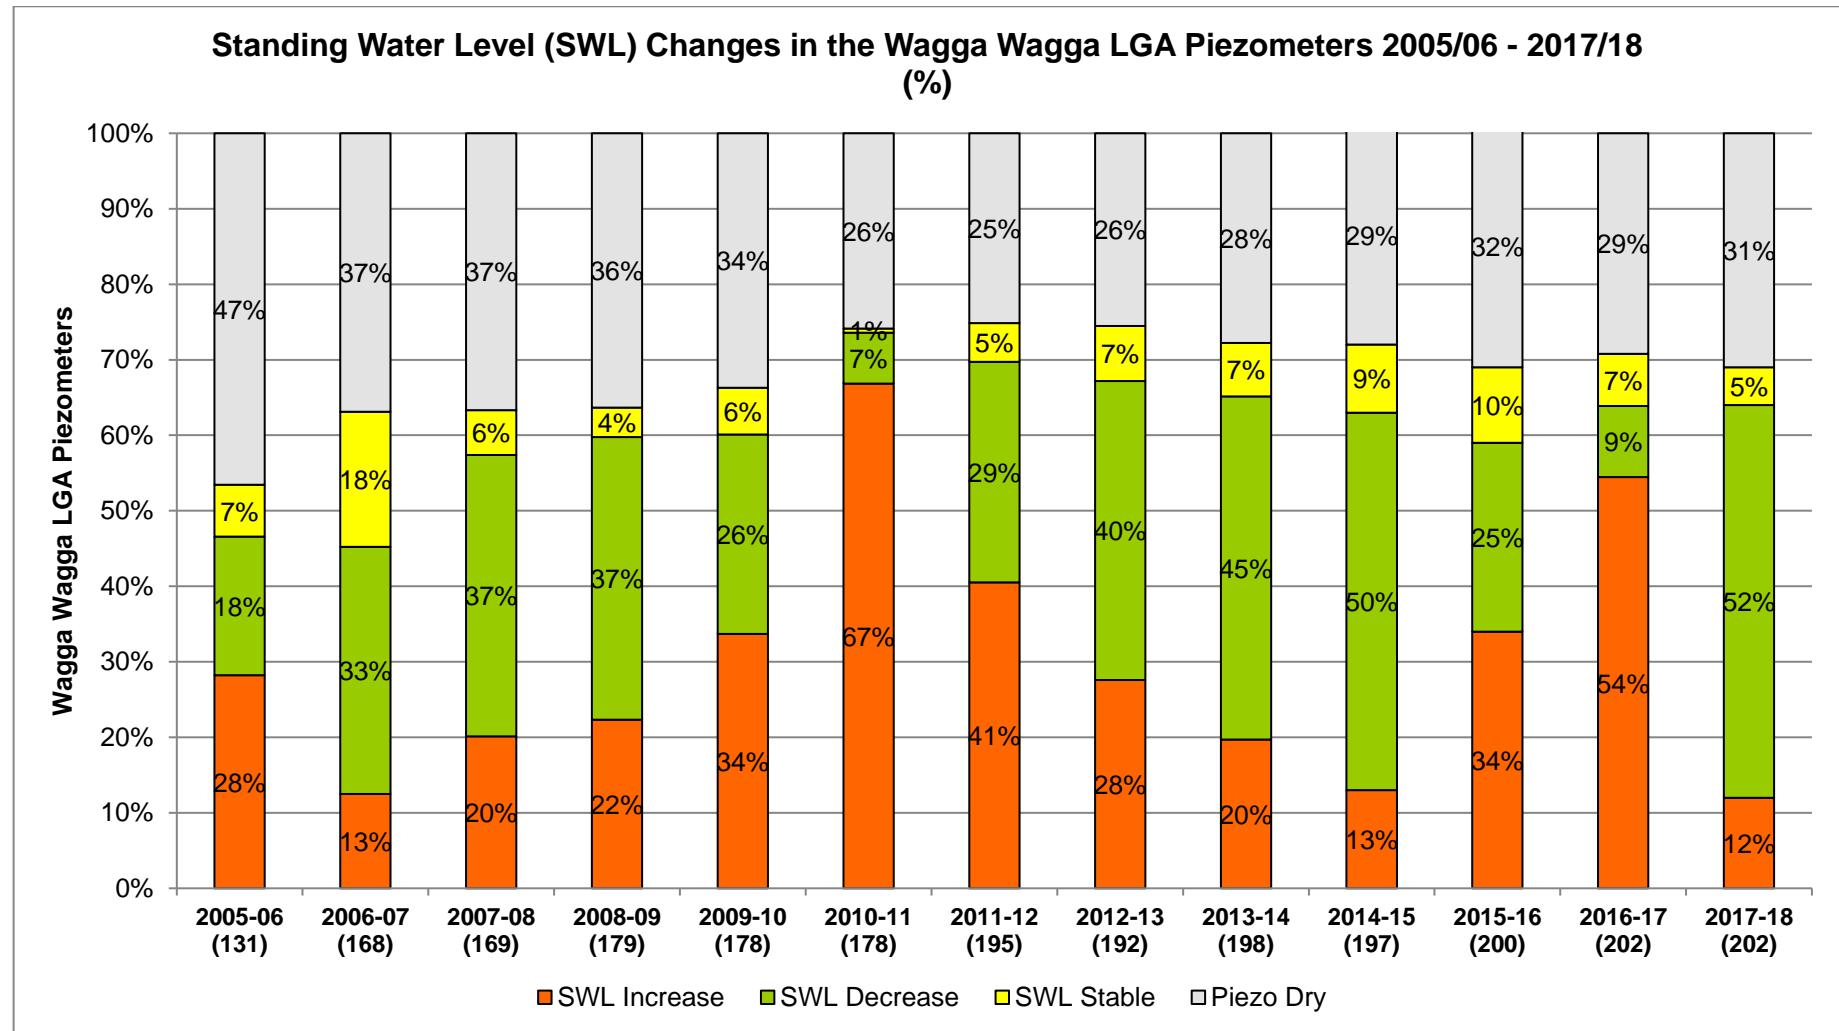
**Figure 1:** Graph depicting annual change in overall piezometer readings as a percentage of all piezometers in the Wagga Wagga LGA.

Figure 1 shows annual changes (as a percentage) in SWL for all piezometers in the Wagga Wagga LGA for annual reporting periods between 2005/06 – 2017/18. For example, of the two hundred and two piezometers measured during the 2017/18 reporting period, 52% showed a decrease in SWL when compared to the previous years' readings, 12% increased in SWL, 31% were dry and 5% remained stable. This allows for overall trending of groundwater conditions for the region based on all piezometers recorded.

It can be seen that from 2006/07 to 2010/11 there was a quite steep rise in SWL increase (from 13 - 67% of all piezometers respectively), coinciding with a decline in both SWL decrease (33 - 7%) and piezometers in a dry state (37 - 26%). Following this period, from 2010/11 to 2014/15, there was a steep declining trend in SWL increase (from 67 – 13%), coinciding with an inverse increase in SWL decrease (from 7 – 50%).

For the current reporting period (2017/18), overall piezometers showing a SWL increase dramatically dropped, reversing a recent trend, from 13 - 54% when comparing results from 2014/15 to 2016/17 to 12% in 2017/18. The majority of these piezometers migrated to a SWL decrease change, increasing from 9% to 52% of all piezometers, when comparing the previous reporting period.

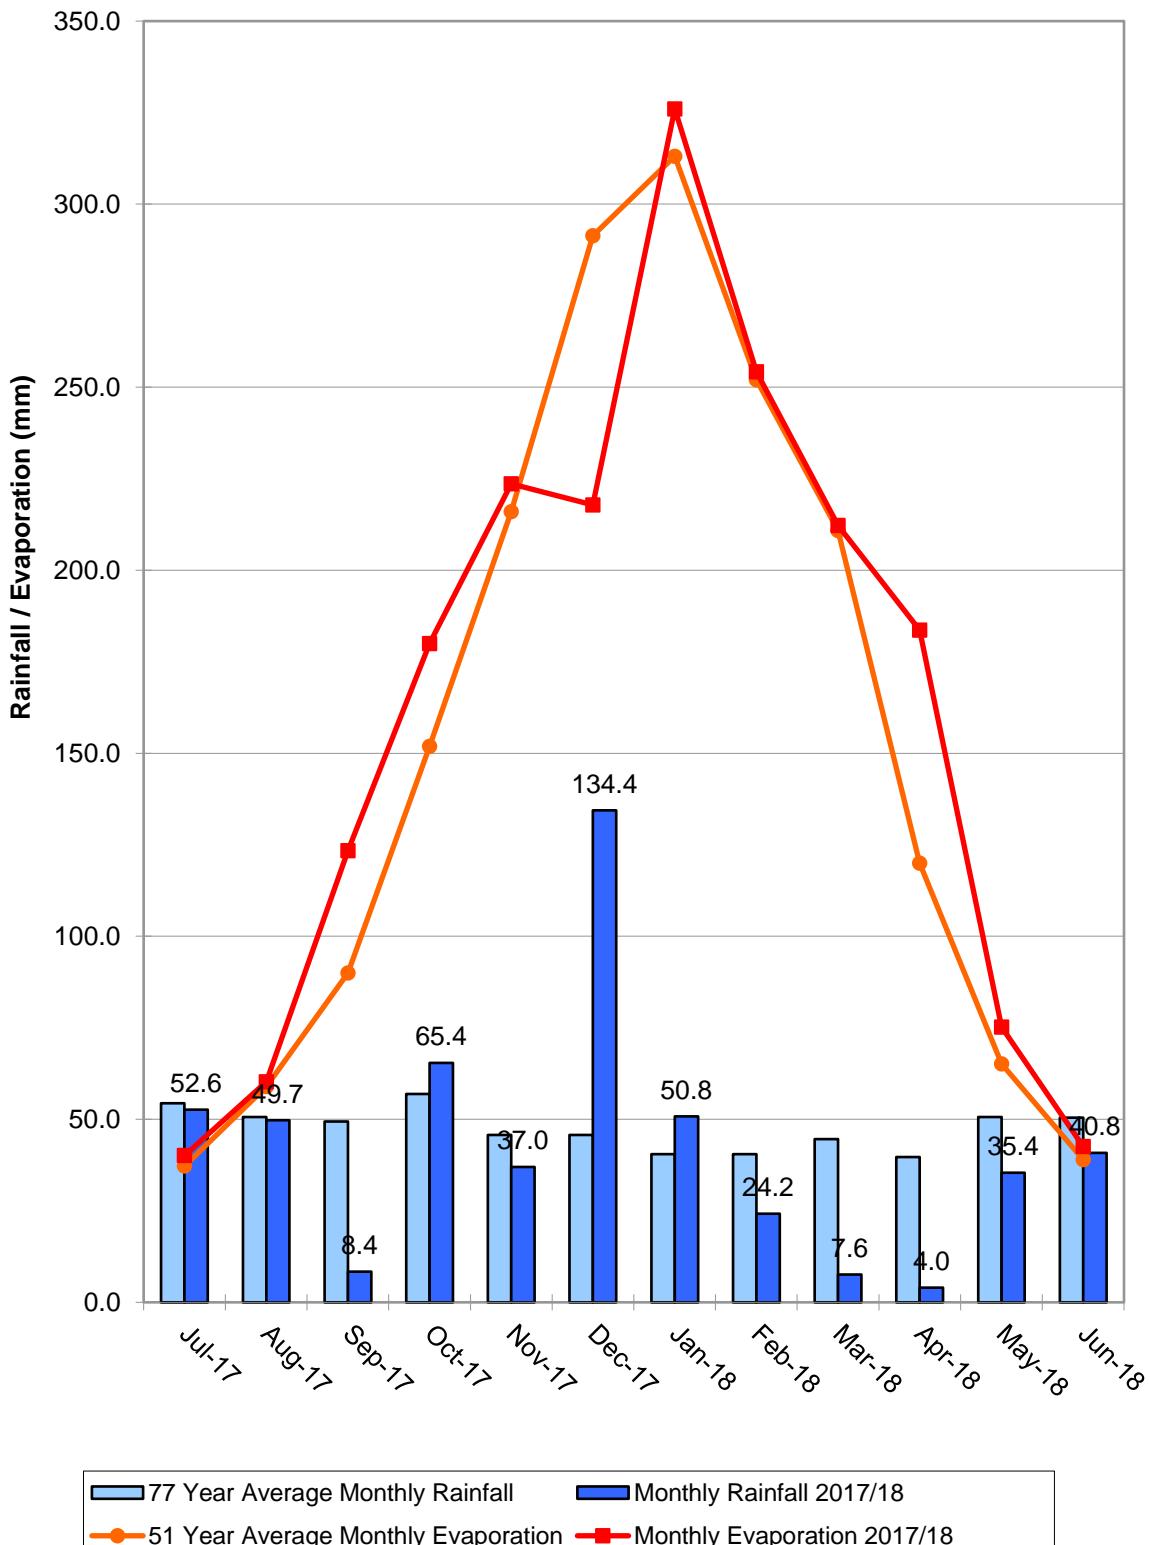
**Long Term versus Short Term Rainfall and Evaporation Data  
for Wagga Wagga**

**Figure 2:** Monthly rainfall and evaporation graph for Wagga Wagga 2017/18.

The Bureau of Meteorology field station at Forest Hill, Wagga Wagga recorded historical averages and annual monthly rainfall and evaporation data during the period from July 2017 to June 2018 (Figure 2).

The 2017/18 reporting period in Wagga Wagga recorded 510mm of rainfall, a decrease of 89mm compared to 2016/17 total of 599mm. This figure represents a 10% increase on historical average rainfall (569mm). Monthly rainfall averages exceeded historical monthly rainfall figures on only three occasions during 2017/18, with a major rainfall events occurring in December. Nine months in 2017/18 saw below average rainfall.

The 2017/18 reporting period in Wagga Wagga recorded 1939mm of evaporation. This figure is 4% higher than historical averages of 1862mm, and an increase from the 2016/17 reporting period evapotranspiration total of 1802mm.

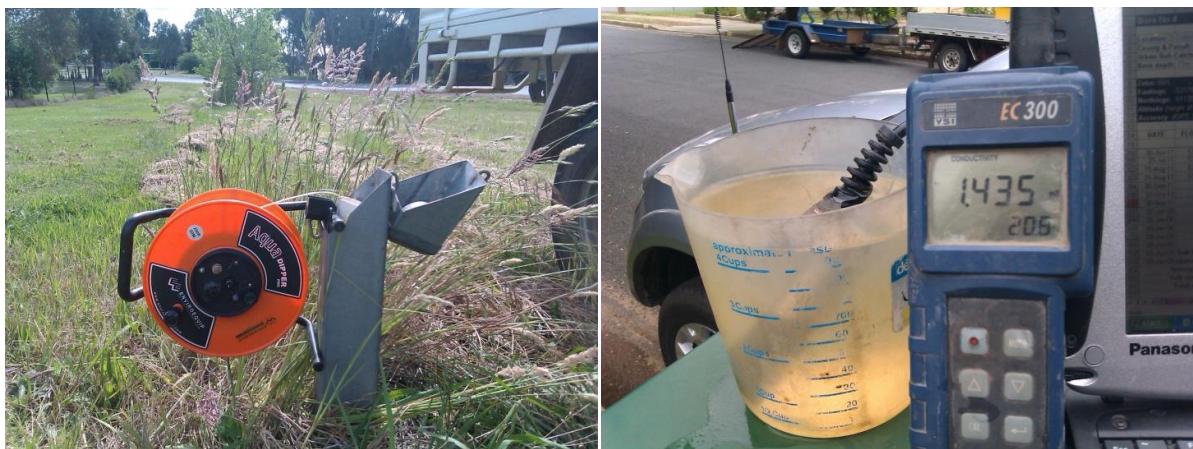
**Figure 3:** Measuring standing water level (left) and electrical conductivity (right) of groundwater.

Standing water level (SWL) and electrical conductivity (EC) readings are collected and used to monitor urban salinity. The SWL is measured in metres below the ground surface to the nearest centimetre using a water level meter. Measurements are taken from the height of the piezometer casing and the height of the extension subtracted from the reading. Piezometers at ground level do not require a subtraction. Water is extracted from the piezometer using a bailer to measure for EC. The EC is measured in decisiemens per metre (dS/m) to two decimal places using a handheld conductivity meter (Figure 3).

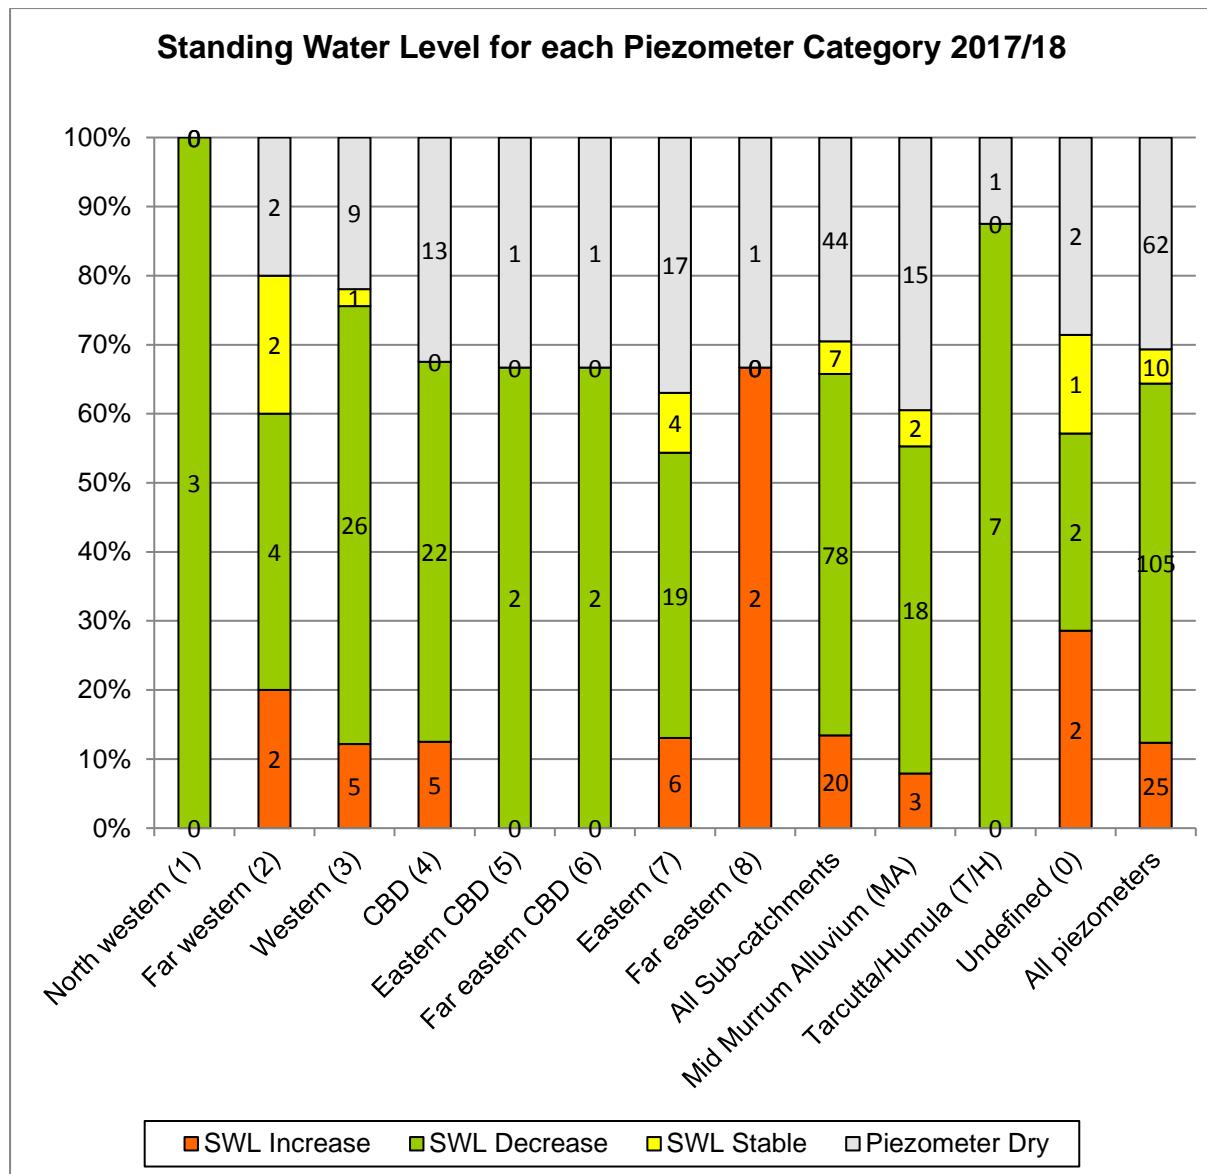
**Figure 5:** Chart depicting change in Standing Water Levels for each piezometer category

The change in SWL for each piezometer category during 2017/18 is presented in Figure 5.

The dataset shows that the greatest number of piezometers, one hundred and five (52%), have decreased in standing water level (SWL) when comparing SWL change between 2016/17 and 2017/18. Twenty-five (12%) recorded an increase in SWL with sixty-two (31%) piezometers remaining dry, during the reporting period. Ten (5%) piezometers remained stable (those with an increase/decrease of 5cm or less).

Piezometers that contained water in the previous year that are now dry have been included in the ‘SWL decreased’ category, whereas piezometers that started as dry but now contain groundwater have been included in the ‘SWL increased’ category. These results were omitted from average increase/decrease calculations. Graphs of individual piezometers containing groundwater have been placed in Appendix D.

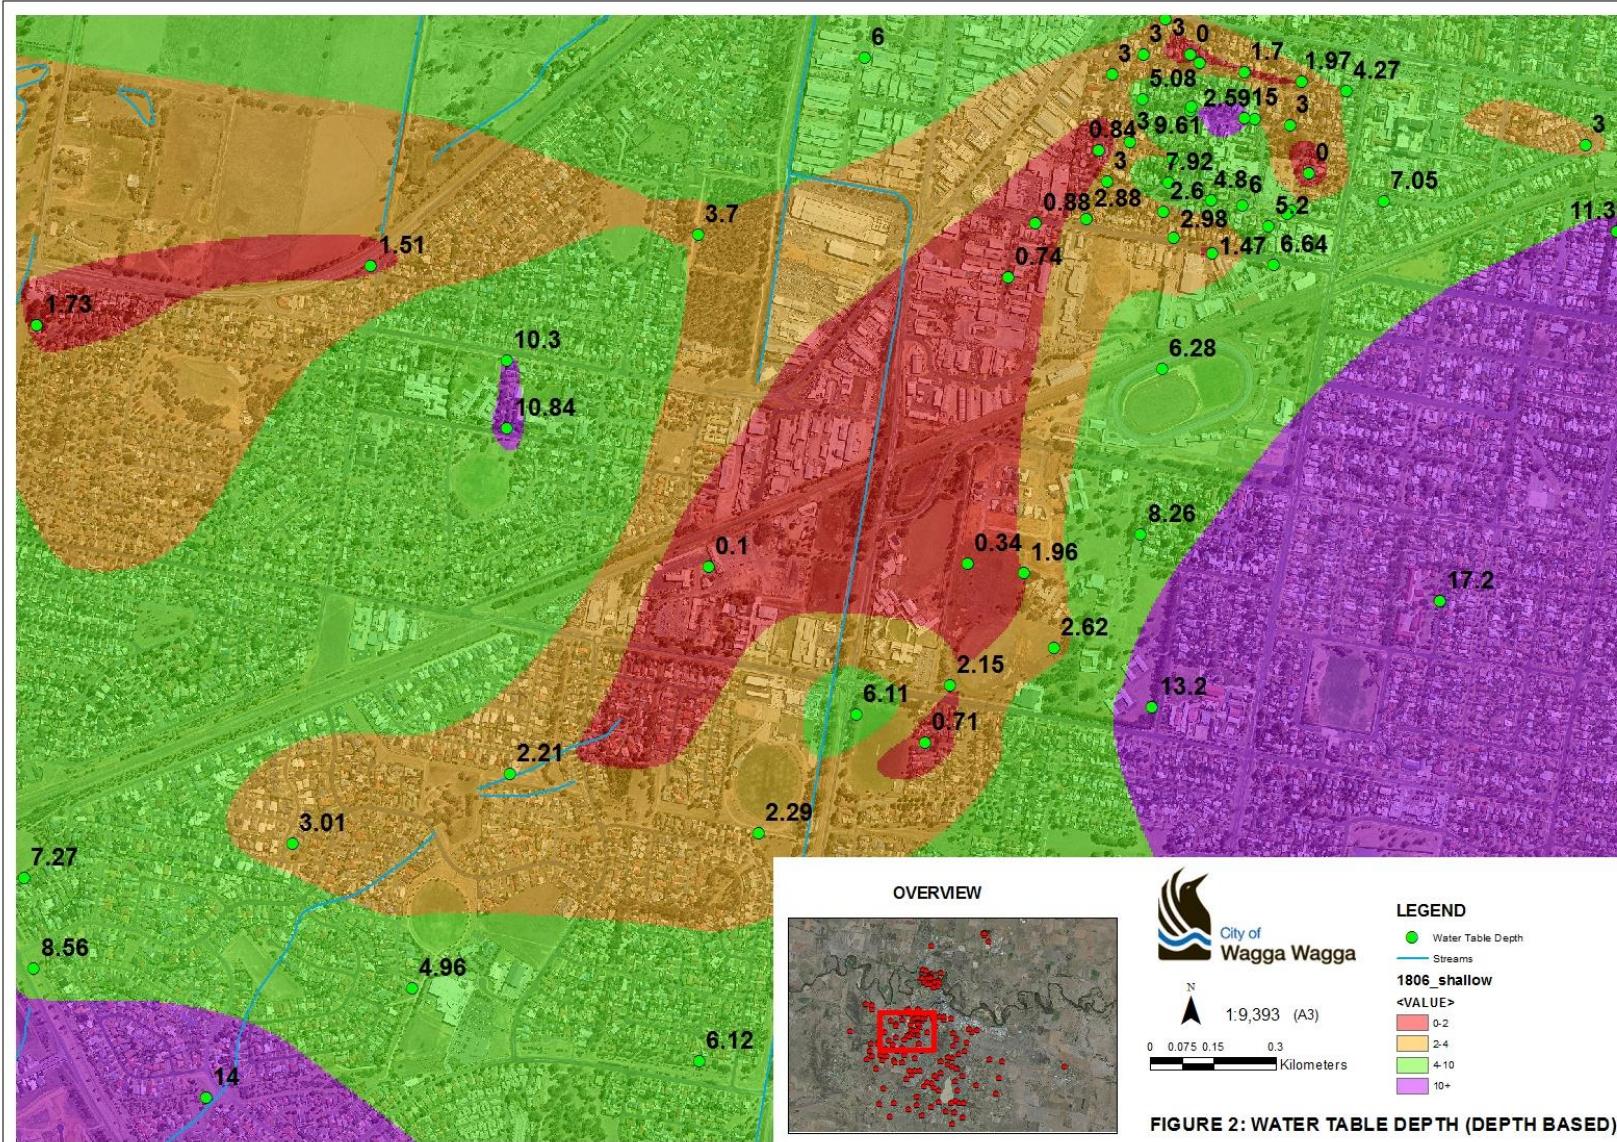
Figure 6: Groundwater contour map showing water table contour levels interpolated from piezometer readings taken in June 2018.

Figure 6 shows the groundwater contour map of Western catchments of Wagga Wagga (Calvary, Turvey Park, Mount Austin, Ashmont, Glenfield, Lloyd) interpolated from piezometers measured in June 2018. Red areas indicate extremely shallow groundwater levels between 0 – 2m from surface level, orange areas show 2 – 4m from surface, green areas showing 4 – 10m from surface and purple areas show groundwater levels greater than 10m from surface. Numbers labelling piezometer points (black dots) show actual readings taken in the field on or before June 2018.
